# Preliminary Information

## PIP5330D Coolant Loss And/Or Coolant Odor

**A vehicle may have a concern with coolant loss and/or coolant odor after driving the vehicle.**

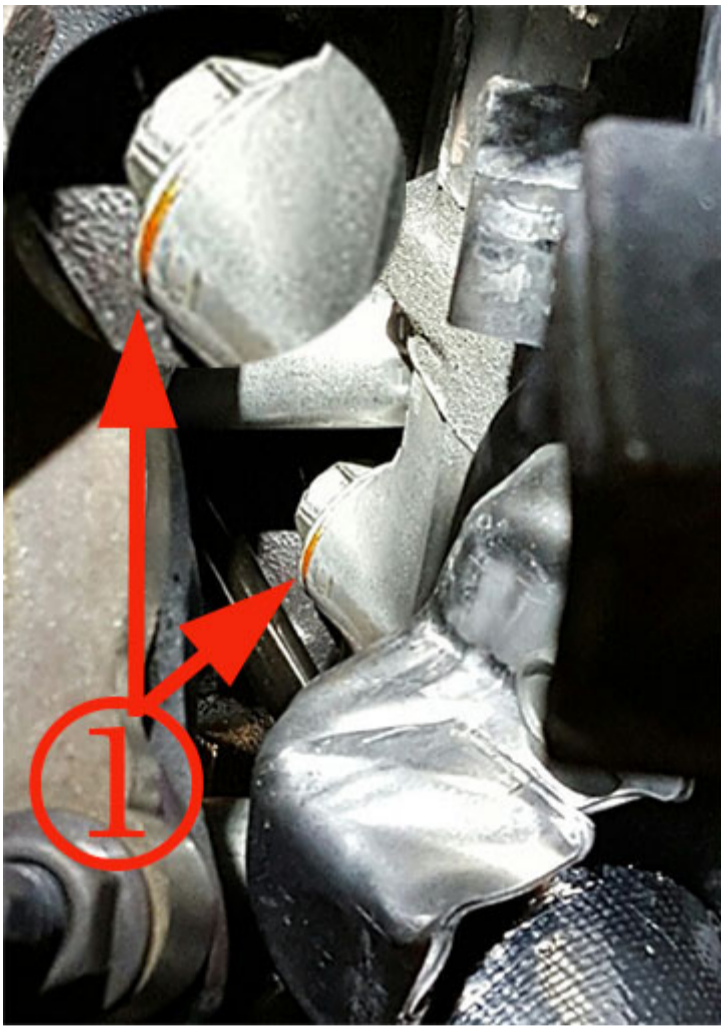
**If the coolant is low pressure test the cooling system looking for leaks at the outer head bolts. See below:**

**If a leak is found the head with the concern will need to be replaced.**
