# 2020 IS300/IS350 Pre-Delivery Service (PDS)

**Section** Pre-Delivery Service

| YEAR(S) | MODEL(S) | ADDITIONAL INFORMATION |
|---|---|---|
| 2020 | IS300, IS350 | |

This bulletin contains the vehicle specific pre-delivery services for 2020 model year IS300 and IS350 vehicles. Additionally, refer to the applicable Pre-Delivery Service (PDS) Check Sheet for services to be performed.

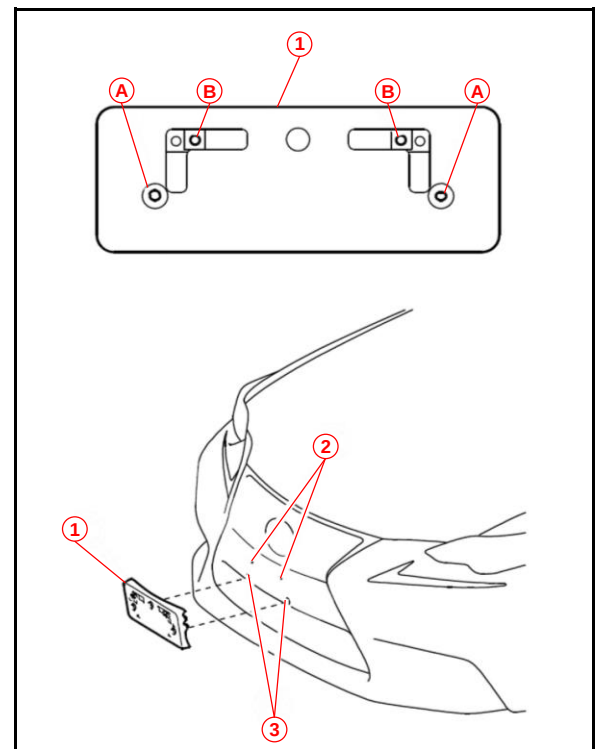
**Figure 1.**

1. Align holes "A" of the mounting bracket with the dimples on the front bumper cover. Mark the location of holes "B" on the front bumper cover.

- Holes "A" are used to install the mounting bracket onto the radiator grille.
- Holes "B" are used to install the front license plate onto the mounting bracket.

2. Drill two relief holes with a diameter of 10 mm (0.39 in.) at the marks on the front bumper cover (holes "B" location) to prevent the license plate retaining bolt ends from contacting the cover.

**Do NOT drill into the dimples on the front bumper cover.**

| 1 | Mounting Bracket |
| 2 | Mark and Drill Holes |
| 3 | Dimple |

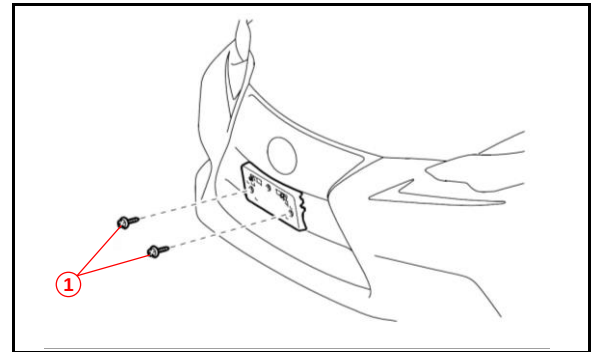
**Figure 2.**

3. Install the mounting bracket to the front bumper cover at holes "A" using the two supplied self-tapping screws.

| <b>1</b> | Self-tapping Screw |

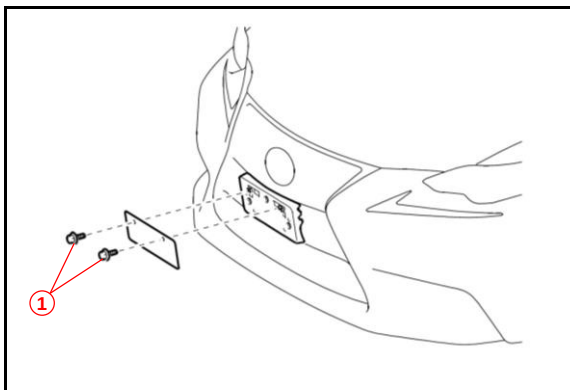
**Figure 3.**

4. Install the front license plate to the mounting bracket at holes "B" using two non-corroding bolts with the following dimensions:

| <b>1</b> | Bolt |

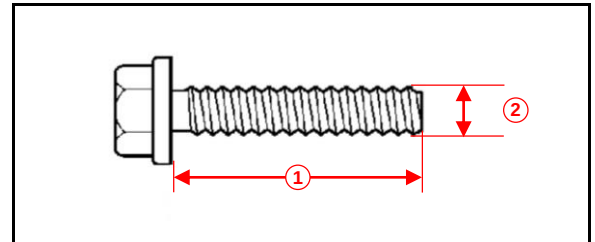
**Figure 4.**

**Nominal Length: 15.0 mm (0.59 in.)**

**Diameter: 6.0 mm (0.24 in.)**

| <b>1</b> | Nominal Length |
| <b>2</b> | Diameter |

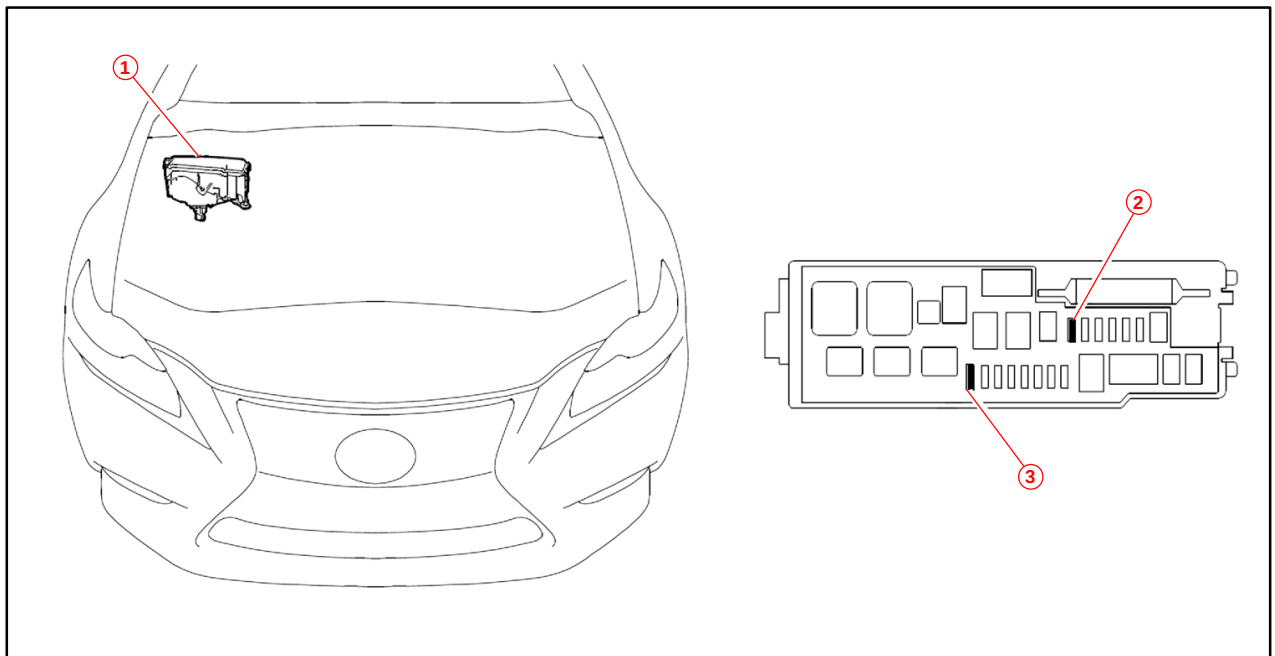
**Figure 5.**

To minimize battery discharge during transportation and storage, the D/C cut fuse (30A) has been removed at the assembly plant and temporarily stored in the blank space of the relay block in the engine compartment.

During PDS, remove the D/C cut fuse (30A) from the blank space of the relay block in the engine compartment and install it in the location shown.

| <b>1</b> | Relay Block |
| <b>2</b> | Install D/C Cut Fuse (30A) (Original Location) |

| <b>3</b> | Remove This D/C Cut Fuse |

- Removing the D/C cut fuse cuts OFF power sources relating to the DOME and MPX-B.
- While the vehicle is stored at the dealership, disconnect the negative (–) battery terminal to prevent battery discharge. Refer to Service Bulletin No. [L-SB-0013-19](#), *Battery Maintenance During PDS*.

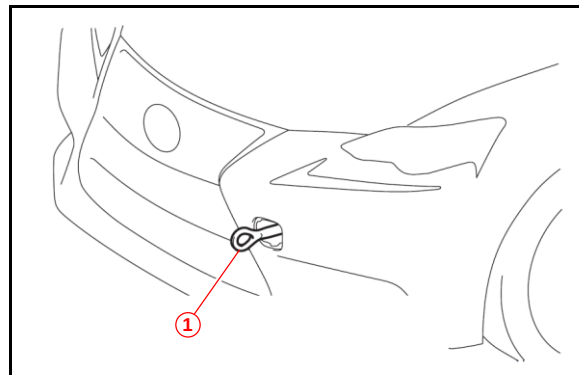
Figure 6.

1. Remove the front emergency towing eyelets from the front bumper by turning them counterclockwise.

If it is difficult to loosen the front emergency towing eyelets, use a steel bar.

1 Front Emergency Towing Eyelet

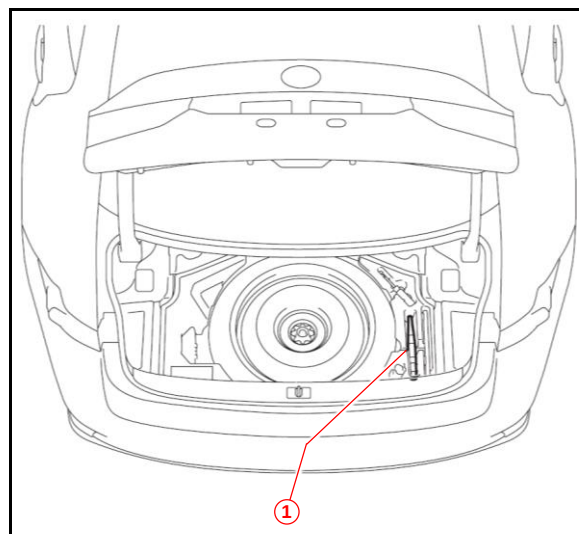
Figure 7.

2. Place the removed front emergency towing eyelet into the tool tray in the luggage compartment.

1 Front Emergency Towing Eyelet

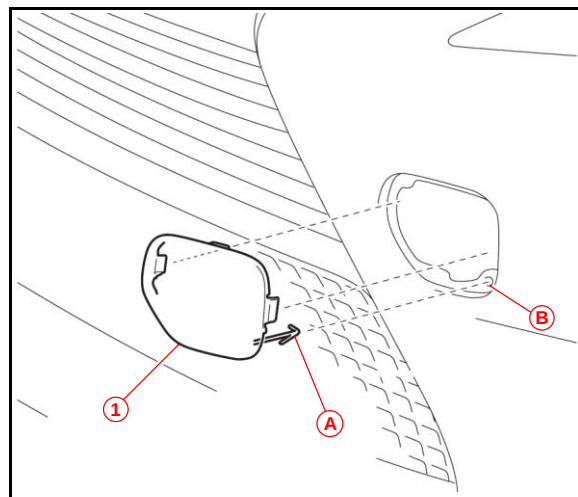
Figure 8.

1. Install the front emergency towing eyelet hole covers, which are stored in the glove compartment, onto the front bumper.
  - A. Insert the arrow-shaped tab of the front emergency towing eyelet hole cover "A" into the eyelet hole tab "B" as shown.
  - B. Install the front emergency towing eyelet hole cover to the hole of the front bumper.

| A | Arrow-Shaped Tab |
| B | Eyelet Hole Tab |
| 1 | Front Emergency Towing Eyelet Hole Cover |

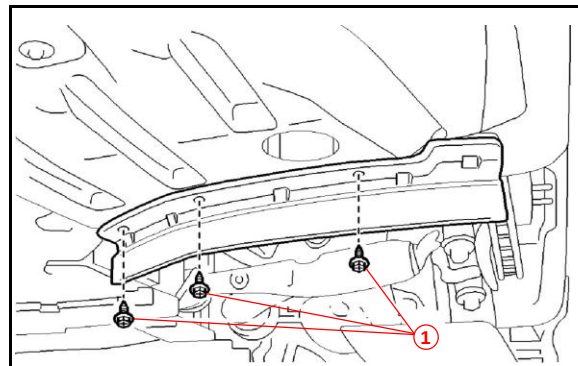
Figure 9.

The front wheel opening extension pad set (right and left front wheel opening extension pads, six self-tapping screws) is loaded in the luggage compartment at the assembly plant to avoid damage in transit.

Install the left and right front wheel opening extension pads with the supplied self-tapping screws.

| 1 | Self-tapping Screw |
