GROUP	NUMBER
BODY	19-BD-001H-1
DATE	MODEL(S)
November, 2019	2015 - 2016MY Genesis
	00110010

Technical Service Bulletin

GENESIS (DH) PANORAMIC SUNROOF REPAIR SUBJECT

This TSB supersedes 19-BD-001H to add Inoperative Slide as a new condition and update the service procedure.

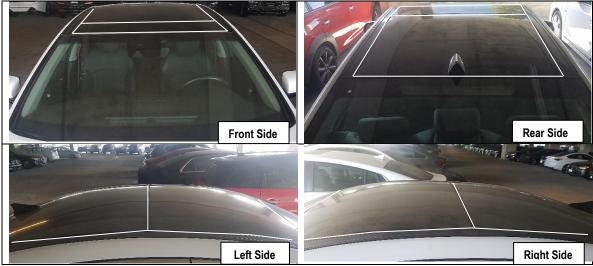
Sunroof Orientation:

- A. Weather Strip (pg. 3)
- B. Front Sunroof Glass Molding (pg. 3)
- C. Rear Fixed Glass (pg. 3)
- D. Rear Sunroof Glass Molding (pg. 4)
- E. Sunroof Button (pg. 4)
- F. Moving Glass (pg. 4,6-7,13)
- G. Front Corner Fixed Seal (pg. 5,7)
- H. Front Sunroof Side Molding (pg. 6)
- I. Rear Glass Molding (pg. 6)
- J. LH/RH Side Molding (pg. 7)
- K. Mechanism Rail Assembly (pg. 8)

- L. Moving Glass Rear (pg. 8)
- M. Front Sunroof Mounting Bolts (pg. 10)
- N. Front Sunroof Mounting Nuts (pg. 10-11)
- O. 'B' Pillar Mounting Nuts (pg. 11)
- P. Sunroof Rear Mounting Nuts (pg. 11)
- Q. Moving Glass Front Mounting Bolts. (pg. 12)
- R. Moving Glass Center/Rear Mounting Bolts (pg. 12)
- T. Rear Locator Mounting Bolts (pg. 13,15)
- U. Rear Locator (pg. 13-16)
- S. Panel Curve (pg. 15-16)
- V. 'C' Pillar Roof Panel (pg. 17)

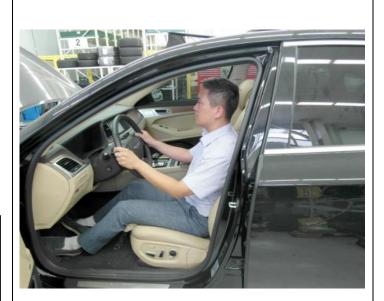
After silicone oil and grease application, open and close the sunroof and set the sunroof to "tilt" position. Inspect for noise or slide non-operation.

If noise or slide non-operation is not observed, the service procedure is now complete.

If creaking/slide non-operation still occurs, move to:

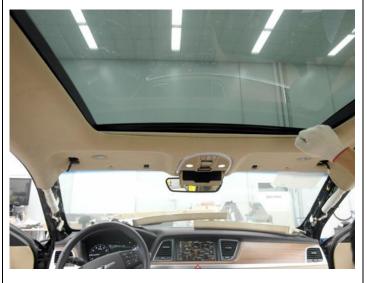
1. The repair of the panoramic sunroof requires sunroof fastener inspection and, if needed, torque to specifications.

To access the sunroof fasteners, the headliner must be partially lowered. To lower the headliner, review the following vehicle shop manual section:

Disregard steps (1-2) of the shop manual repair procedure. Lowering the headliner will not require removal of the seat assembly.
