HYUNDAI Technical Service Bulletin

GROUP Campaign	NUMBER 19-01-033H
DATE November, 2019	MODEL(S) NEXO (FE)

SUBJECT: NEXO HYDROGEN PRESSURE SENSOR REPLACEMENT
(SERVICE CAMPAIGN T4E)

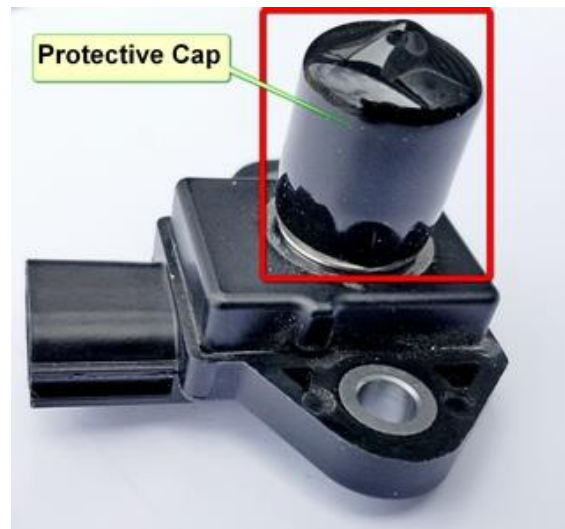
- Perform this procedure only outdoors at a designated Hydrogen venting location.
- Damage to the sensor may occur if the thin metal membrane (A) makes contact with other objects. Do not touch or allow sensor membrane to contact other objects.
- Use extreme care when handling and installing the sensor! Keep protective cap installed until the sensor is ready to install.

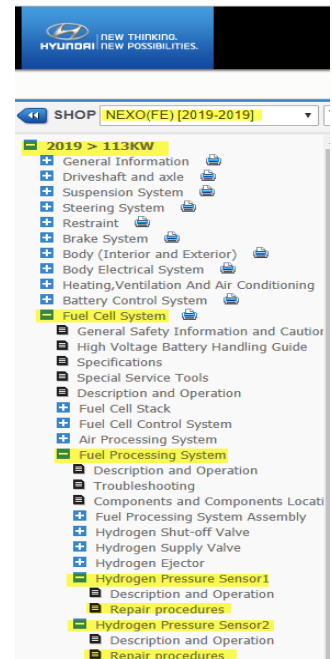
1. Ensure Hyundai GDS Mobile has the latest software update per TSB 15-GI-001.
2. Park vehicle outdoors at designated location for Hydrogen venting.
3. Using the Hyundai GDS Mobile scan tool, check all systems for Diagnostic Trouble Codes (DTCs). Record DTCs that are unrelated to this TSB. Once recorded, clear all DTC's.
4. Use the **Start/Stop** push button, turn off the vehicle.
5. Login to <https://www.hyundaitechinfo.com/>
6. Go to the Shop tab under Service Information.
7. Using the model field, select, **Nexo (FE) [2019-2019]** from the drop down list. Then select the following links in order:
 - 2019 > 113KW
 - Fuel Cell System
 - Fuel Processing System
 - Hydrogen Pressure Sensor 1
 - Repair Procedures
 - Hydrogen Pressure Sensor 2
 - Repair Procedures
8. Replace Hydrogen Pressure Sensors 1 and 2 by following the instructions as found in step 6.

Ensure fuel stack compartment is free of ignition sources while performing this procedure. A small amount of Hydrogen gas may escape from the fuel cell while the Hydrogen Pressure Sensors are out of the fuel cell.
