Technical Journal

Voice Control Database Upgrades

REF NO:
TJ 33211.7.0

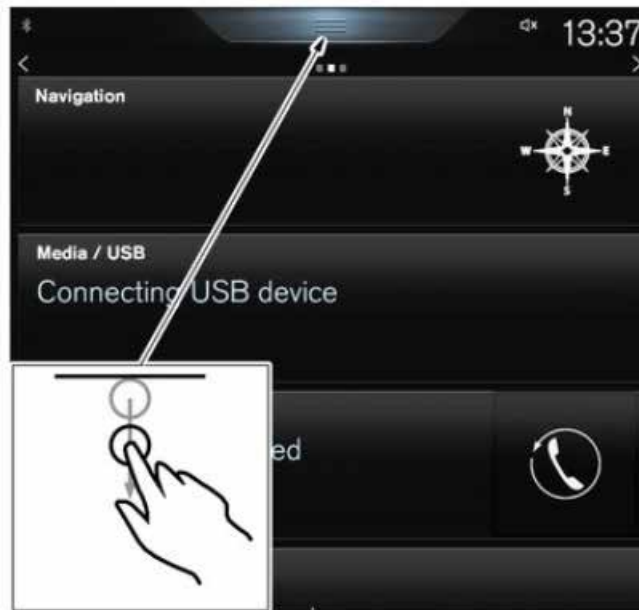
- Among the changes/improvements is the inclusion of a download progress indicator that can be found on the Settings pull-down menu (see attachment TJ 33211_1.jpg, TJ 33211_2.jpg).

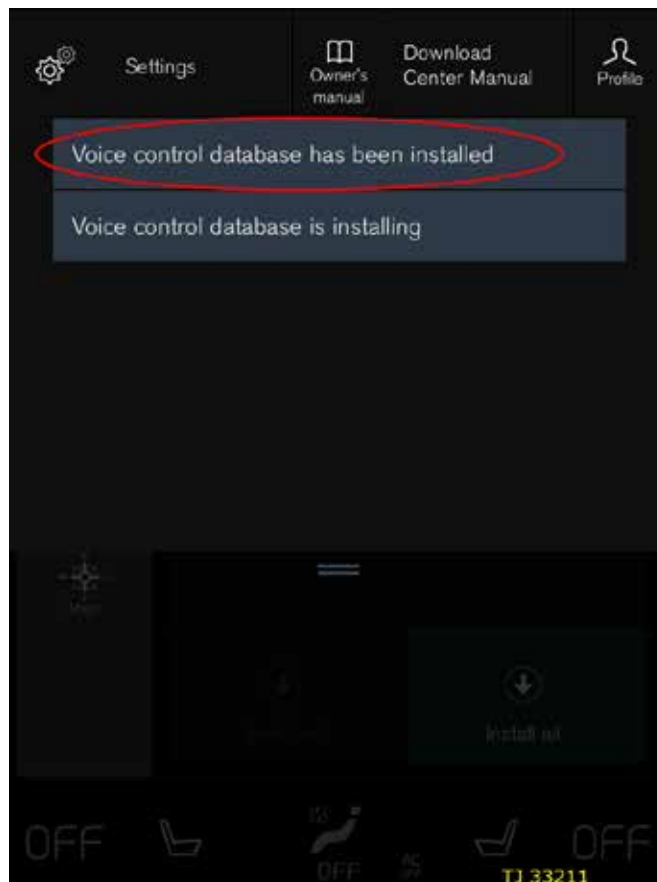
DO NOT remove the USB memory stick until the software has been fully downloaded and the “Voice control database has been installed” message is present in the Settings pull-down menu (attachment TJ 33211_3.jpg).

At this point, shut the ignition off, remove the USB, then close and lock the vehicle for ~3-5 minutes before checking voice control operation at the next ignition cycle.
