Note:
Vacuum Ports were installed too close to MorRyde Step Bracket and won't open.

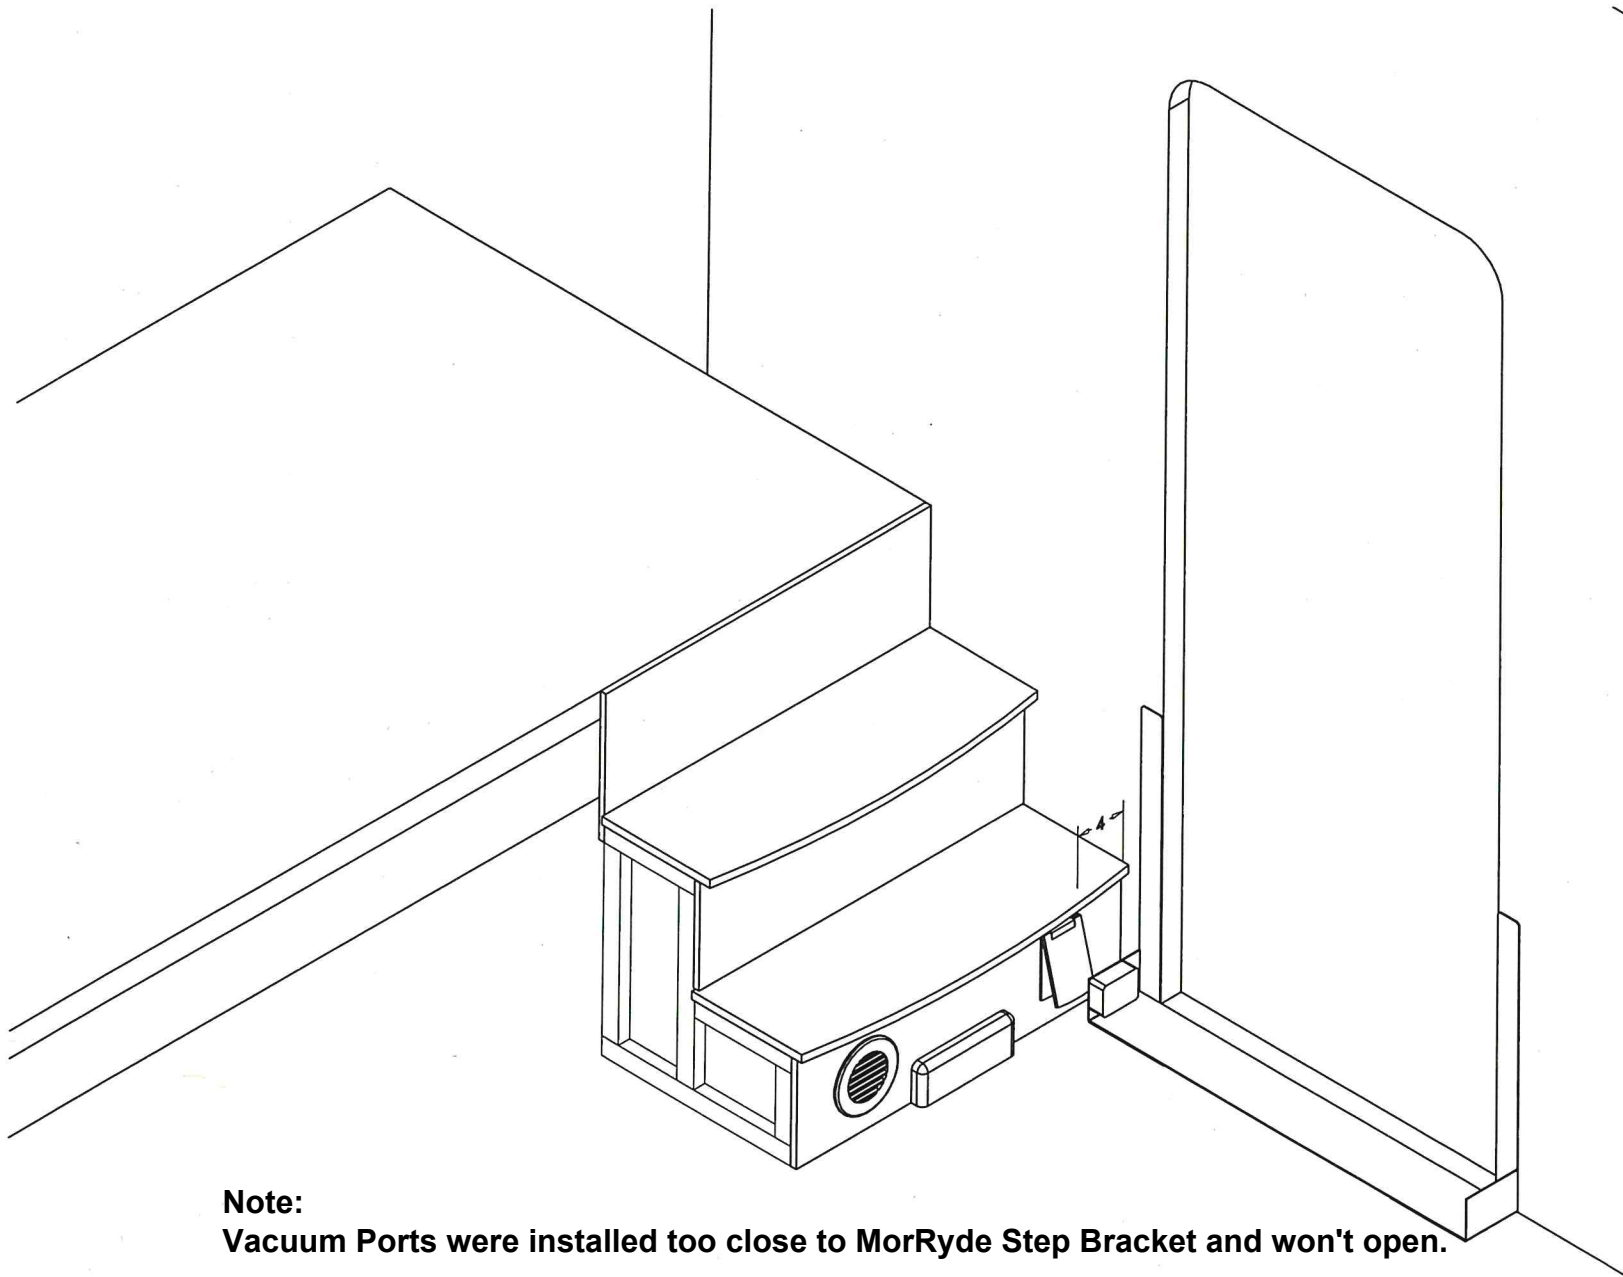
**Note:
Step Bracket impedes opening vacuum port**

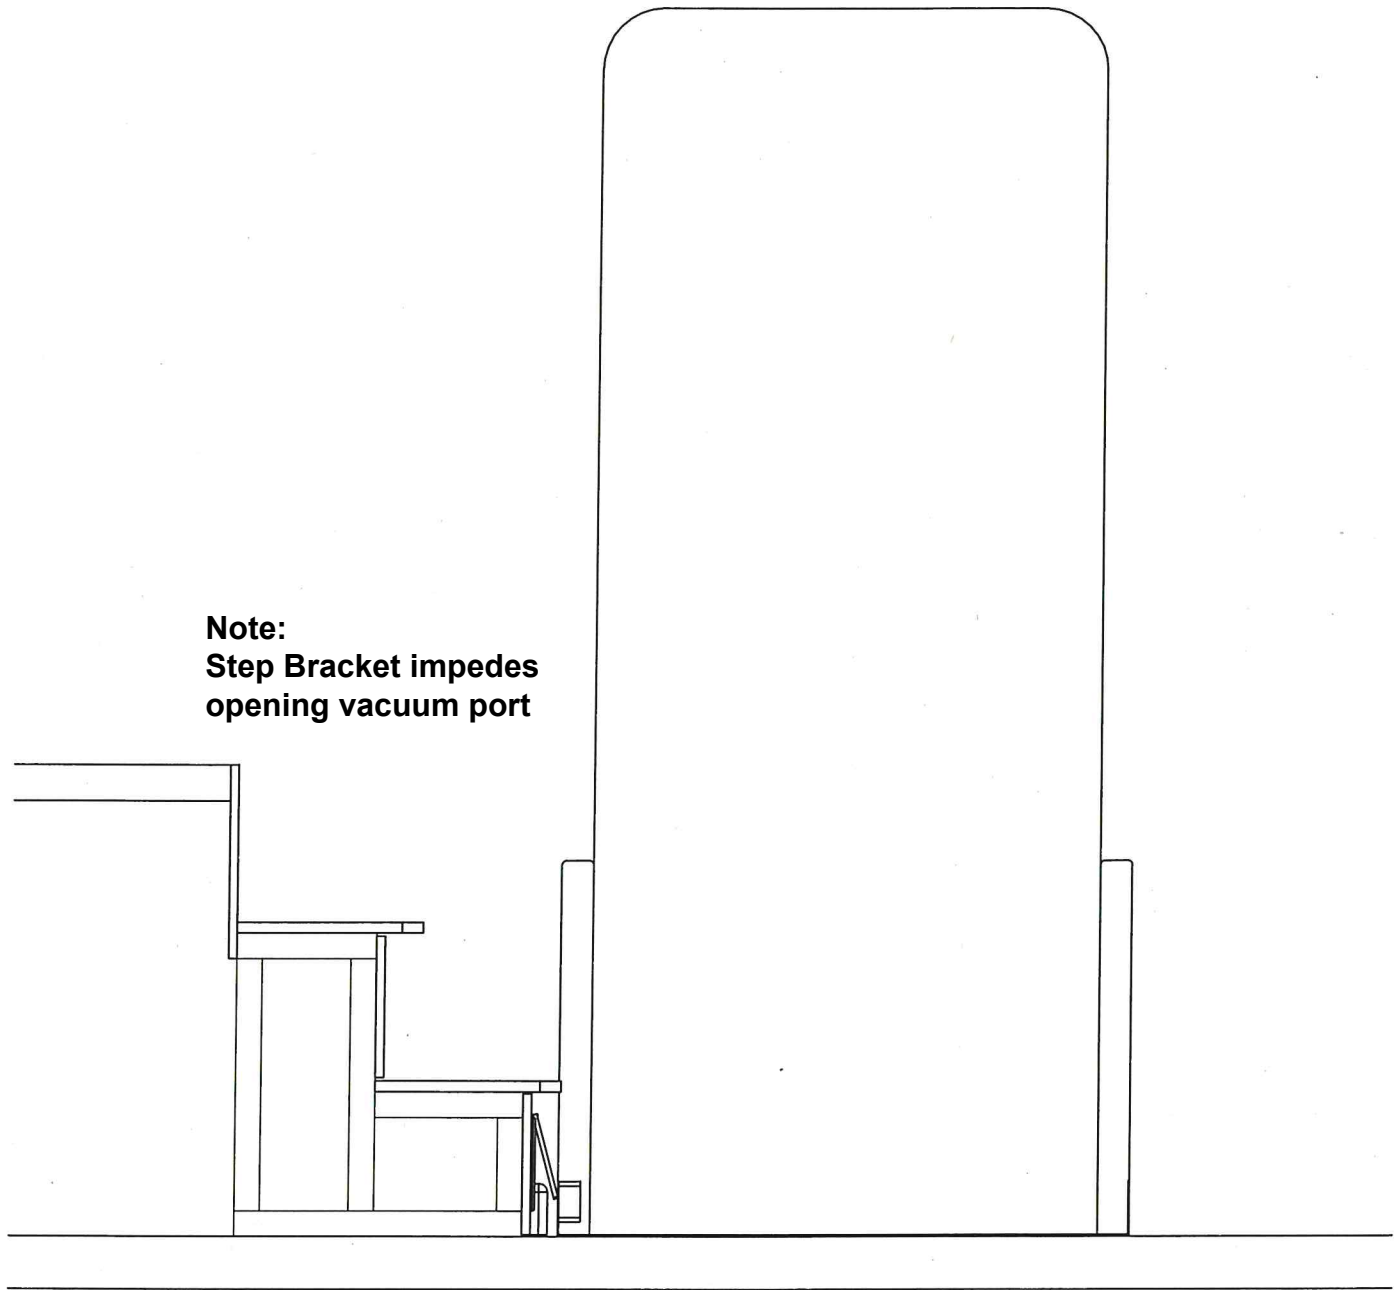
**Note:
Step Bracket impedes
opening vacuum port**

Note:
Vacuum Port Need to move at least
1" inboard, away from sidewall.

5
MIN.

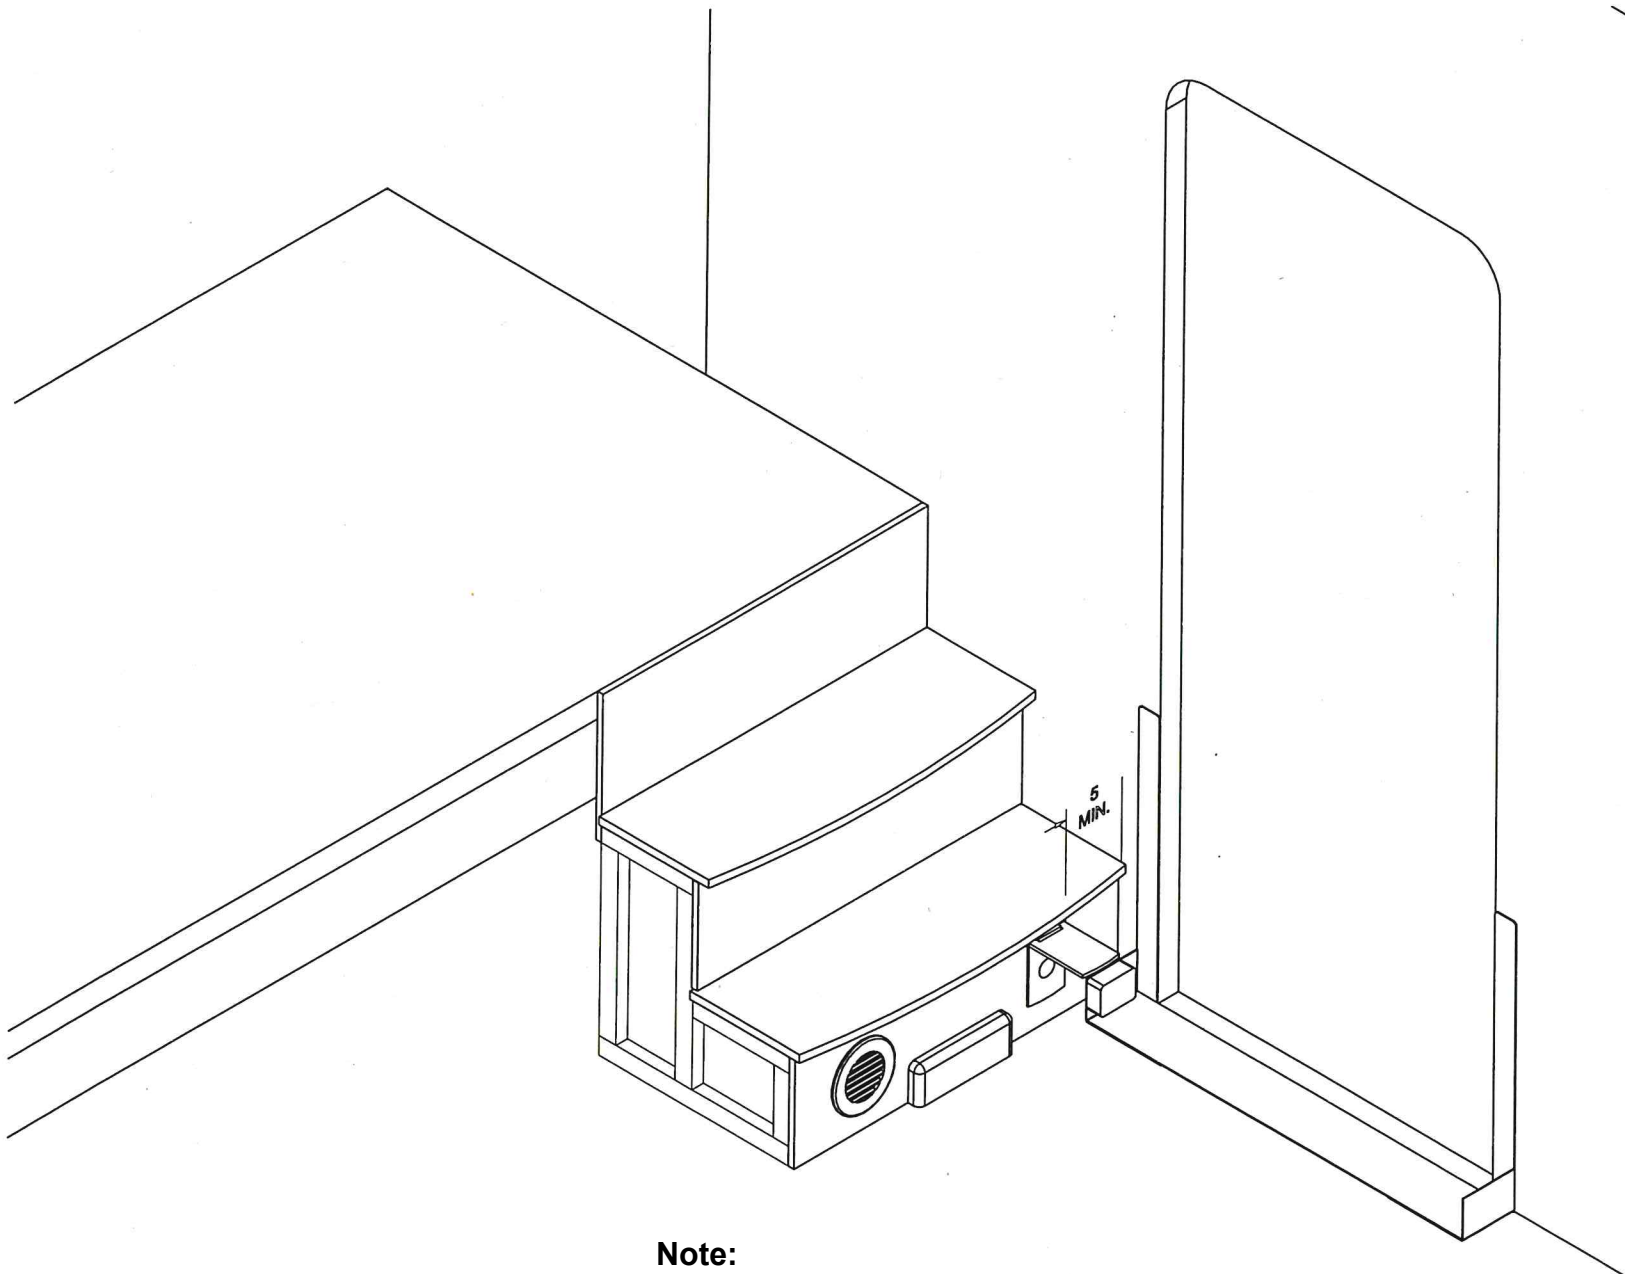
Note:
Moving 1" will allow it to open.

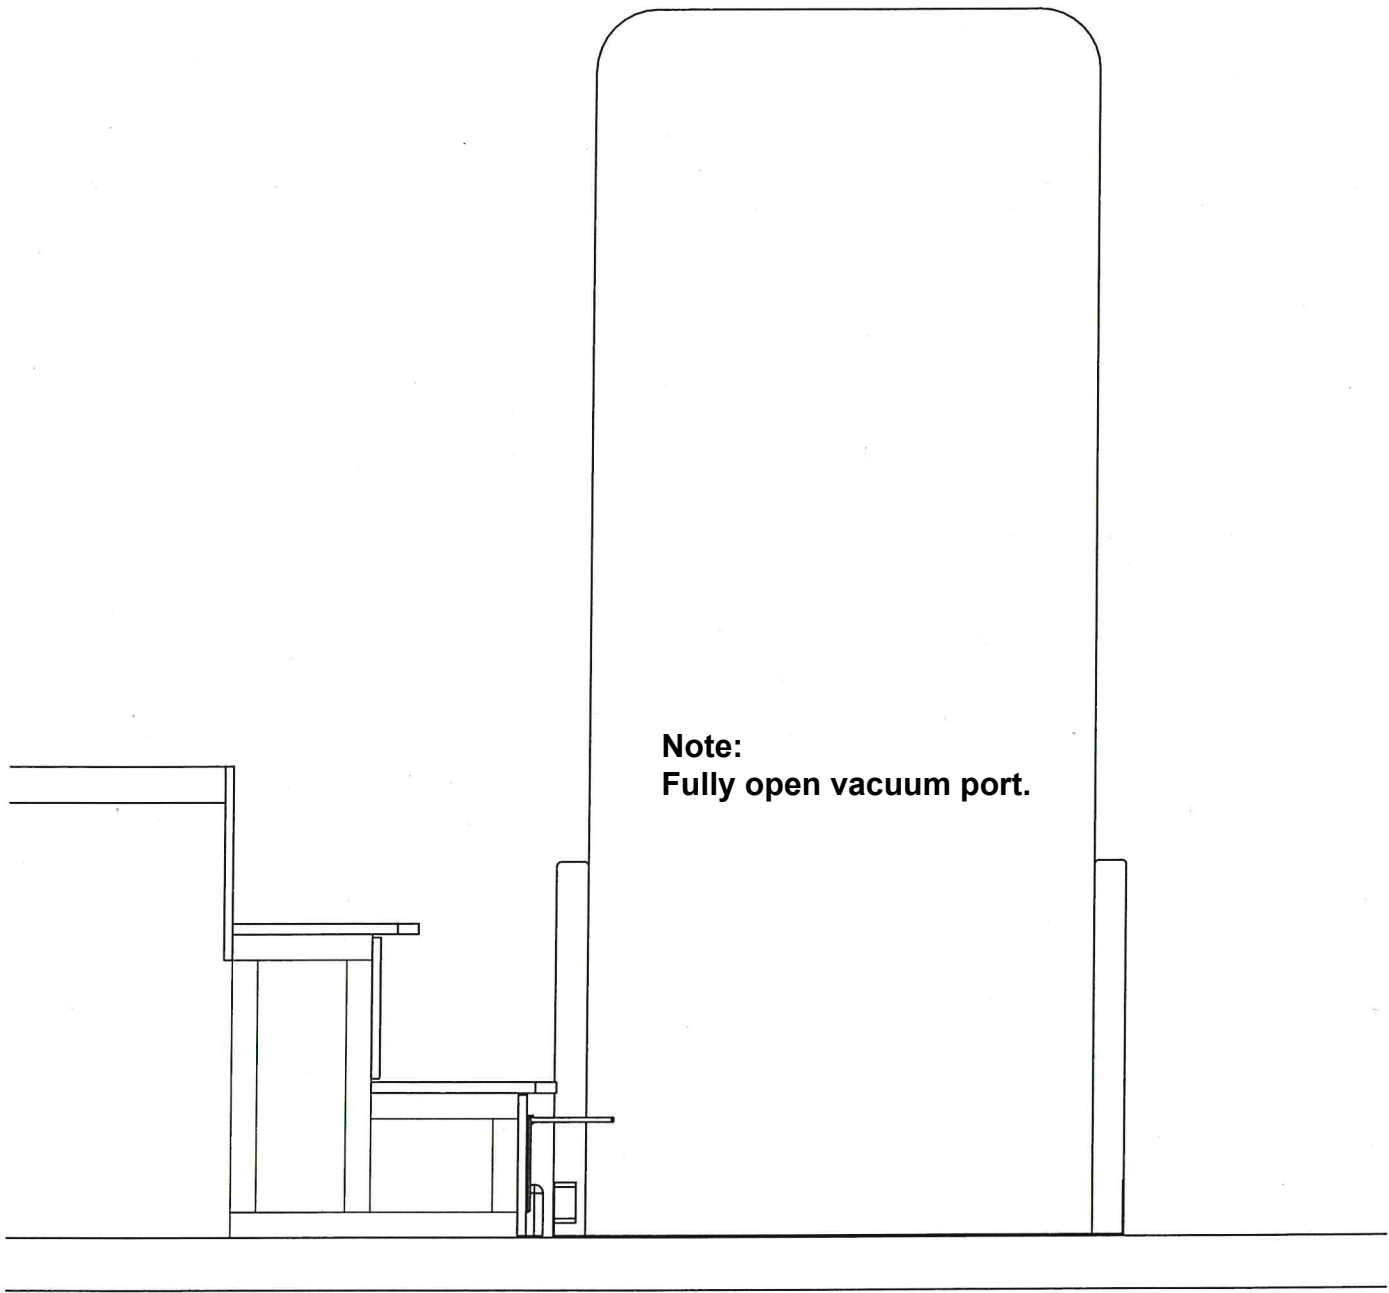
**Note:
Fully open vacuum port.**
