RSB 550  
Sep. 17, 2019

NHTSA #19V 610  
TC #2019-417

## RECALL SERVICE BULLETIN

## Recall 19V 610 Work Instructions: Securing the Bedroom Fascia Header

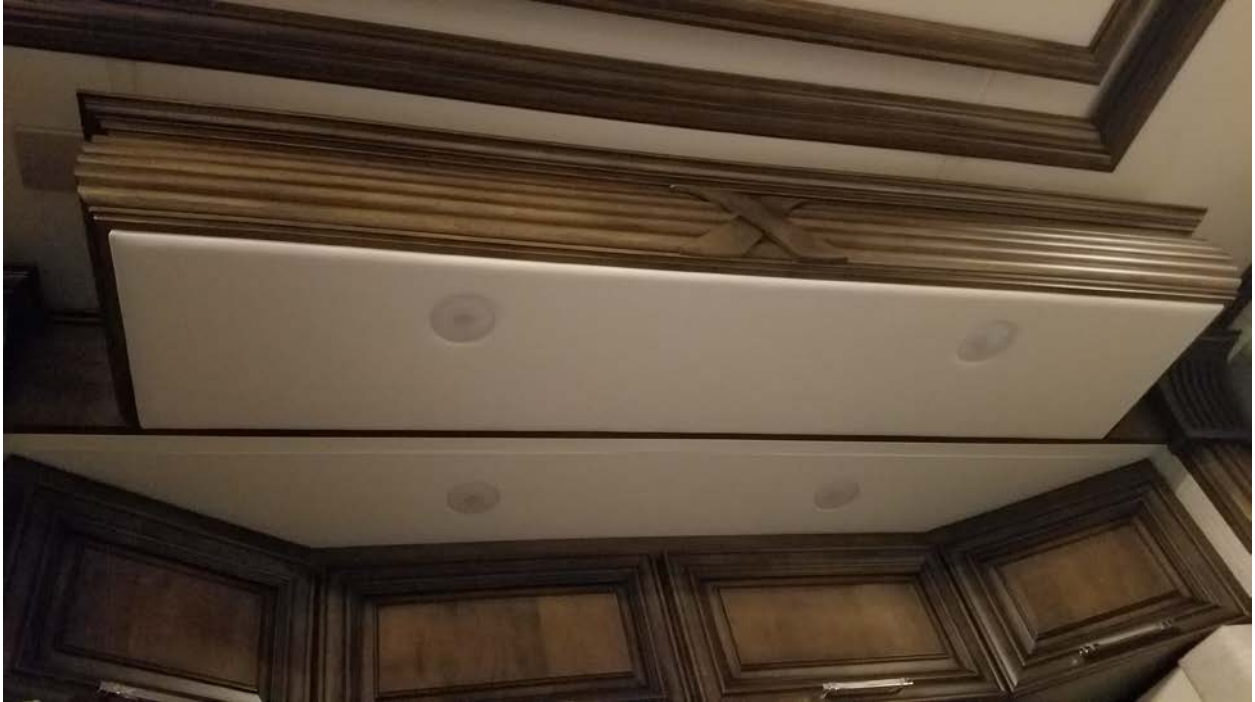
1. Order eight brackets (Newmar part # 62122) and 16 screws (5/8", Newmar part # 138326).
