## SRS Message Displayed in Instrument Cluster

Topic number	LI54.21-P-070658
Version	1
Function group	54.21 Control units / basic modules
Date	12-17-2019
Validity	A-Class (177) CLA-Class (118)
Reason for change	
Reason for block

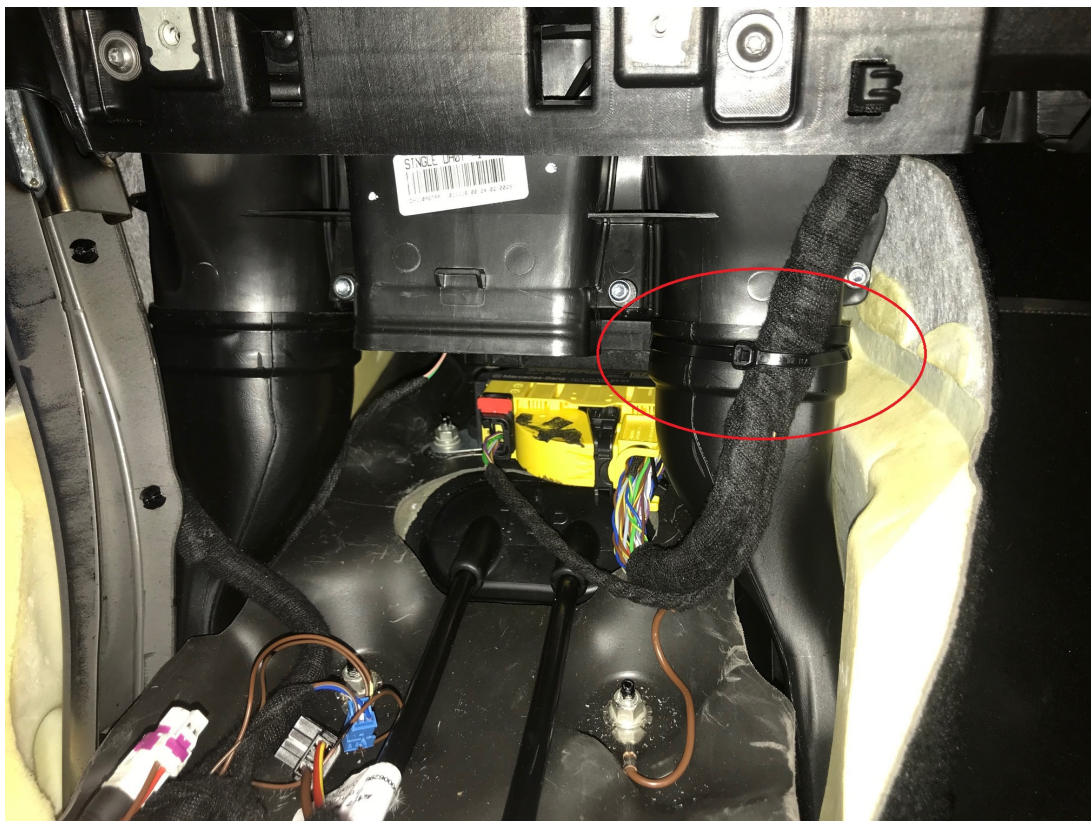
Harness attach to vent.  
jpg:

Attachments	
File	Description
Harness attach to vent.jpg	Figure 1. SRS harness is attached to the AC Vent
SRS CU Q Level 3.jpg	Figure 2. Location of Q-Level
Work Instructions.pdf	Work Instructions

Fault-trace wire for affected component and ensure that there is no chafing or damaged areas. Ensure that all connections are secure and wires are firmly attached to connectors. If the inspection does not find a root cause, proceed with the attached work instructions.
