## Seat belt does not roll up correctly

Topic number	LI91.40-N-062773
Version	4
Function group	91.40 Seat belts, emergency tensioning retractors
Date	12-17-2019
Validity	Model 447, 906, & 907
Reason for change	Validity of Service Information SI91.40-S-0012A referenced in operation step 3 has been adjusted.
Reason for block

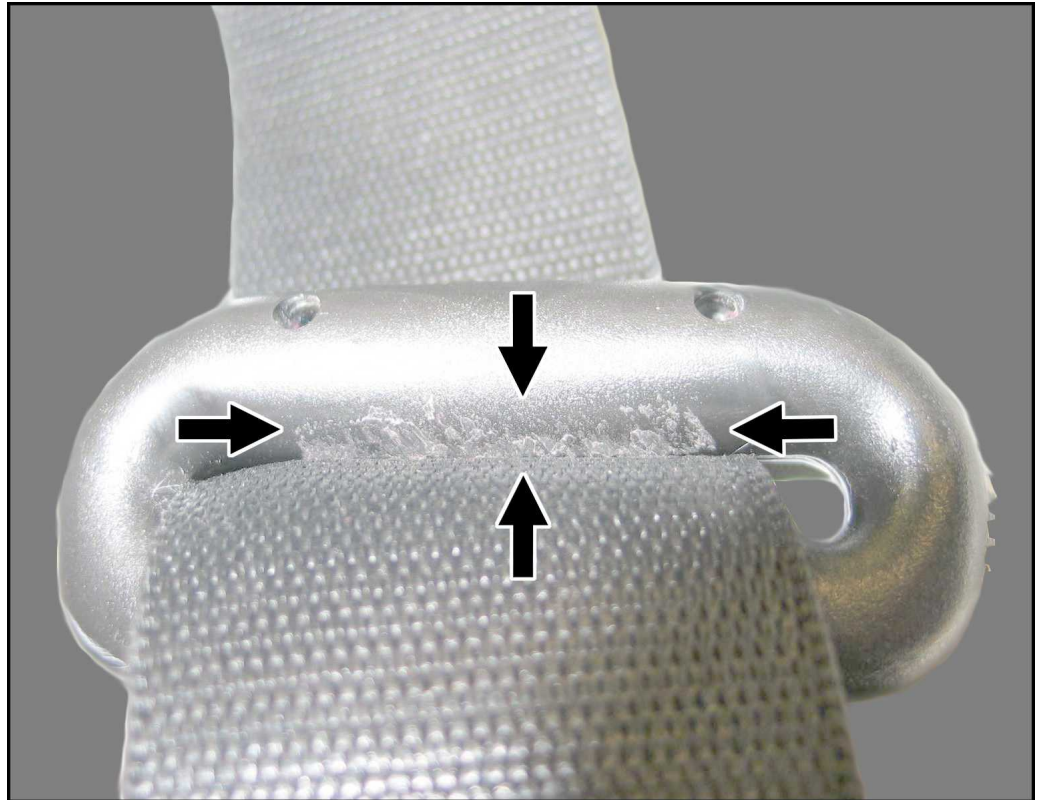
01.jpg:

Dirt deposits on the seat belt guide due to a soiled seat belt (see picture 01).

Attachments	
File	Description
01.jpg	Seat belt guide dirty. The dirt visible here can stop the seat belt rolling up properly.

1. Remove dirt deposits on seat belt using a dry cloth or a soft brush then clean seat belt (see AP91.40-S-1000-01A).  
-----
2. Check guide slot of belt guide on B-pillars or passenger seats for soiling, and clean if necessary (see AP68.30-S-1000-01A).

**Note:** When cleaning the seat belt guide bracket, observe cleaning instructions for seat belts in the owner's manual! Use cleaner for plastic parts. Only treat the belt guide, not the seat belt.

3. If the cleaning does not bring about any improvement, replace the corresponding seat belt.
