Technical Bulletin 203
12.2019

Item: 203.1
 Description: Rear Bevel Box Breather
 Model Affected: Rocket 3 GT, Rocket 3 R, Rocket 3 TFC

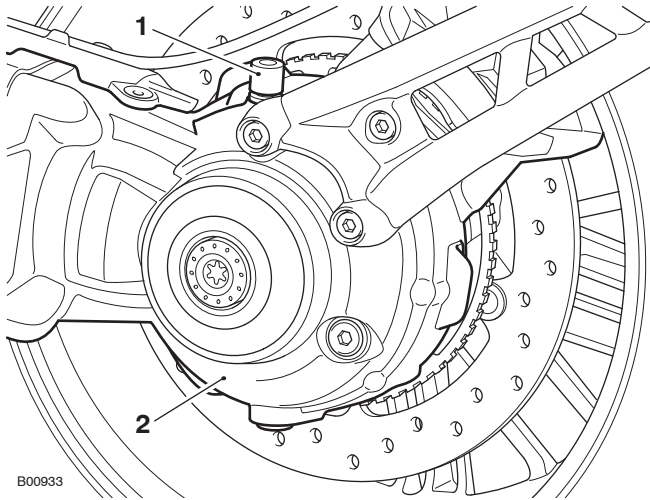
For the above models from VIN 971688 the rear bevel box is fitted with a breather.
 Before washing the motorcycle make sure the engine and the rear bevel box are cold.
 While washing the motorcycle care must be taken when cleaning the rear bevel box to make sure water does not enter the breather.

- 1. Breather
- 2. Bevel box

Do not use high pressure spray washers or steam cleaners.
 Use of high pressure spray washers and steam cleaners may damage seals, cause water and steam to be forced into bearings and other components causing premature wear from corrosion and loss of lubrication.
