Subject <b>Whine Noise Upon Starter Engagement</b>		Market <b>USA</b>
Service Category <b>Engine/Hybrid System</b>	Section <b>Starting</b>	
Applicability <b>20MY Tundra, Sequoia</b>

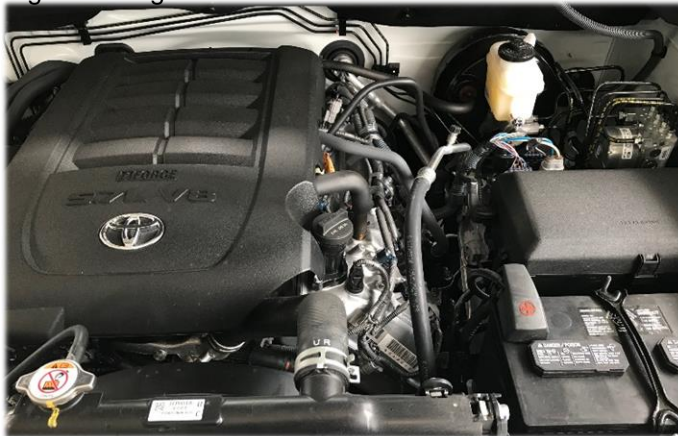
Figure 1: Engine serial number location – Zoom out

- Confirm a whine noise upon starter engagement.
- Locate the engine serial number on the driver’s side cylinder head cover as shown in figures 1 and 2.
- Create a TAS case, noting the engine serial number.
- For weekend or holiday cases, contact TAS at the next opportunity.

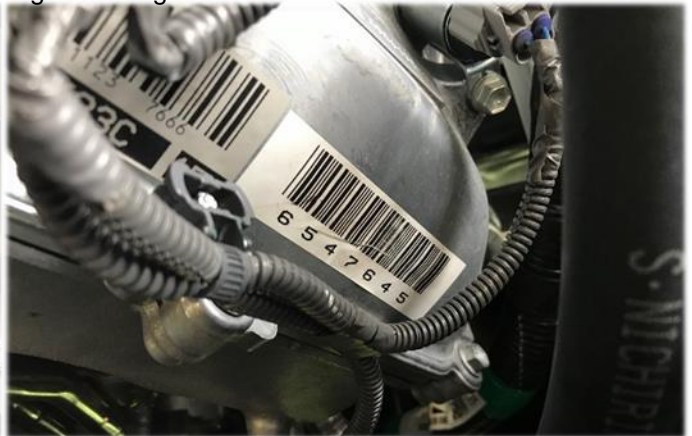
Figure 2: Engine serial number location – Zoom in
