# SS 1034598 Legacy Cascadia Vehicles, Trailer Turn Signal Relay Inoperative or Flashing Very Fast

This solution applies to all Legacy Cascadia vehicles.

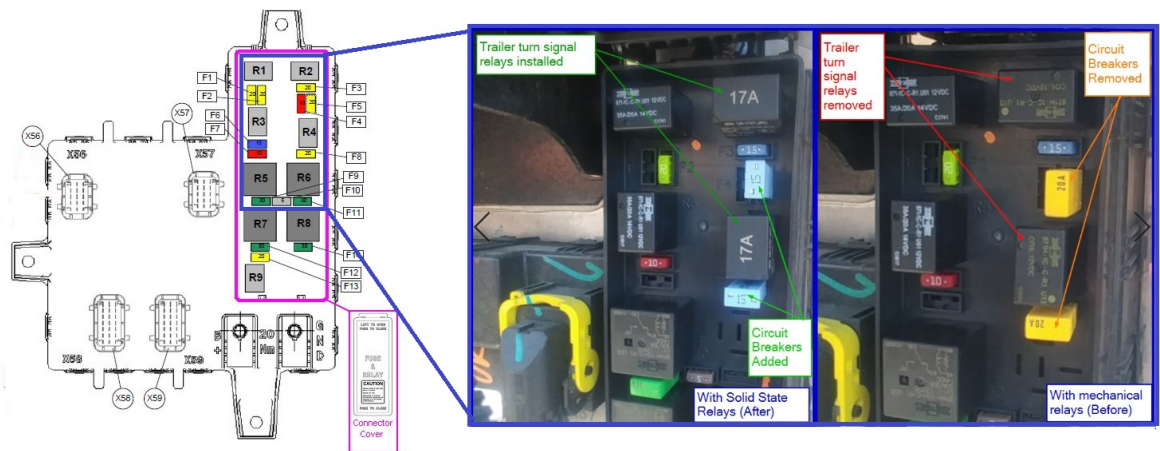
Image below, pictured on the left, is new 17-amp solid-state relays with 15-amp circuit breakers installed and pictured on the right is the old mechanical relays with the 20-amp circuit breakers installed. Note: Changing from the factory supplied 20- amp protective device to the 15-amp protected device for most applications should provide plenty power

for trailer left and right turnsignal applications. If for some reason the vehicle is in an applications where the full 20-amps is required, then this solution should not be applied.

For applications where a more durable relay is being requested, there is now a solid state relay P/N 23-14668-000 that can be used to replace the mechanical relays for these applications. Because the new solid-state relay is rated at 17 amps and the relay being replaced is protected by a 20 fuse or circuit breaker, this change will require replacing the fuse or circuit breaker with a 15 amp protective device. Left trailer turn is located at F5 and right trailer turn is located at F8 in the SAM Chassis. The P/N for the relay, fuse and circuit breaker are listed below. It would be recommended to replace both relays when performing this upgrade and only a 15-amp fuse or circuit breaker would be required.

Solid-state relay---P/N 23-14668-000-- QTY 2

15-amp fuse P/N 23-12537-015 or 15-amp circuit breaker P/N 23-13125-215--QTY 2
