# TIFFIN

**SB-61**

## **Water filter housing installation, 2018 - 2020 Allegro Buses & Phaetons**

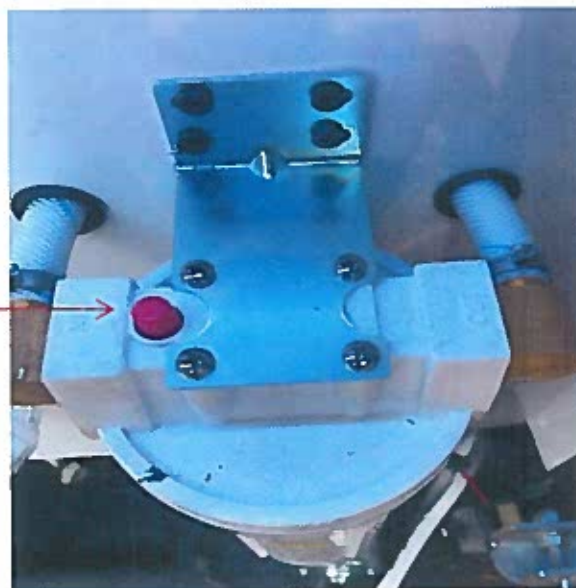
### **Correct position of water filter housing**

This is the **correct** installation of the water filter housing. The red button is located on the **left** side of the installation bracket.

If the water filter housing in your motorhome is attached to the board in the sewer compartment, please look at the filter housing to see on which side of the bracket the red button is located. The correct installation is for the red button on top of the housing to be located on the left side of the bracket at the top. If the installation is correct, no work is required. Please contact our warranty department at 256-356-8661 extension 2176 or by email at [jeannie.madden@tiffinmotorhomes.com](mailto:jeannie.madden@tiffinmotorhomes.com) with the last 8 digits of your VIN so we can clear the service bulletin from your motorhome.

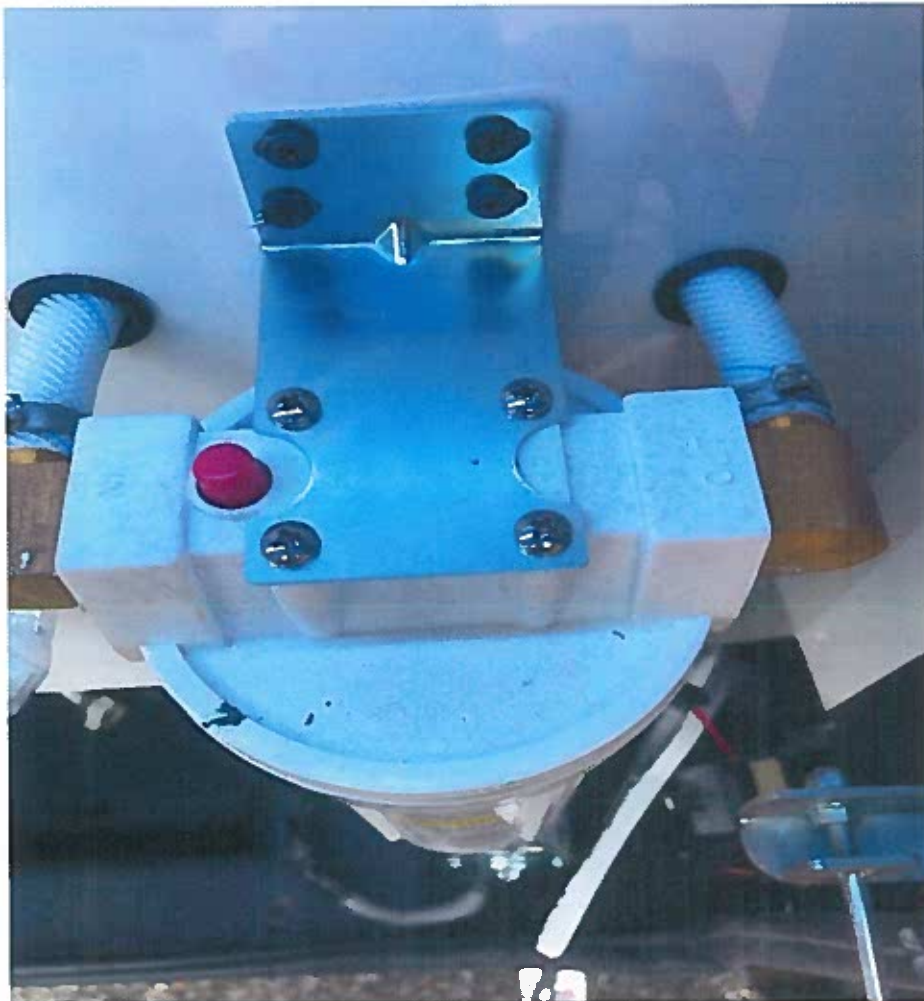
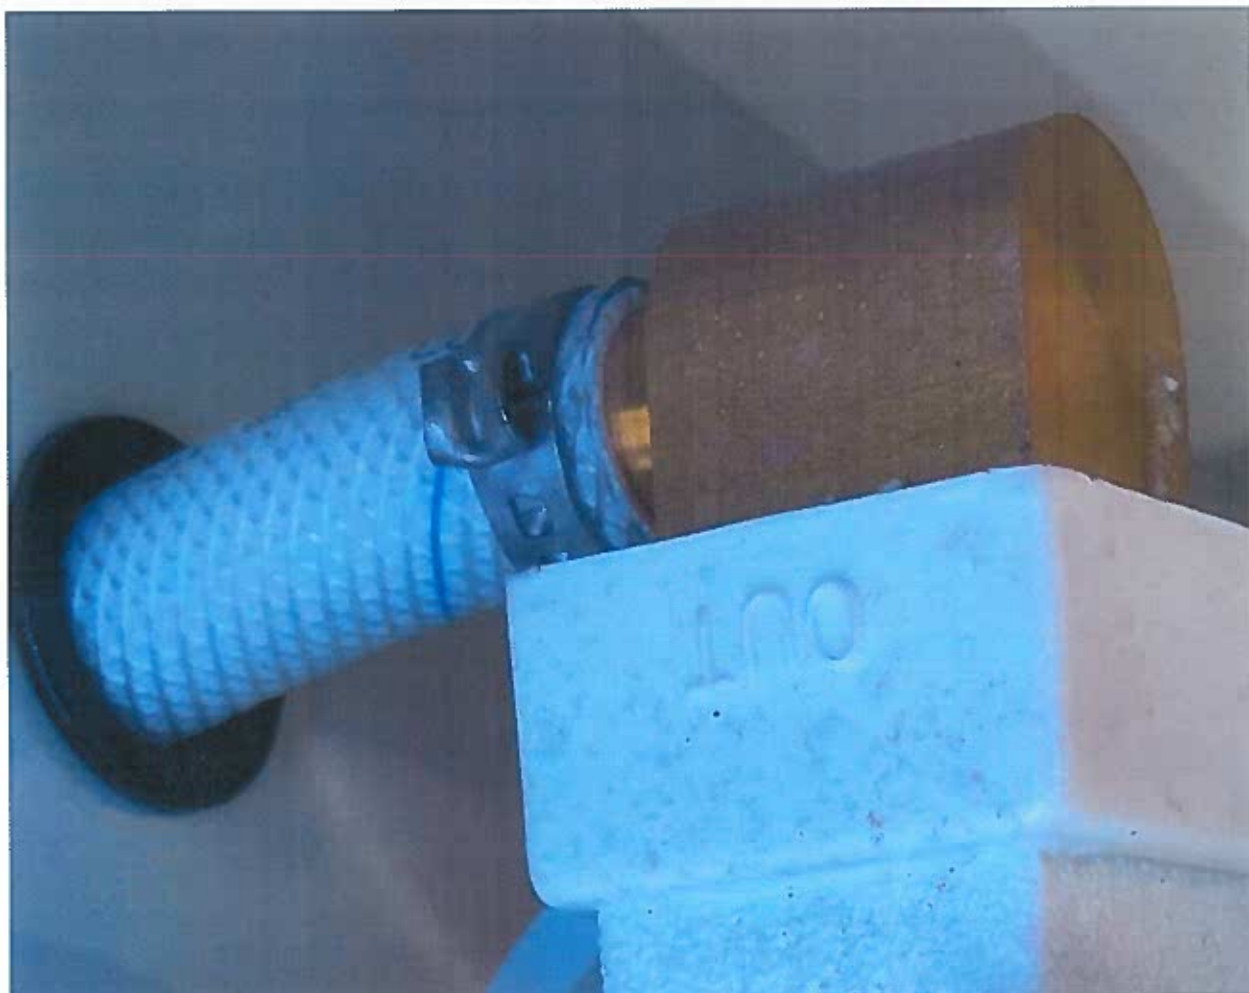
*Figure 1 silver crimp rings/gold fittings*

1. Remove silver crimp rings from water lines on both sides of the filter housing by cutting the tabs on the crimp rings.
2. Remove the four silver screws from the bracket on top of the water filter housing.

3. Remove the water lines from both sides of the filter housing.
4. Next turn the water filter housing 180 degrees also turn the gold fittings on the filter housing 180 degrees.

5. Once completed the red button on the top of the filter housing should be on the left side. Reattach the filter housing.
6. Take silver hose clamps and place one on each water line. Now you can insert water lines back into the gold fittings on the filter housing. Once lines are pushed completely on the fittings slide the silver hose clamps no more than 1/8 of an inch or about the thickness of a fingernail from the end of the water line, and tighten the screws on the clamp. Repeat these steps for the second water line.

7. Hold the filter housing up to the bracket and use the four silver screws that you removed to attach.
