# Technical Service Bulletin

<b>Subject:</b>  <b>RATTLING NOISE FROM FRONT OF VEHICLE WHILE DRIVING</b>	<b>Bulletin No.:</b> 09-005/20
	<b>Last Issued:</b> 01/10/2020

2016-2020 CX-9

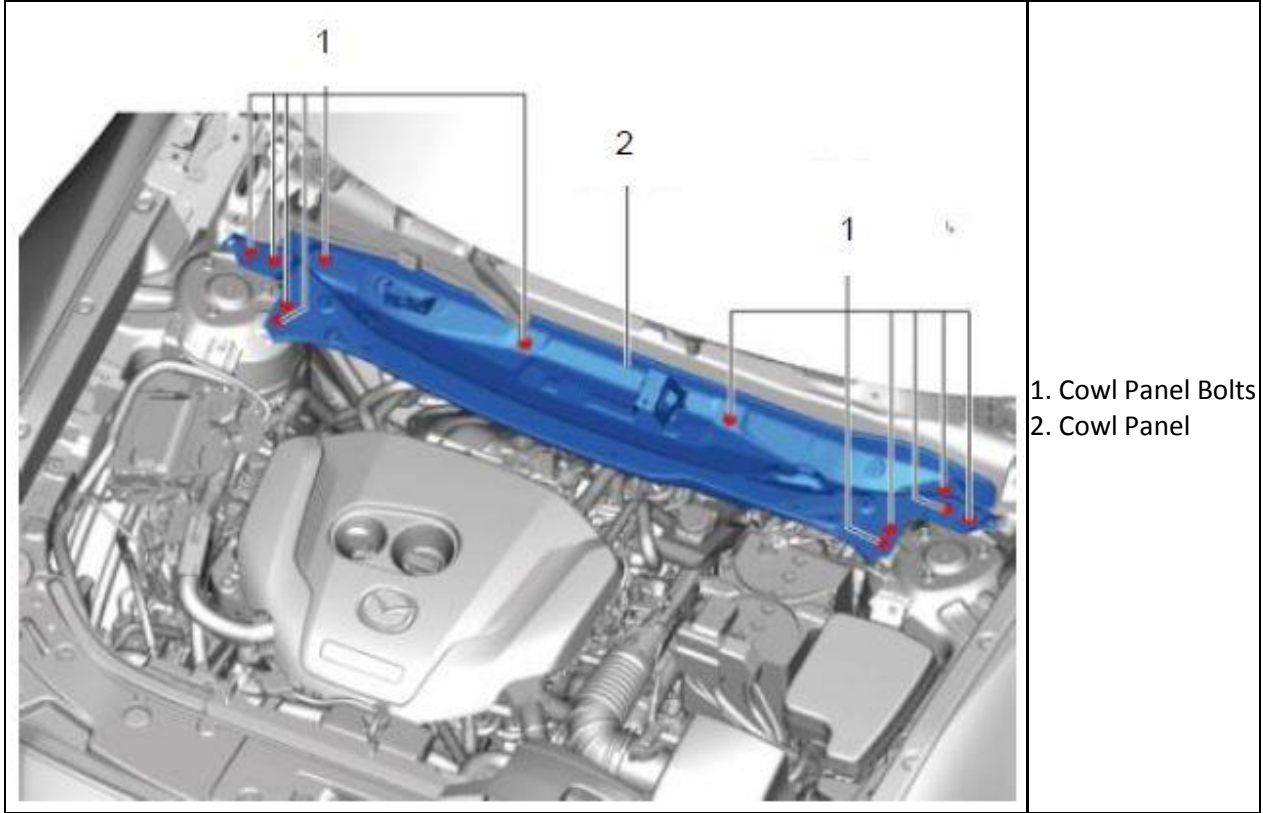
Some vehicles may exhibit a rattling noise from the front of the vehicle while driving. The noise may be caused by loose cowl panel bolts.

1. Cowl Panel Bolts  
2. Cowl Panel

1. Verify the customer concern.
2. Tighten all cowl panel bolts according to the instructions on MGSS online (COWL PANEL REMOVAL/INSTALLATION).

- **Tightening Torque: 29 ft.-lbf. {40 kgf-m, 40 N-m}**
