Latest Vehicle Concern Fixes

Battery Junction Box Fuse Fasteners

20MY Range Rover Evoque

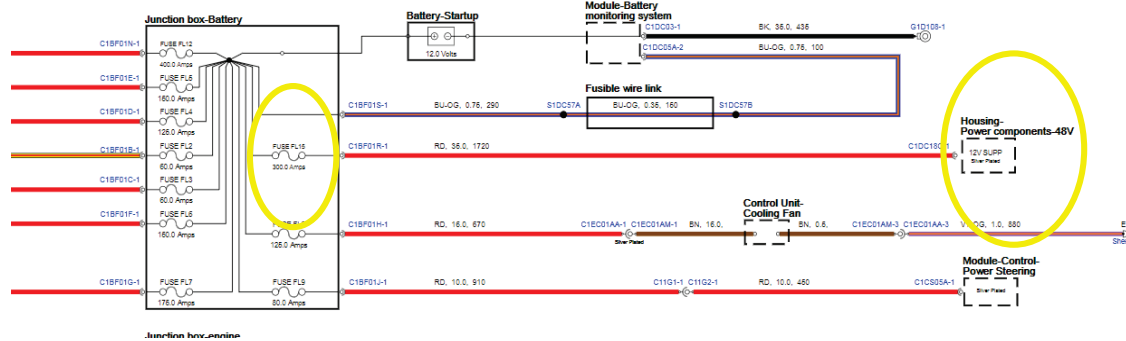
- During PDI, two fasteners are found not to be installed in the battery junction box.

- Vehicles that are non MHEV do not have fasteners or wiring installed. This is a normal condition and the connections do not require fasteners installed as non MHEV vehicles do not have a 48V battery equipped.
