Description of Revisions: *This bulletin replaces the version dated February 2016. Sewing Seam Ripper tool part and TwistTube® part list are added in the bulletin and convolute tubing has been removed.*

54-061 Guidelines for Repairing or Replacing an Electrical Harness

Western Star
Service Bulletin

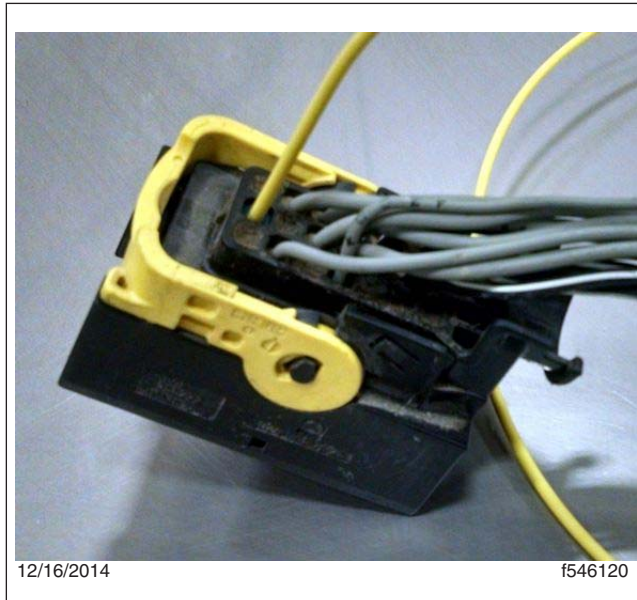
Fig. 3, Terminal Inserted Into the Connector

4. Insert the terminal into the connector. See [Fig. 3](#).
5. Run the wire along the harness up to the section of wire that is being replaced. See [Fig. 4](#).
6. Splice the wires using a Daimler splice kit ESY ES66 404, or Phillips STA-DRY® Crimp and Solder connector parts. See [Fig. 5](#). Refer to [Table 4](#) for a list of connector parts.
7. Inspect the harness and make sure there is enough slack. See [Fig. 6](#).
8. Wrap the harness with TwistTube® fiber wrap. See [Fig. 7](#).

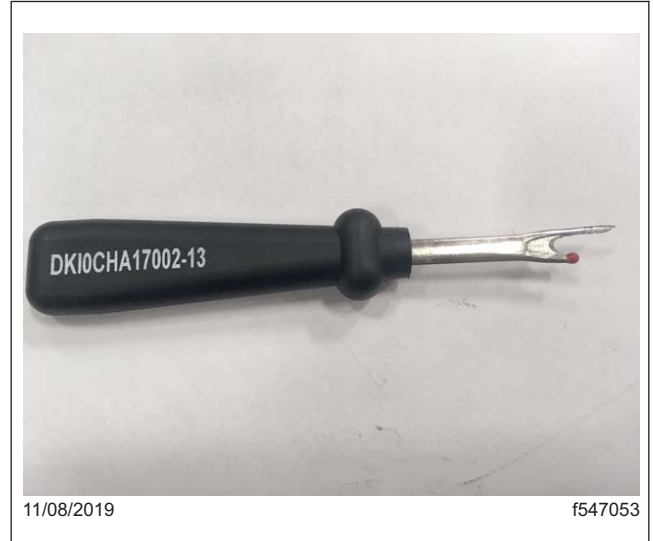
Fig. 8, Sewing Seam Ripper

IMPORTANT: Do not use a hook razor blade to cut fiber wrap. Use a sewing seam ripper to cut the fiber tape ([Fig. 8](#)), taking care not to cut the harness wires.

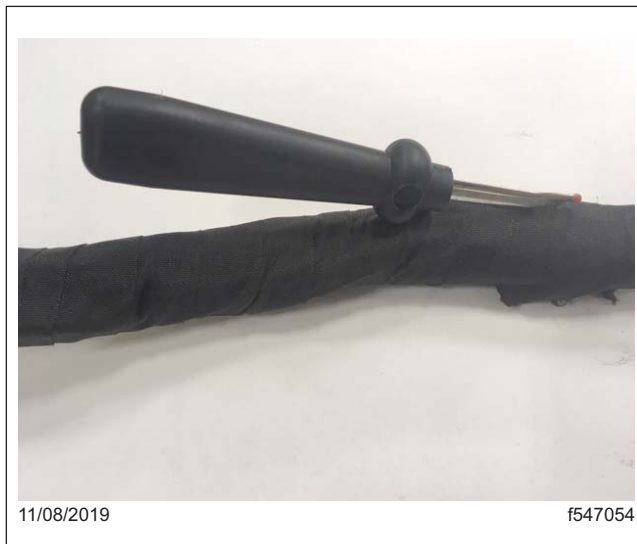
Fig. 9, Cutting an Opening into the Fiber Wrap

2. Flip the tool over so the blunt end is facing wiring, then cut enough length to allow the fiber to be unwrapped. See [Fig. 9](#).

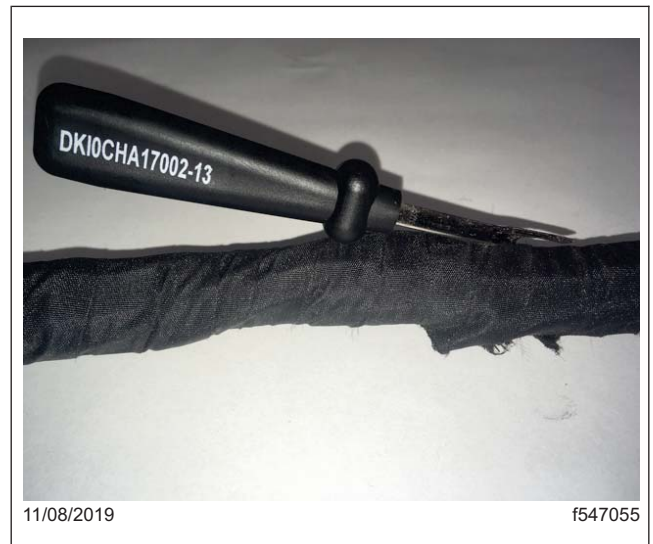
Fig. 10, Cutting the Fiber Using the Blunt End of the Seam Cutter

1. Locate damaged area and carefully make an opening in the fiber wrap using a sewing seam ripper. See [Fig. 10](#).

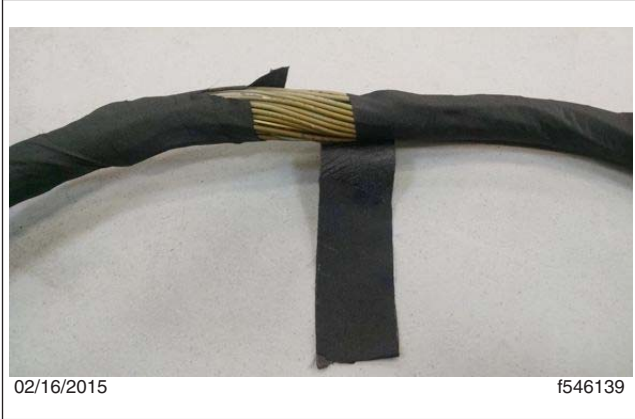
Fig. 11, Unwrapping the Harness

3. Unwrap the fiber until a sufficient area is exposed to make the repair. See [Fig. 11](#).
4. If an overlay is necessary, remove just enough fiber to allow for a splice into the damaged wire. See [Fig. 12](#).

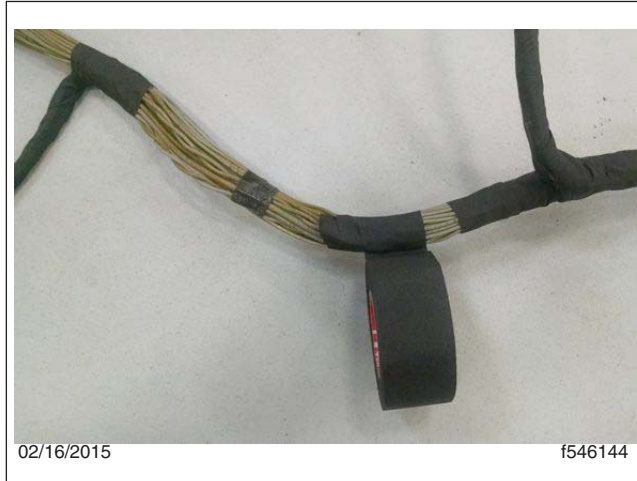
Fig. 14, Wrapping the Harness with Fiber Tape

7. Wrap the harness with fiber tape. Refer to [Table 5](#). Make sure enough tape is used to overlap the starting point. See [Fig. 14](#).
8. When the harness is completely wrapped, secure both ends of the fiber wrap with electrical tape. See [Fig. 15](#).
