SIB 54 16 19 CLICKING NOISE FROM ROLLER SUNSHADE

2020-01-13

E-Series	Model Description
G20	3 Series Sedan

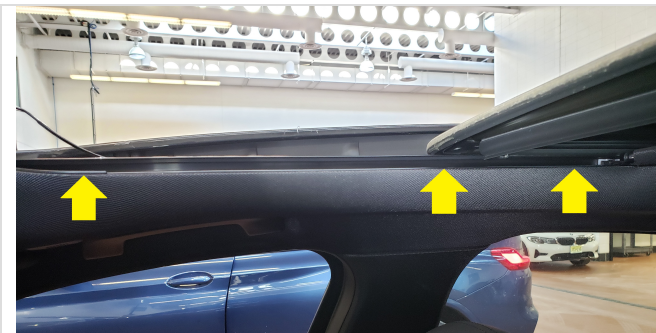
When driving over rough road surfaces, a clicking noise is present from the area of the roller sunshade of the sunroof.

Insufficient grease for the roller sunshade mechanism, allowing excessive movement inside the sunshade guide rail.

2. Lightly grease the sunshade guide rail will at the 3 points (arrows). Ensure the grease is applied as far into the rail as possible to avoid excess spillover onto the sunshade.

Note: At each point, apply a 5 mm x 5 mm spot of sunroof lubricant RHF 1
P/N 83 19 2 157 321.

3. Repeat the procedure on both sides of the vehicle.
4. Operate the roller sunshade forwards and backwards to evenly spread the grease. Ensure that no grease has spilled over onto the sunshade.
