Technical Journal

Inner weather strip on door noisy

REF NO: TJ 35333.1.0	ISSUING DEPARTMENT: Technical Service	CAR MARKET: United States and Canada	
PARTNER: 3 US 7510 Volvo Car USA		ISSUE DATE: 2020-01-02	STATUS DATE: 2020-01-06
FUNC GROUP: 8455	FUNC DESC: Guide moulding for door glass; sealing	Page 1 of 6

Title	Inner weatherstrip, door window	Page	1 (4)
Action	Replacement	Operation number:	98742-2

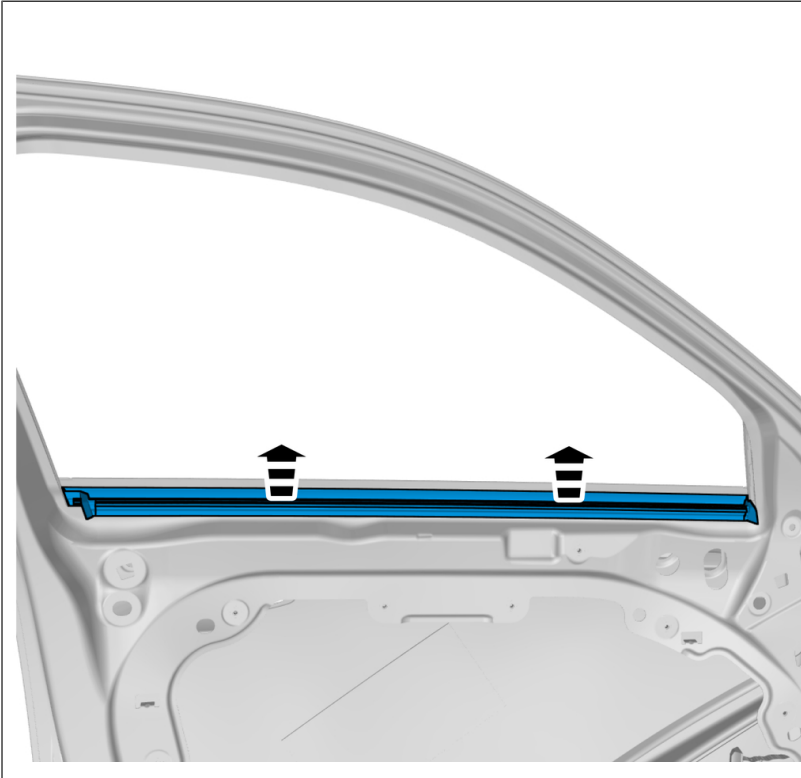
Applies to front door

Remove the marked part.
The part is not to be reused.

Remove panel side door front , refer to:
 Removal, replacement and installation
 8 - Body and interior
 85 - Interior
 851 - upholstery for wall/door, side, rear shelf, luggage rack

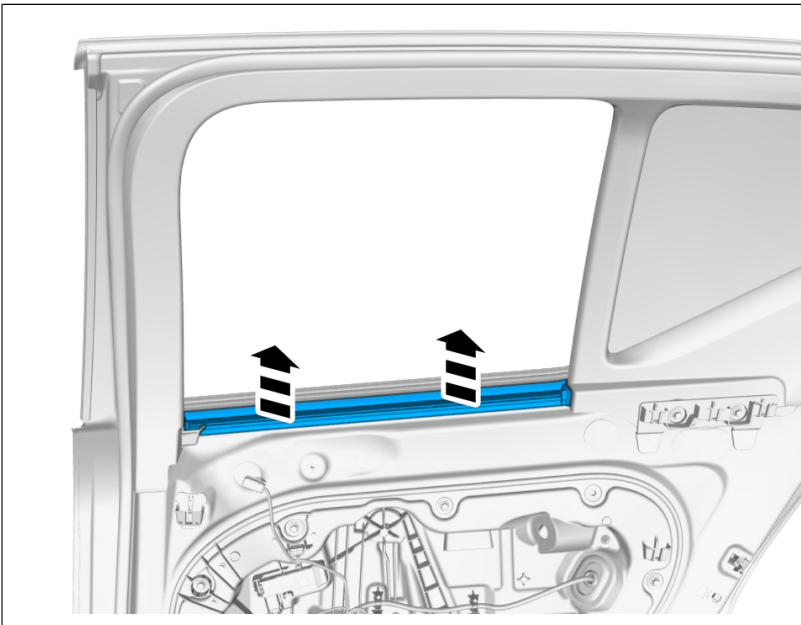
Applies to rear door

Remove the marked part.
The part is not to be reused.

Remove panel side door rear , refer to:
Removal, replacement and installation
8 - Body and interior
85 - Interior
851 - upholstery for wall/door, side, rear
shelf, luggage rack
