SERVICE BULLETIN

Vermeer Corporation

SVC2020-052 Rev. 1

**PRODUCT
SAFETY
RECALL**

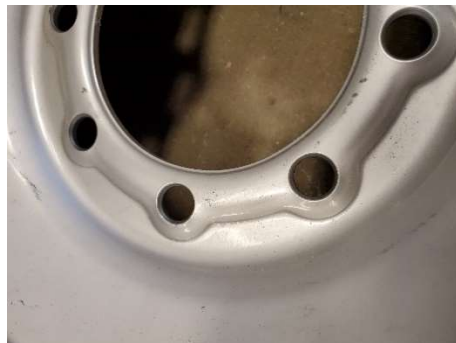
Defective Supplier Wheel Improper Lug Nut Seat and Potential Cracks

- have an incorrect lug nut contact area causing wheel lug nuts to loosen; and/or
- can develop possible cracks causing the tire to lose air pressure.

Identified by continuously raised lug nut surface

The supplier defective steel rim/wheels identified by part numbers above can never be used or sold for any purpose. **The wheels MUST be destroyed:**

1. Remove the tire from the steel rim/wheel.
2. Torch cut the wheel(s) across the bead area and lug nut area.
3. Take photo(s) of the destroyed wheel(s).
4. Discard the lug nuts so they can never be used or sold for any purpose.
5. The removed new tires can be returned to your new parts inventory.

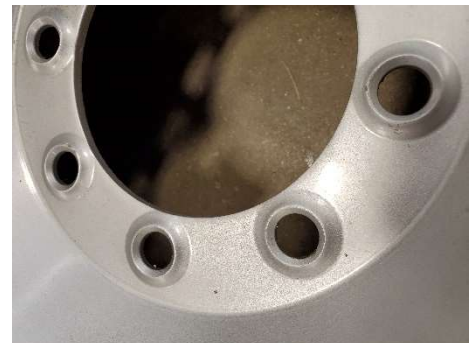
Properly Manufactured Wheel Correct Lug Nut Seat

Identified by raised surface only around lug nut location

Due to wheel supplier delivery variances, some brush chippers identified in the “as-manufactured” SN ranges above may have been manufactured with Properly Manufactured Wheel (right photo above). Our records do not contain sufficient data to identify which wheels were installed on each machine. Through an abundance of caution, we identified the SN ranges for when the Defective Supplier Wheel (left photo above) may have been installed during manufacturing. Product Safety and Engineering are currently preparing dealer instructions for inspection of the wheels which will be posted to Dealer Center soon. In the meantime, if there are questions, take photos of the wheel, along with Model/VIN, and email to: productsafety@vermeer.com.
