P4 Halogen Headlamp – Production Changes

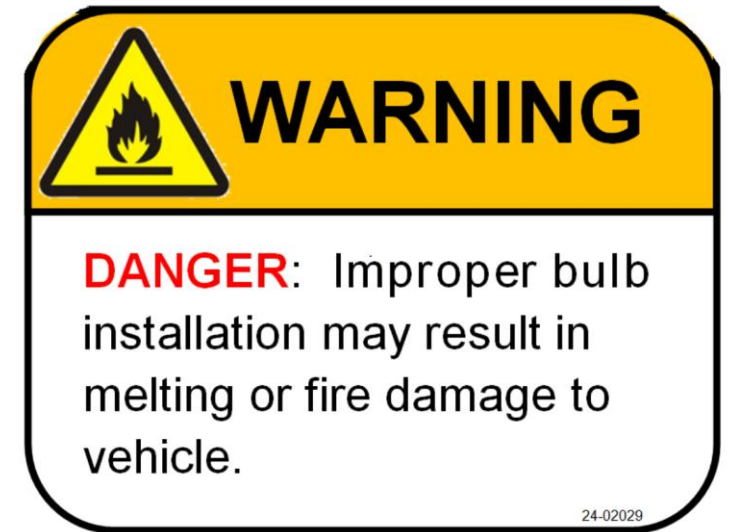
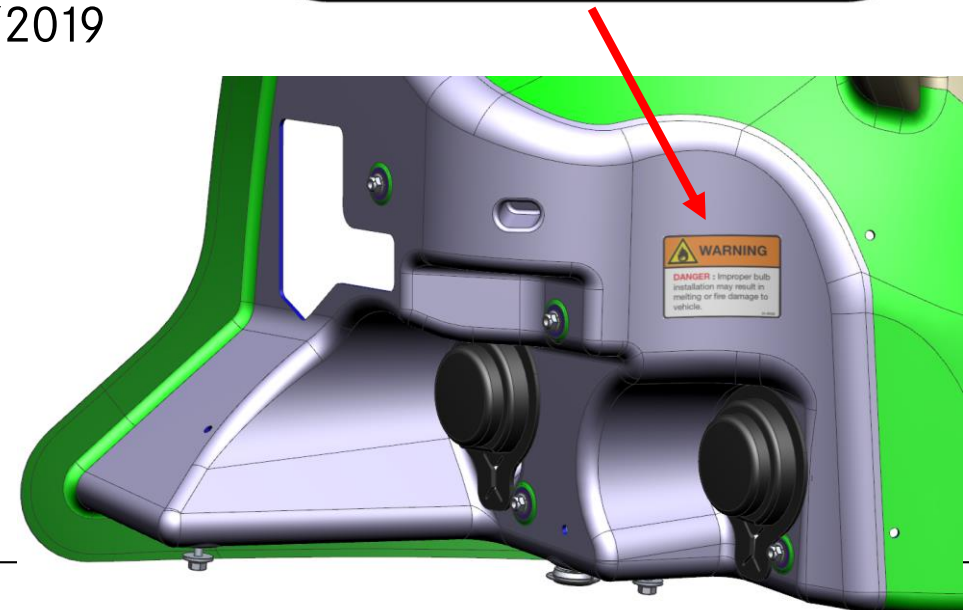
Warning label

- Installed on the under side of hood, near bulb access covers
- One on each side of the hood
- Part number: 24-02029-000

- Labels have been installed, in production, since 10/21/2019
NOTE: Initially installed under deviation; official production changeover 1/13/2020 (ref. EWR P5958)

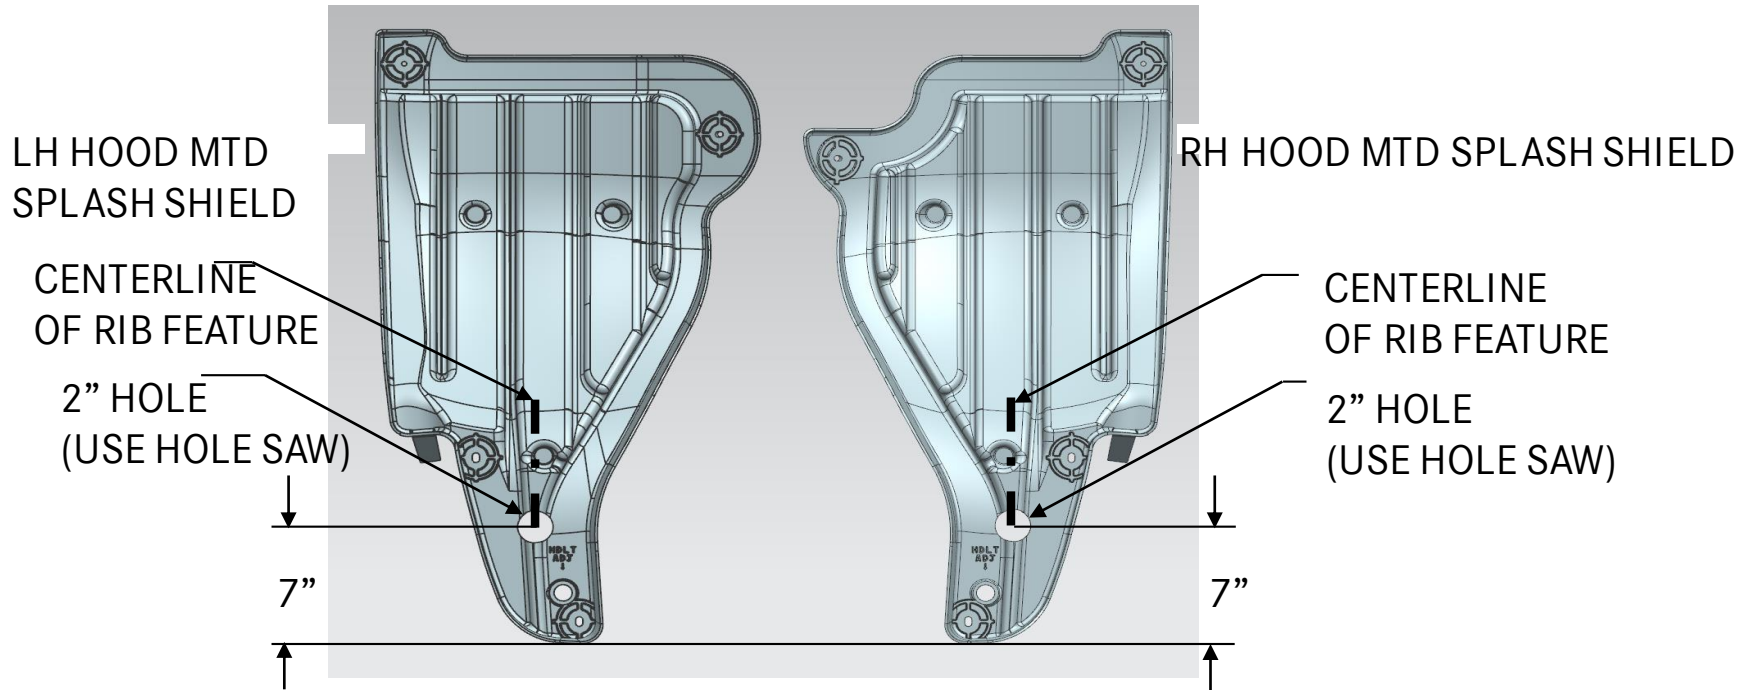
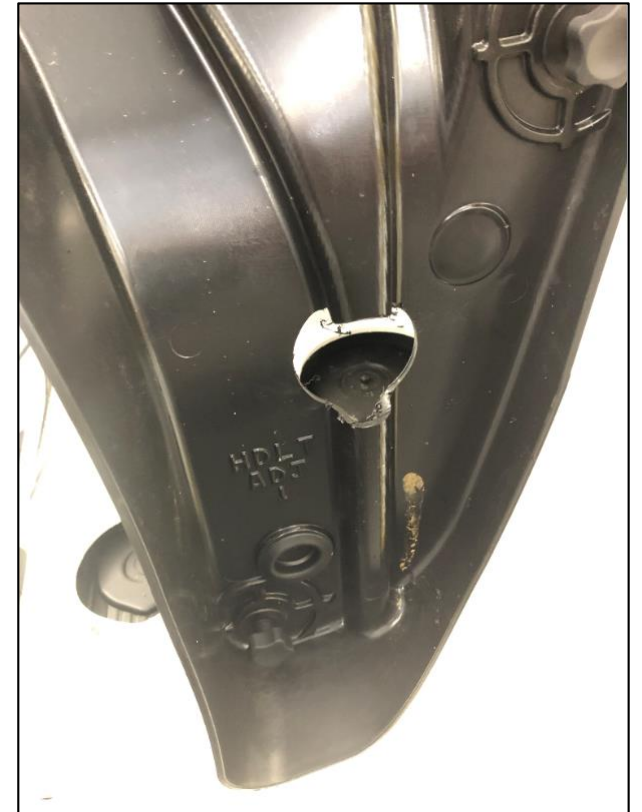
RH HOOD MTD
SPLASH SHIELD
SHOWN

Trim splash shield to improve access without removal

- Cut access hole – field solution

- Production change scheduled for 3/23/2020 (ref. EWR P59939)
