Latest Vehicle Concern Fixes

Intermittent Battery Ground Connection

19-20MY Discovery

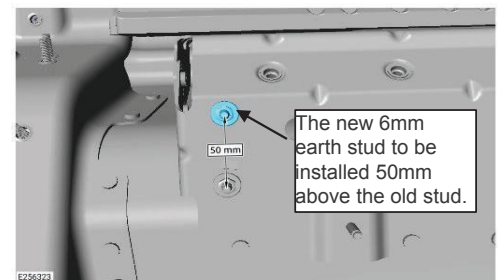
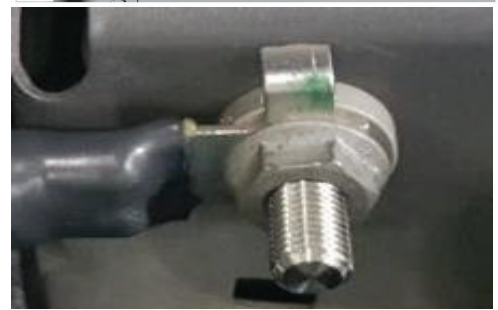
- The 6mm earth (ground) stud maybe loose in the body and require replacement. Currently, most retailers have the 8mm earth stud tool and do not have the 6mm tool. While waiting for the 6mm earth stud tool procurement, please check with your locally approved aluminum body shop as they should have the 6mm earth studs and tool.

- TOPIx instructions to replace the earth stud are located under 501-25A: Body Repairs - General Information
- Studs can now be purchased as quantity of one from the JLR tooling and equipment website - <https://jlrquipment.service-solutions.com>.
 - Stud part # 78905-SINGLE
 - Tool part # JLR-MRPK4081 (installs 6mm and 8mm earth studs)
 - The earth will become a mandatory tool.
 - The tool is expected to be available April 2020
