March 10, 2020

Warranty Extension: Customer Support Program for Front Passenger's Airbag Inflator for 2001-05 Civic and Other Listed Years and Models (Expires January 31, 2030)

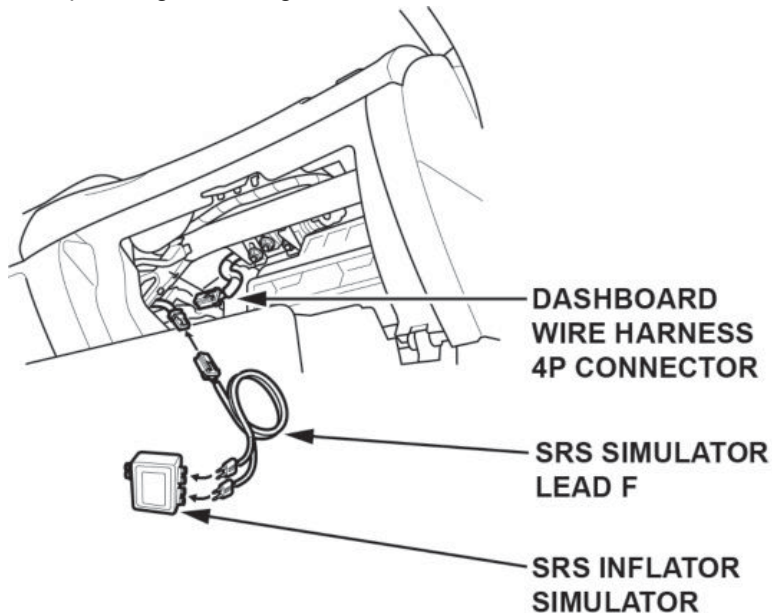
9. Turn the ignition to OFF.
 10. Disconnect the negative cable from the battery, and wait at least 3 minutes.
 11. Access the front passenger's airbag, and disconnect the dashboard wire harness connector 4P connector from the front passenger's airbag 4P connector.

12. Connect the terminals of SRS simulator lead F to the SRS inflator simulator (2 Ω connectors), then connect SRS simulator lead F to the 4P connector as shown.
13. Reconnect the negative battery cable.
14. Turn the ignition to ON, not ACC, and wait 10 seconds.
15. Check if the SRS DTC listed in step 8 returns.
 - If the same SRS DTC returned, the inflator is OK. The Customer Support Program does not apply. Continue with normal troubleshooting.
 - If the same SRS DTC **did not** return, go to the REPAIR PROCEDURE.

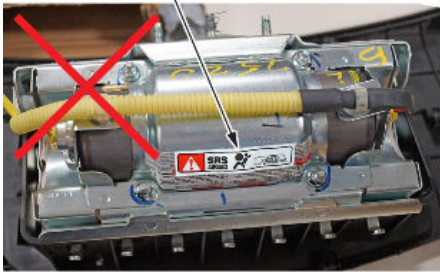
NON-STANDARD SAFETY LABEL

- If there are any unusual markings, like an incorrect label or a model year written in marker, the airbag module and inflator may not be the correct airbag module and/or inflator for the vehicle or it may be a counterfeit part. For more information about counterfeit airbags, you can refer to safercar.gov, enter keywords **MANAGING COUNTERFEIT**, and select **Recommended Dealer Guidance for Managing Counterfeit Air Bags** from the list. **If you suspect that the airbag module or inflator is counterfeit, do not continue this procedure.** Contact your DPSM for assistance.

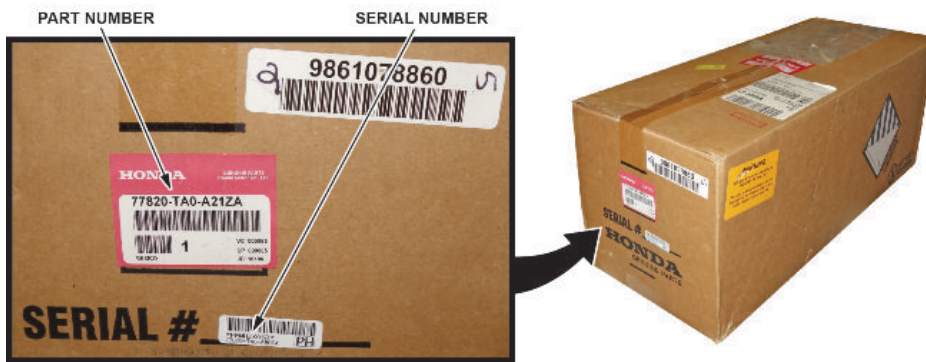
6. Write the serial number and part number from the outside of the airbag module box on the RO.

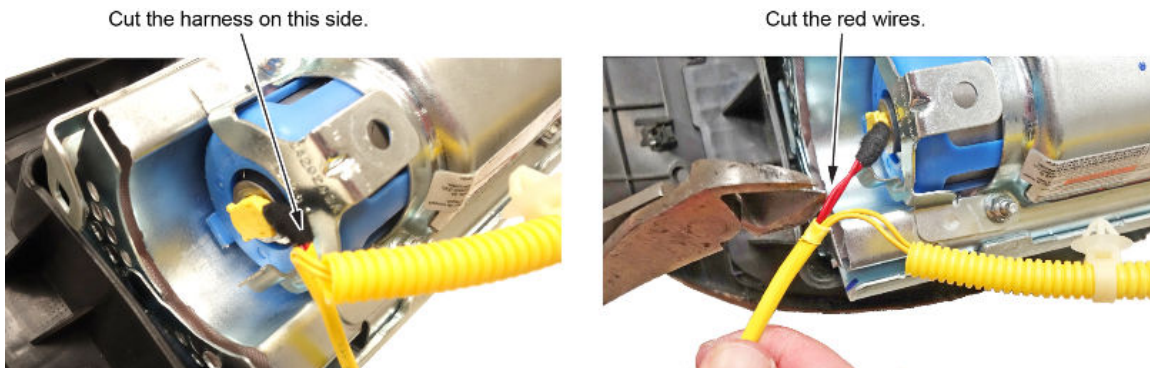
- 3.1. Cut the red wires about **2 inches** from the inflator.

There may be some protective tube covering the wires that needs to be cut away to access the wires.

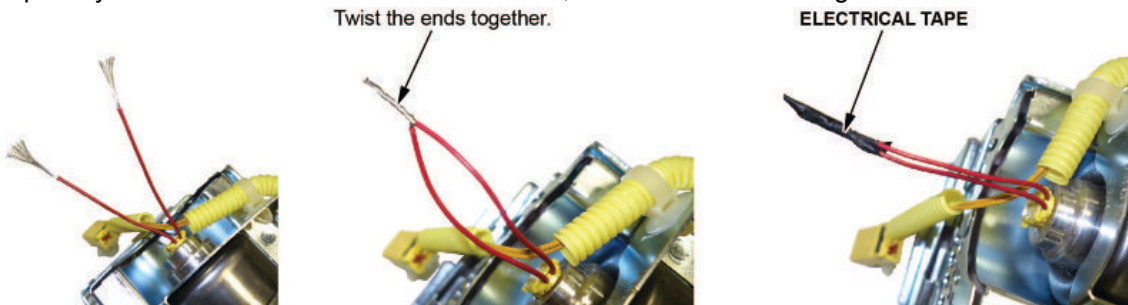
- 3.2. Strip away about **1 inch** of the red wire insulation, then twist the wires together.

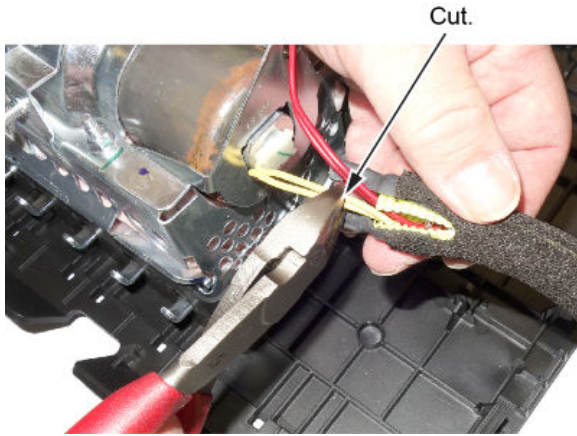
3.4. Cut the yellow wires about **2 inches** from the inflator.

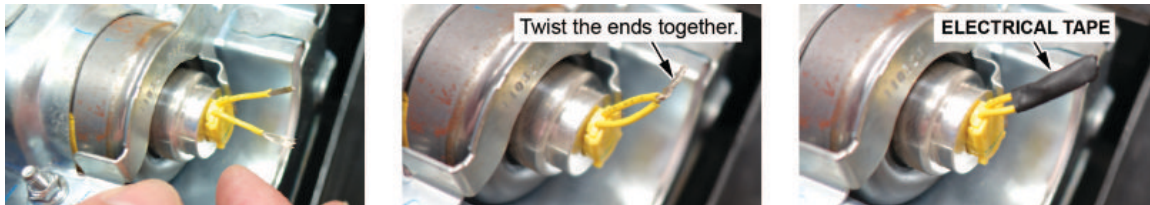
3.5. Strip away about **1 inch** of the yellow wire insulation, then twist the wires together.

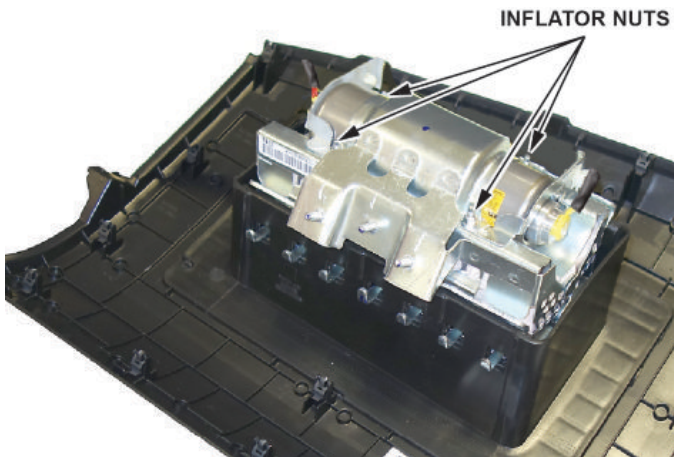
3.7. Remove the four inflator nuts.

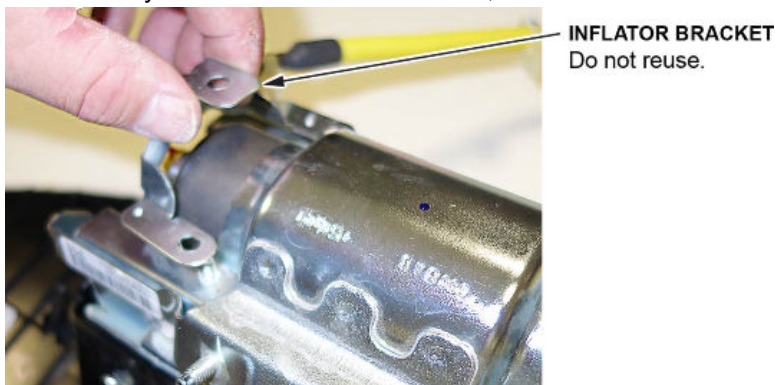
4. Remove the inflator bracket.

You can only remove one of the brackets; the other is welded to the airbag housing.

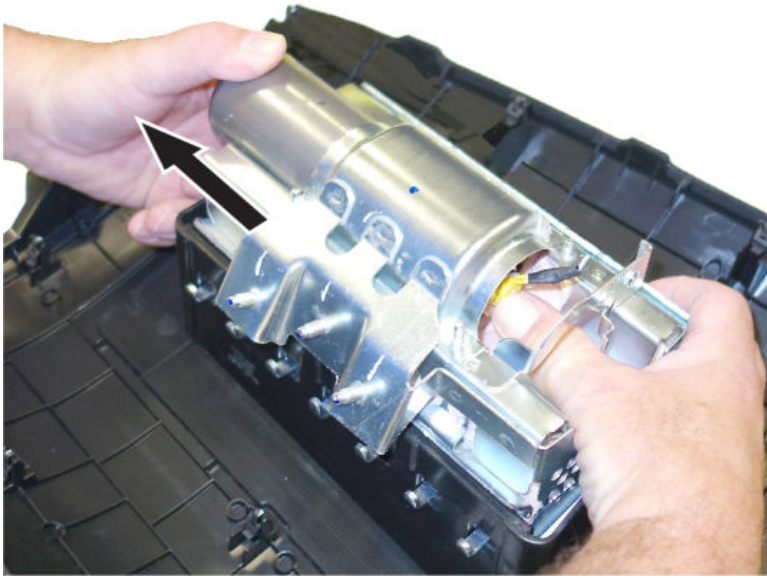
5. Remove the inflator by pulling it out.
