Applicable Vehicles

21-20-01TT - MIL ON, DTC P0101 Mass Air Incorrect Flow

Release date: 03/6/2020

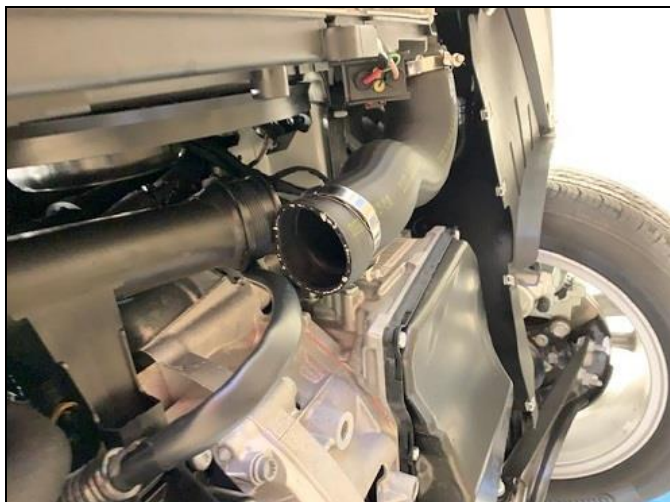
Figure 1

DTC P0101 sets when Mass Air Flow -**G70**- draw is too high or too low.

Pressure test Charge Air System and check for leaks, see Repair Manual Group 21 in Elsa. Look for a loose or a popped out boost hose (Figure 1). Reinstall and secure as needed.
