Technical Service Bulletin

91 MIB2+: Both MMI displays turn blue

91 20 49 2054009/2 March 10, 2020. Supersedes Technical Service Bulletin Group 91 number 19-47 dated March 12, 2019 for reasons listed below.

Model(s)	Year	VIN Range	Vehicle-Specific Equipment
A6, A7, A8, Q8, and Audi e-tron quattro	2019	All	MIB2+

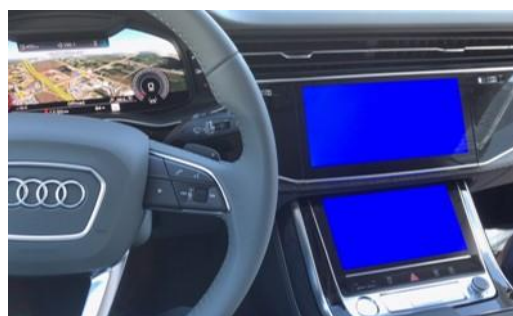
- Both MMI screens have turned blue (Figure 1).
- Everything is displayed correctly in the instrument cluster.

Figure 1. MMI screens are blue.

- The blue screen will go away after a bus sleep cycle has been performed.
- No DTCs are stored in the information electronics control module 1, J794 (address word 005F).

A software bug can cause a buffer overflow in the display driver.

The problem is caused by a buffer overflow in the display driver, mostly due to multiple short ignition cycles. To resolve the problem, let the vehicle go to sleep for 10 – 15 minutes. It might take multiple sleep cycles to resolve.

Do not replace any components.

If the customer experiences the problem more than one time or it does not resolve with multiple sleep cycles, please contact the Technical Assistance Center (TAC) for assistance.
