Technical Service Bulletin

01 "Switch off the engine and check coolant" message in the instrument cluster, DTC P00000 is stored in the ECM

01 20 50 2058890/1 March 18, 2020.

Model(s)	Year	VIN Range	Vehicle-Specific Equipment
A4	2017 - 2019	All	V6TFSI
A5, Q5	2018 - 2019	All	V6TFSI

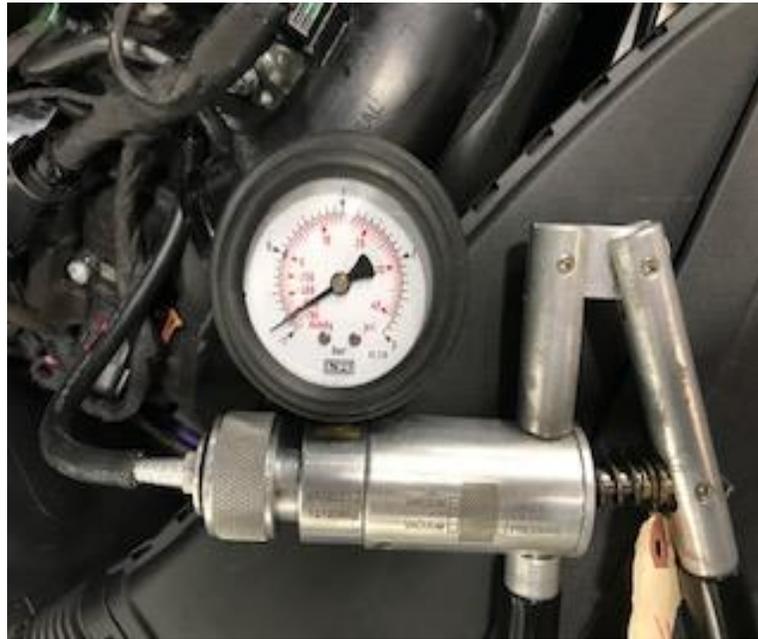
A. Check for vacuum (using VAS6213) at the output port of solenoid N649 which commands the water pump sleeve (Figures 1 and 2). The engine needs to be cold to generate a command signal to the N649 solenoid to switch to a vacuum. **With the engine cold**, start the engine briefly and monitor that vacuum is created.

Figure 1. Checking the vacuum at the output port of N649.

B. If there is no vacuum measured at the output port of N649, the cause of the fault could be related to the solenoid valve N649 or the vacuum hoses (check for leaks). In this case, repair and check the operation of the vacuum system.

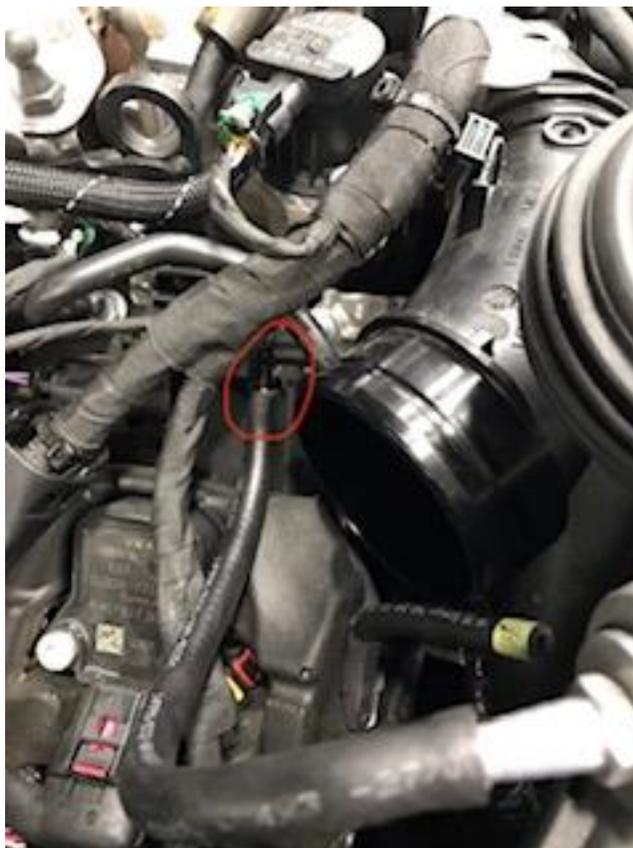
Figure 2. The output port of N649 (close-up picture).

4. If there are no malfunctions found in the vacuum system, check the operation of the water pump sleeve by applying a vacuum to the hose going to the water pump (hose connected to the output port of N649). When applying a vacuum to the pump, pay attention to the clicking sound of the water pump sleeve. If no clicking is heard or felt, replace the mechanical coolant pump.
