## SERVICE POLICY LETTER

| Reference number: | SPL-03-0594V4 | Issued: 17 March, 2020 |
| Subject: | Engine Oil Leaks for Vehicles still in Manufacturer's Warranty | |

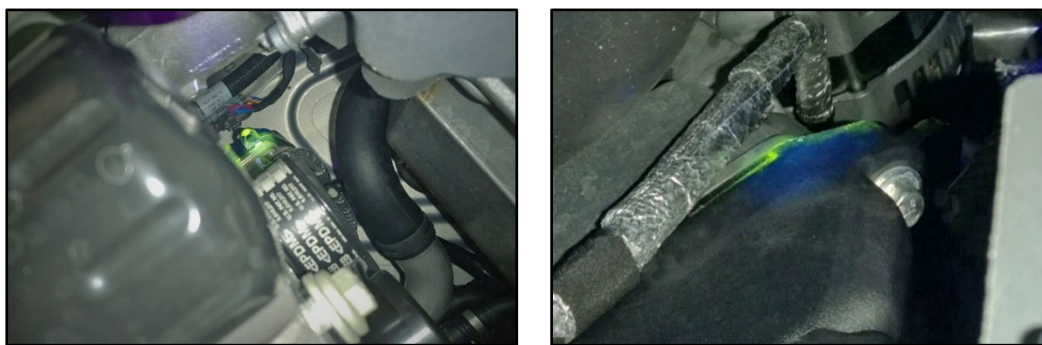
When you use the correct lamp, the dye in the oil of new AML engines will glow bright green (refer to Figure 1).

**Figure 1 - Examples of dye in engine oil**

To do a check if there is dye in the engine oil, remove the oil filler cap and point the UV lamp into the oil filler opening. You should see the dye glow green.

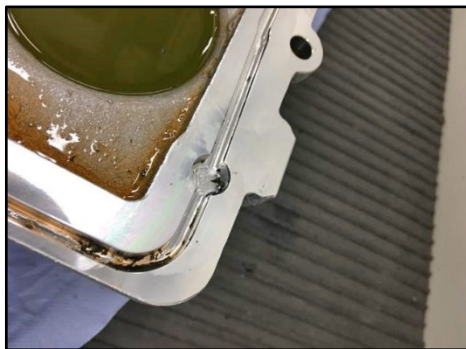
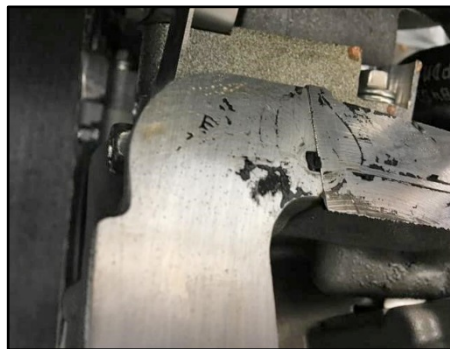
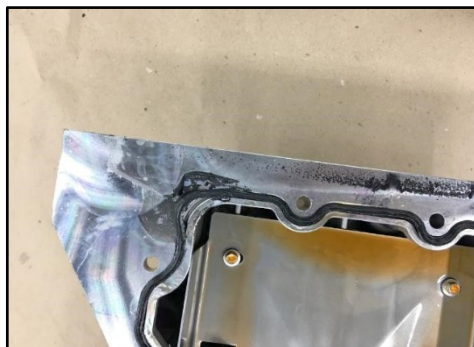
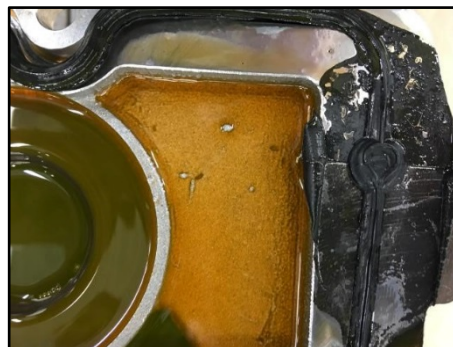
After we have given the approval to do the repair, during the repair process, please take more photographs. We ask you to do this to give us more information about why the leak occurred. This will help us to increase reliability and quality in the future. For examples, refer to Figure 2 thru Figure 5. The photographs must show data about the cause of the leak.

Some usual causes of oils leaks can be:

- Damaged seal
- Loose or incorrect fastener torque(s)
- Damage to mating surfaces or seal groove
- Contamination or debris in the joint or on/under a seal
- Incorrect application or insufficient quantity of liquid sealant (RTV)
- RTV does not bond to the joint surfaces because of incorrect degreasing
- Missing or misplaced seal.
