WKK8 - Replacing and Teaching Remote Controls (Workshop Campaign)

Vehicle type: Taycan (Y1A)

Subject: Remote control

Information: There is a possibility that the "open on approach" comfort access function will not work as intended for the affected vehicles.

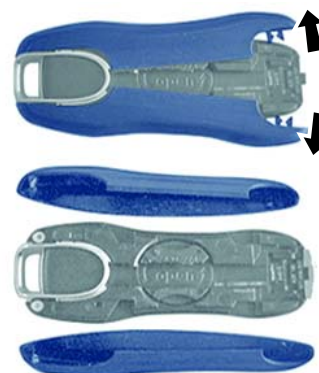
Replacing side faces

- 3 **Only for vehicles with driver's key painted in exterior color or leather-covered vehicle key (I-no. AFL, AFP):** Pull the personalized side faces outwards off both keys ⇒ *Replacing side faces* -**arrow**- and then clip them back into the new remote control.

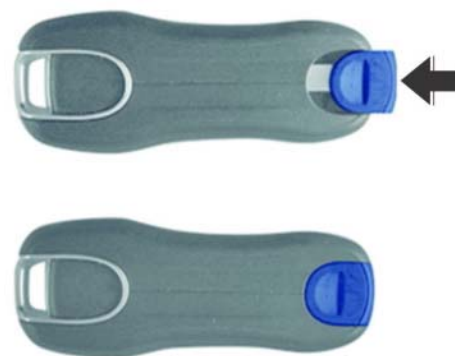
Inserting emergency key

- 4 Insert both emergency keys into the new remote controls ⇒ *Inserting emergency key.*
- 5 Connect a suitable battery charger, e.g. VAS 5908 - 90 A battery charger, to the jump-start terminals in the front luggage compartment and switch it on.
- 6 **9900 - PIWIS Tester 3** must be connected to the vehicle communication module (VCI) via the **USB cable**. Then connect the communication module to the vehicle and switch on the PIWIS Tester.

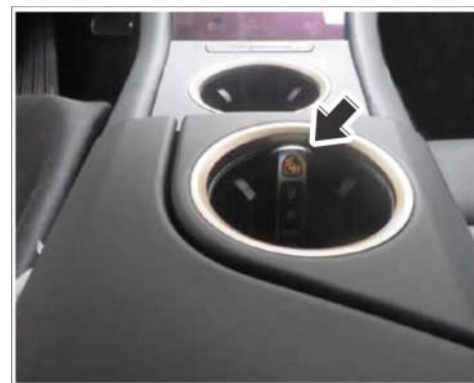
Emergency start tray

Position the **remote control** with the back facing forward upright between the holding struts in the rear cupholder (**emergency start tray**) to guarantee a permanent radio link between the vehicle and remote control ⇒ *Emergency start tray* -**arrow**-.
