STAR ONLINE PUBLICATION

Case Number: S1805000006

Symptom/Vehicle Issue: ESC Light Illuminated. DTC C1252-92 VACUUM PUMP CONTROL CIRCUIT And Or P258B ELECTRONIC VACUUM PUMP PERFORMANCE

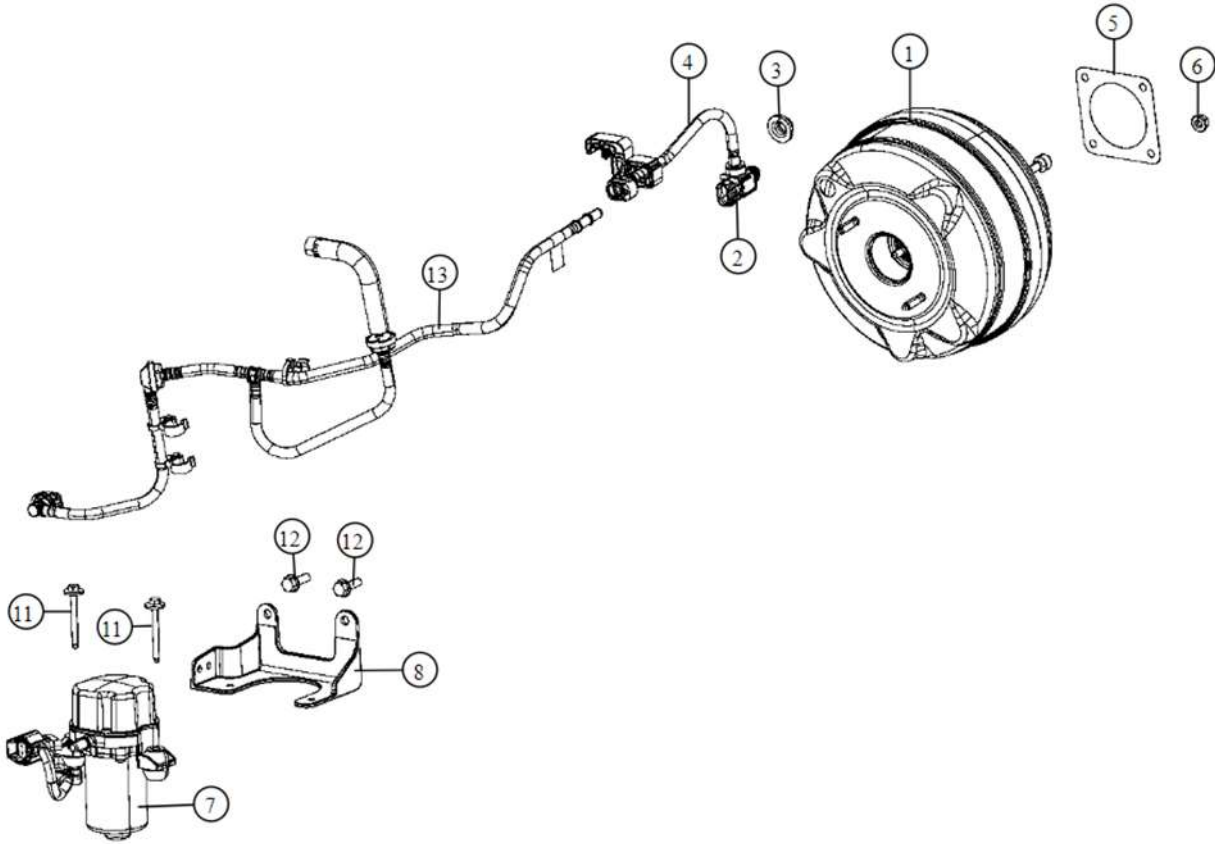
In addition when checking Vacuum lines, please ensure to check Vacuum hoses and check valves between the engine intake, booster and vacuum pump. Because the check valves only allow flow of air on one direction, each vacuum circuit must be checked separately to make sure there are no leaks, kinks or damages. Please refer to the correct vacuum diagram.

>>>**Note**>>> If the vacuum pump is found to be failed, replace the pump and diagnose the vacuum system again. It is possible a vacuum leak may have caused the pump to run too often or too long causing a pump failure.

<<<**Note**>>> Confirm PCM is up to date, there are new flashes released in February 2019 with improved vacuum pump duty cycle. This will help protect future pump failures.
