AJ20P4 Coolant Leak

2018 Onward F PACE, XE, XF, RR
Velar quipped with AJ20P4

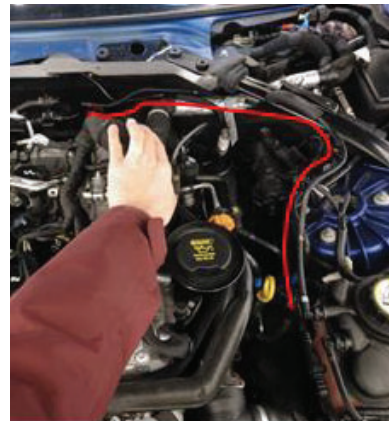
- Coolant is identified as leaking from the engine compartment.
- The leak is found to be originating from JX73-8C362-AC.

- We are interested in executing a specific test plan on a vehicle prior to any disassembly.
- Should you encounter a leak from this pipe, please raise an EPQR and include pictures showing the leak.
- Specific instruction will be provided via the EPQR.
