SIB 51 13 20 REAR DOOR SEAL DETACHED

2020-04-29

| E-Series | Model Description | |
|---|---|--|
| G05 | X5 Sports Activity Vehicle | |
| G07 | X7 Sports Activity Vehicle | |

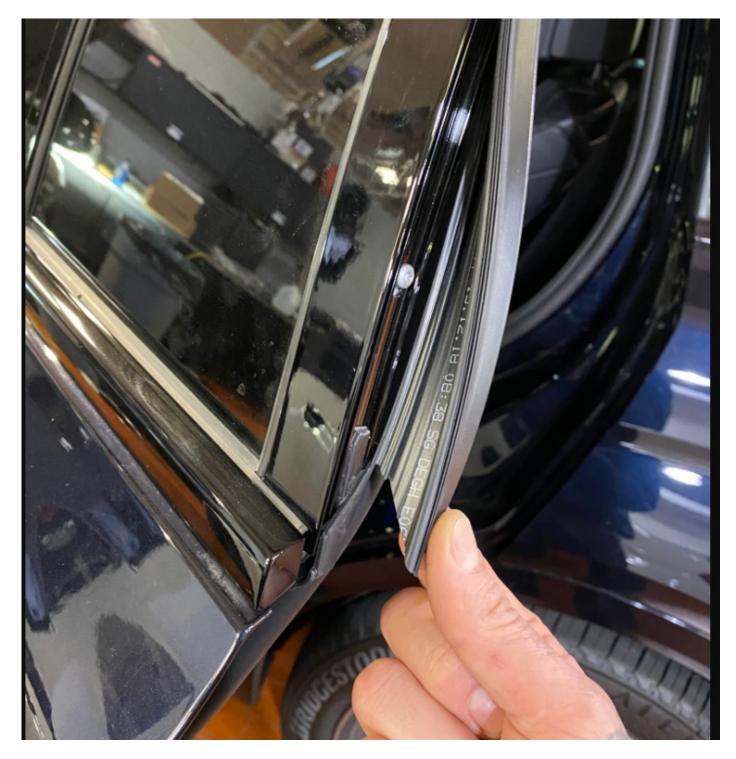
<u>SITUATION</u> One or both rear door seals are detached from the rear door(s).

CAUSE

Improper connection of the door seal to the door.

CORRECTION

Apply adhesive and reinstall the rear door seal(s).

- 1. Install a small dab (1 mm x 1 mm) of adhesive P/N 83 19 2 289 180 to the middle and bottom of the seal channel.
- 2. Re-install the seal by pressing it firmly into the channel. Use the window frame as a guide to ensure the seal is completely seated inside the channel.
- 3. Complete the procedure on the opposite side of the vehicle.
