DTC (Code) P0544-15
Codigo:

Bulletin: RD18-002
Date Fecha: June 12, 2018

Description: Exhaust Gas Temperature Sensor Bank 1 Sensor 1

Application: US13 – US20 Emissions

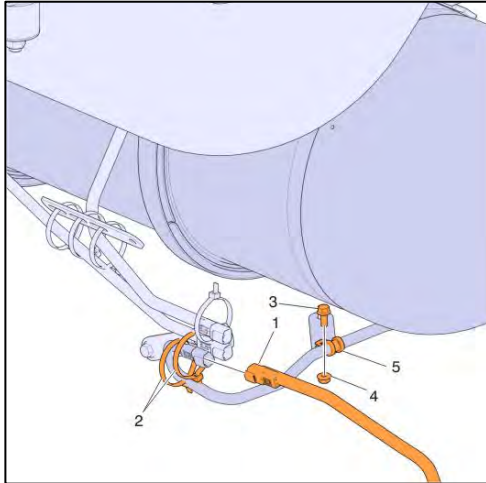
7. Remove clamps and disconnect the wiring harness connector from the exhaust temperature sensor.

1. Electrical Harness
2. Cable Tie
3. Screw
4. Nut
5. Clamp

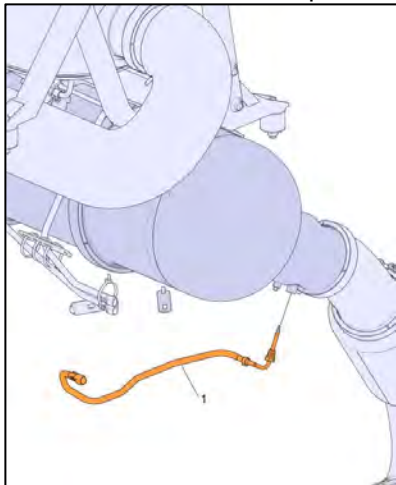
8. Remove the defective temperature sensor.

1. Sensor

1. Clean the exhaust temperature sensor contact surface.
2. Install the replacement exhaust temperature sensor.
3. Reconnect the wiring harness connector to the exhaust temperature sensor and install clamps.
4. Secure the wiring harness with cable ties.
5. Reconnect all previously removed cables to the negative (ground) battery terminals.
6. Start the engine and check for function and leaks.
7. Connect Tech Tool to the vehicle. Use Guided Diagnostics to read and clear any diagnostic trouble codes (DTCs).
8. Install insulation, if removed.
9. Close the battery compartment access doors.
10. Close the rear engine service doors.
