DTC (Code) P20E8-92 Codigo:	Bulletin: RD18-002 Date Fecha: July 2, 2018
Description: Reductant Pressure Too Low - Performance or incorrect operation	
Application: US13 – US20 Emissions

Aftertreatment Diesel Exhaust Fluid (DEF) Pump Unit, Replacement

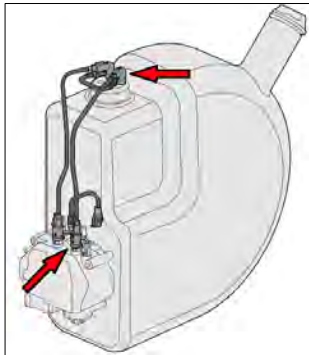
- Disconnect and clean the aftertreatment DEF lines between the DEF tank and the DEF pump using water and compressed air. If the line is broken then it will have to be replaced.

Before replacing the DEF Pump Unit please check for damaged return hoses and connectors.

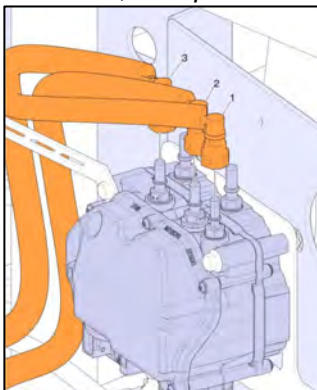
7. Mark the DEF lines before removal. Remove the DEF inlet, backflow and outlet lines from the pump. Place protective caps on the DEF lines. *Note: For information on the handling of DEF, refer to "General Safety Practices", Group 20. Note: If inlet and backflow lines are switched, the system will not start.*

1. DEF Outlet Line
2. DEF Backflow Line
3. DEF Inlet Line

4. Install DEF inlet, backflow and outlet lines onto the pump. Note: If inlet and backflow lines are switched, the system will not start.
5. Fill the cooling system with the recommended coolant using the coolant extractor. Ensure the coolant system is full. Special tools: 85112740

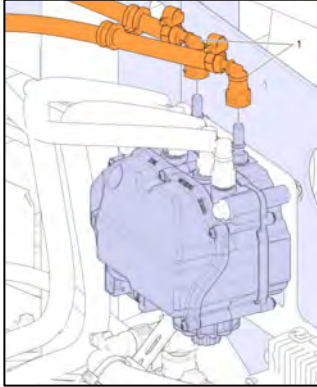
8. Remove the inlet and outlet coolant lines from the pump. Place protective caps on the coolant lines.

1. Coolant Lines

2. Remove plastic bag from the wiring harness connector. Attach the wiring harness connector to the DEF pump and secure the harness using a cable tie.
3. Install the inlet and outlet coolant lines onto the DEF pump.

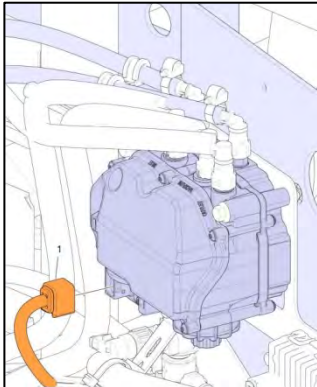
9. Remove cable tie and disconnect the wiring harness connector from the DEF pump. Cover the wiring harness connector with a plastic bag to protect from possible damage from DEF.

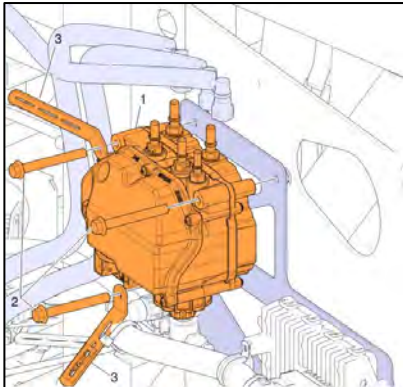
10. Remove the fasteners, brackets and DEF pump from the mounting bracket.

1. DEF Pump
2. Fasteners
3. Brackets

1. Position the DEF pump onto the mounting bracket and install brackets and fasteners. Tighten the fasteners to specification, refer to Function Group 20, Specifications.
