# SS 1034711 Hadley Upper Mirror Glass Vibration

Hadley upper mirror glass vibration

All WST model trucks with Hadley cab mounted mirrors

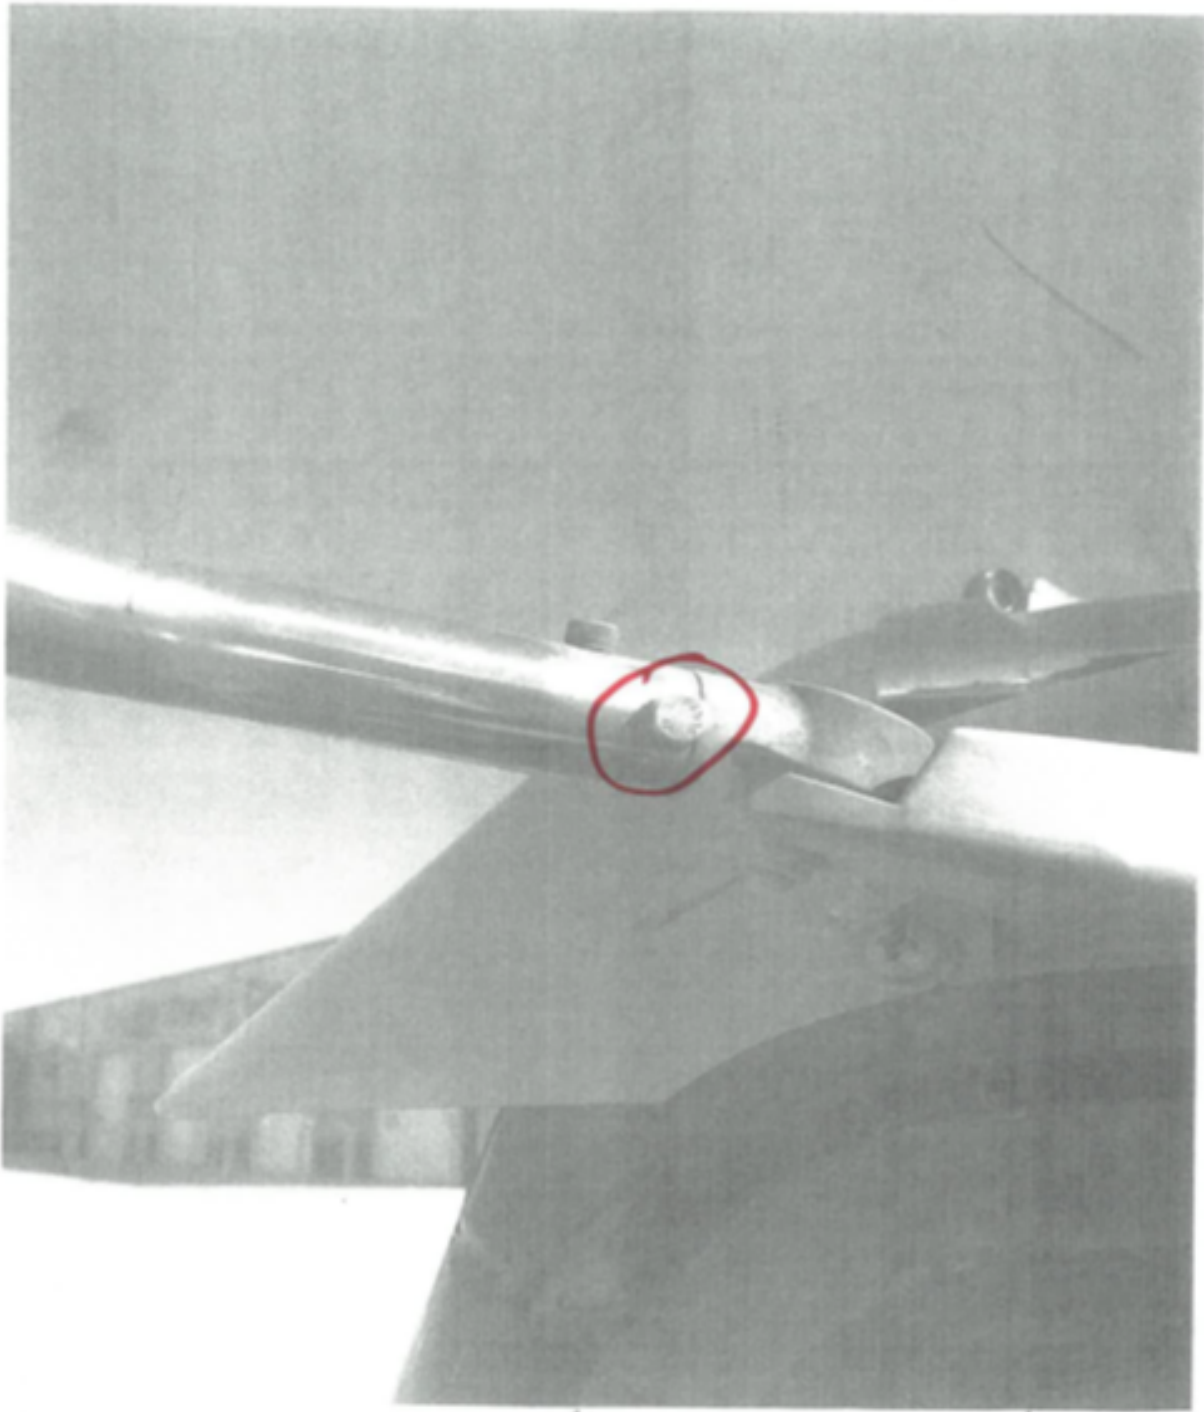
Work Instructions if Whole Mirror is Vibrating

1. Drill a ¼-inch hole where the mirror tubes and cab brackets come together. (see example below)
2. Install a stainless ¼ inch bolt into the drilled hole
3. Tighten bolt firmly while being careful to not over tighten
4. Test for vibration
