STAR ONLINE PUBLICATION

Case Number: S1808000005

Symptom/Vehicle Issue: No Start, Multiple Modules Are Not Responding

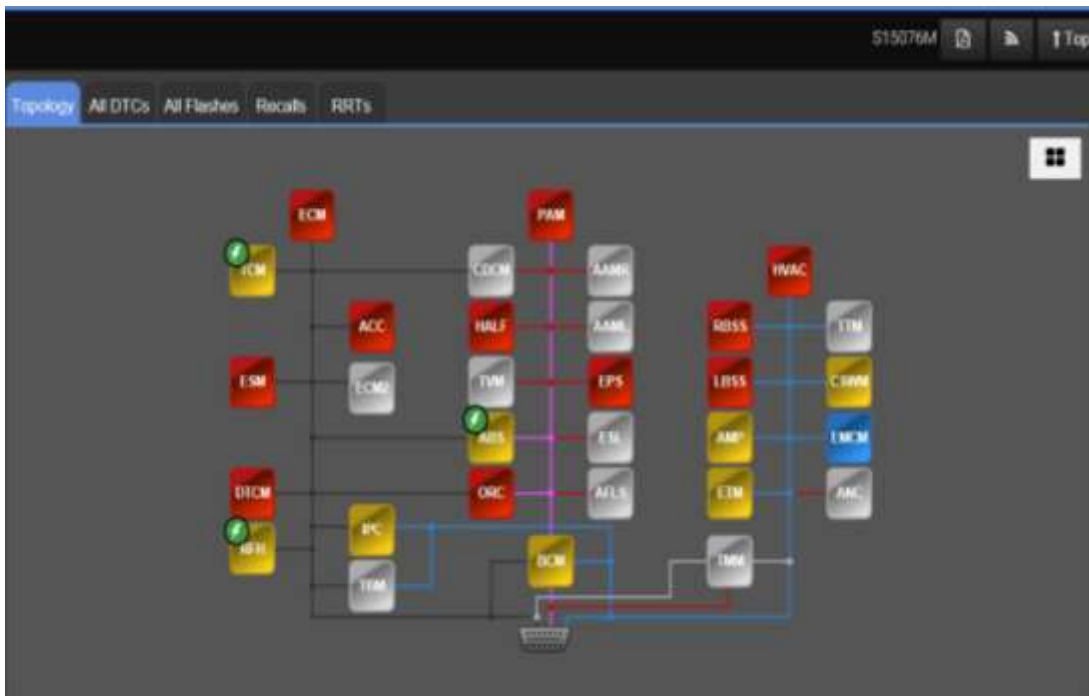
Fig 1

Discussion: For conditions of a no start with multiple modules not responding, inspect all power feed circuits to the BCM including the stand alone fuse Fig 1, 2, 3. Check and correct B+ A0 circuit, to the BCM Or 20 Amp standalone fuse as needed. For GU / Stelvio inspect the F82 fuse in the rear PDC to the BCM A901 circuit, Fig 4, 5.

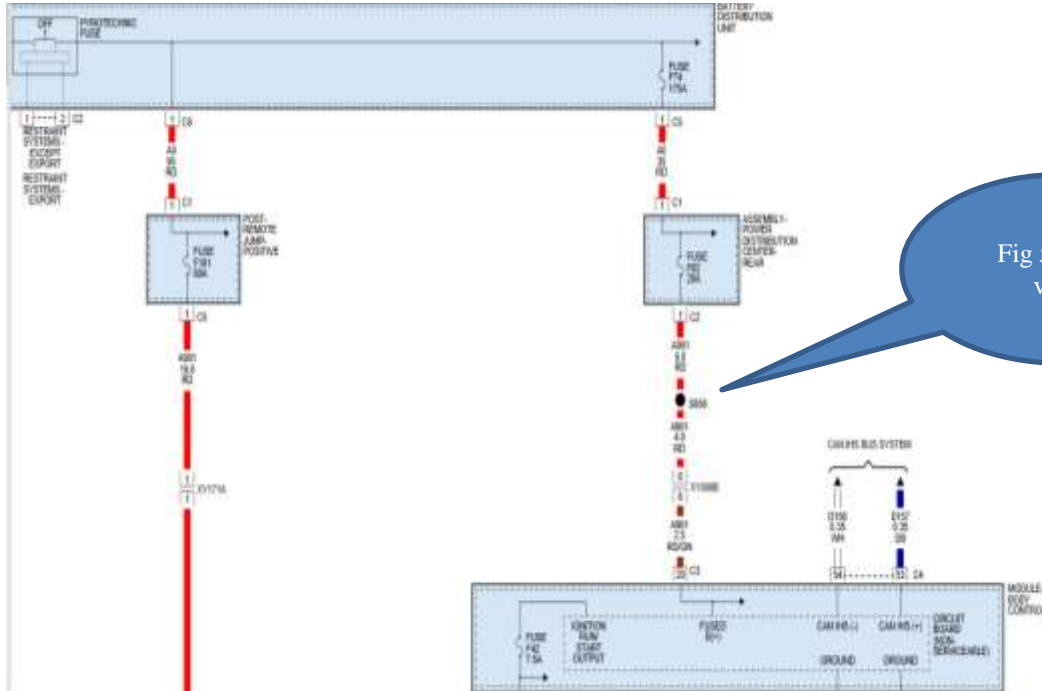
Fig 5 circuit view.

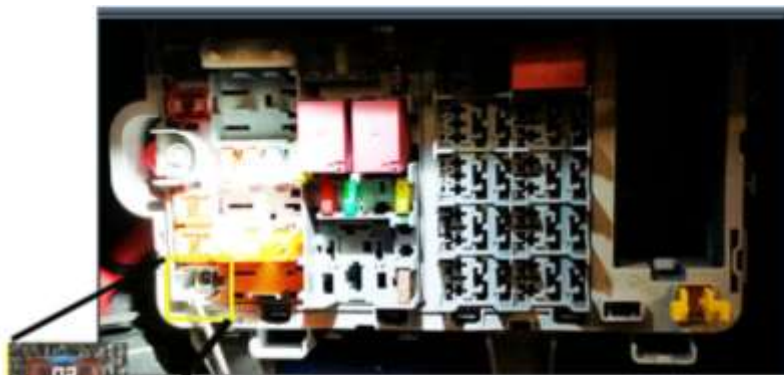
Fig 4

Fuse F82 (20 Amp JCASE Fuse) Located in the Rear PDC was Open/Blown
