**NUMBER:** 11-001-20

GROUP: 11 - Exhaust System

Active Exhaust Valve Rattle

2018 - 2020 (LA) Dodge Challenger 2018 - 2020 (LD) Dodge Charger

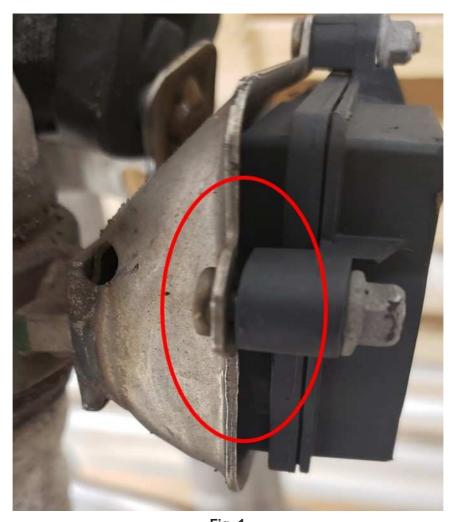
- Raise and support the vehicle. Refer to the detailed service procedures available in DealerConnect> Service Library under: Service Info> 04 - Vehicle Quick Reference / Hoisting / Standard Procedure .
- 2. Is there a gap showing or are any of the nuts loose on the actuator(s) (Fig. 1)?
  - YES>>> Proceed to Step 3.
  - NO>>> This Bulletin does not apply. Normal diagnosis should be performed. Refer to the
    detailed service procedures available in DealerConnect> Service Library under: Service
    Info>11 Exhaust System / Diagnosis and Testing.

Fig. 1
Actuator not Tight to the Exhaust

- 3. Remove the exhaust valve actuator. Refer to the detailed service procedures available in DealerConnect> Service Library under: Service Info> 11 Exhaust System / Valve, Active Exhaust / Removal.
- 4. Clean the threads of nut and stud to remove any dirt, mud, or other contamination.
- 5. Once the stud and nut are clean, hand start the nut back onto the stud.

6. Install the exhaust valve actuator. Refer to the detailed service procedures available in DealerConnect> Service Library under: Service Info> 11 - Exhaust System / Valve, Active Exhaust / Installation.

7. Hold down the actuator so there are no gaps between actuator and housing. Using a torque wrench, Tighten the nut to 4 N·m (35 in lbs.).

# CAUTION! It is important to use hand tools to prevent cracking of actuator plastic.
