# Emissions Recall

## Code: 26N6

**Subject** Catalyst

**Problem Description** Over time and mileage, the factory-installed catalyst may not perform as required. If the effectiveness of the catalyst is reduced, this may result in increased tailpipe emissions and the vehicle could fail an emissions (IM) inspection.

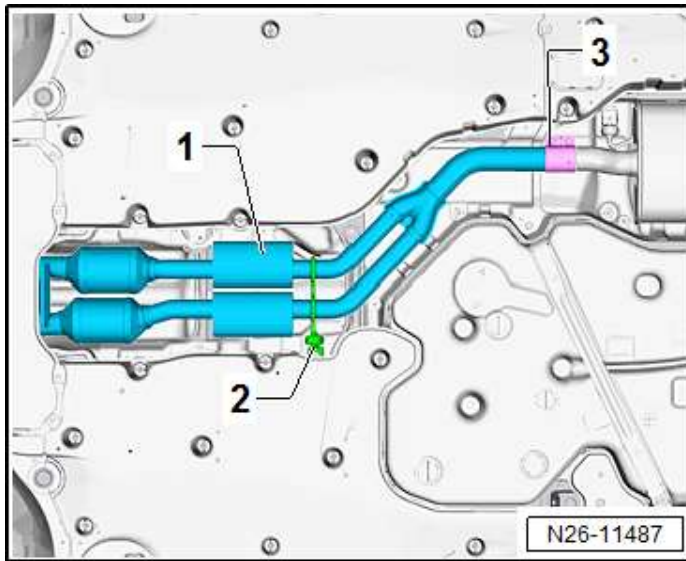
## Repair Overview

- Replace catalyst and update ECM software.

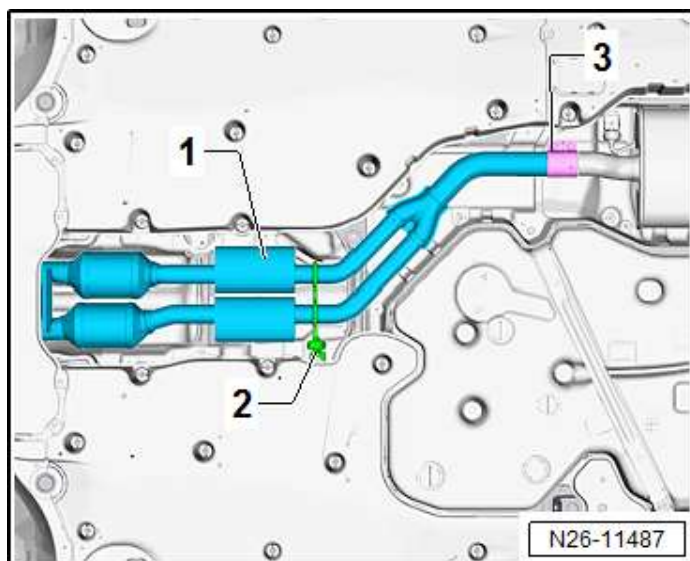
## Section B – Replacing Catalyst

Oxygen sensors <1>, <3> and <4> can be removed with tools from the Ring Wrench 7-Piece Set -3337-.

Oxygen sensor <2> will have to be removed with a locally sourced oxygen sensor socket.

- See ELSA Repair Manual: *Repair Manual > Engine > 6-Cylinder Direct Injection (3.6L Engine, 4V) > 26 Exhaust System, Emission Controls > Emissions Control System > Catalytic Converter, Removing and Installing*
- After replacing the catalyst:
  - **Proceed to Section C to update the ECM software.**

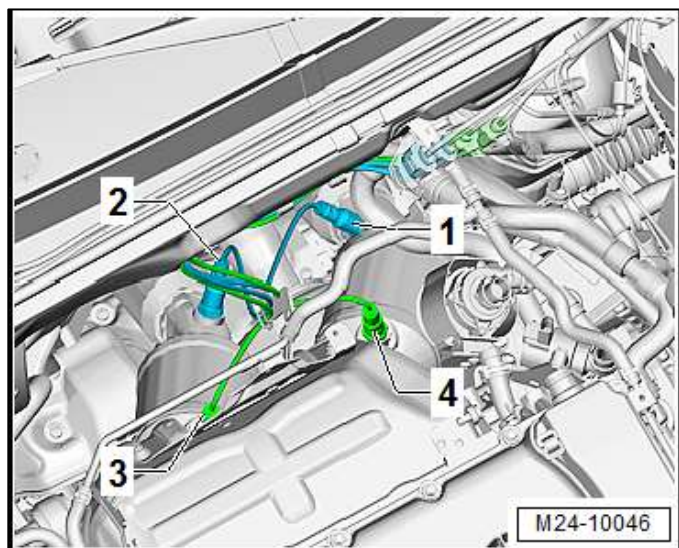
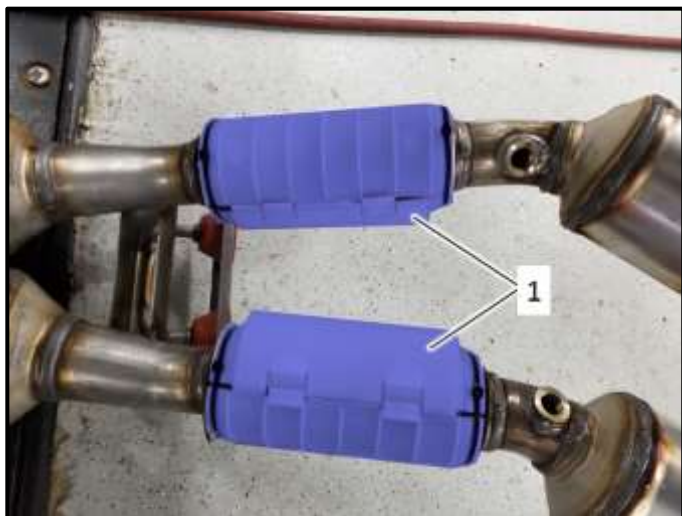
Do not bend the decoupling element more than 10°. Do not damage the wire mesh on the decoupling element.

- Ensure the transportation protection <1> is secured on the new catalyst before installing.
- After installing and securing the catalyst to the exhaust manifold, remove the transportation protection from the catalysts.

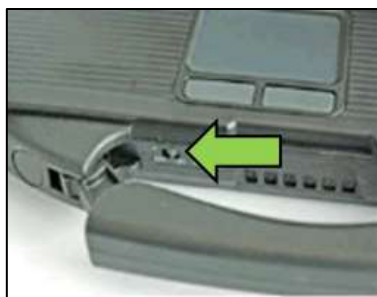
**VAS 6150 & VAS 6150A**  
(Front panel behind handle)

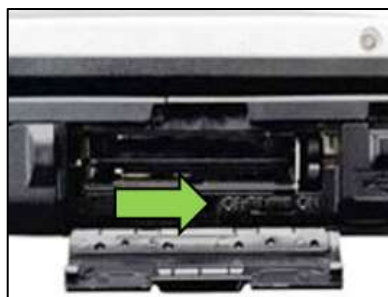
**VAS 6150B**  
(Right side behind WIRELESS door)

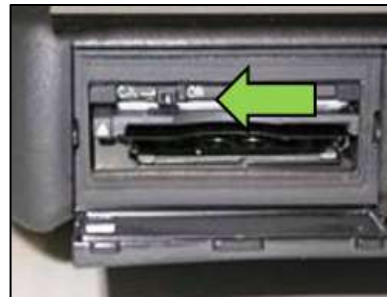
**VAS 6150C/D**  
(Left side behind SC/EX door)

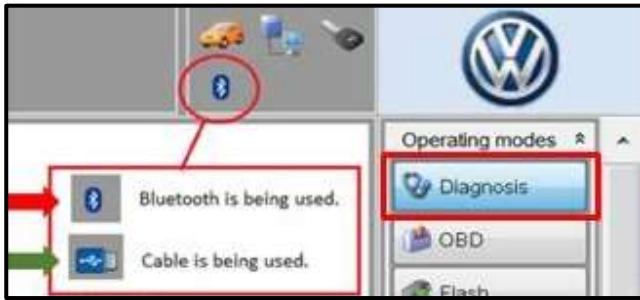
- Confirm that scan tool is communicating with the diagnostic head by USB <Green Arrow>.
  - If the Bluetooth symbol is shown <Red Arrow> then disconnect the diagnostic head from the vehicle and reconnect the USB cable to the diagnostic head and then reattach to the vehicle.
- Upon ODIS startup, verify the "Diagnosis" operating mode is selected <as shown>.
- Once the GFF scan is complete, select "Special functions" <arrow 1>, then "Adapting software" <arrow 2>, then select "Perform test" <arrow 3>.

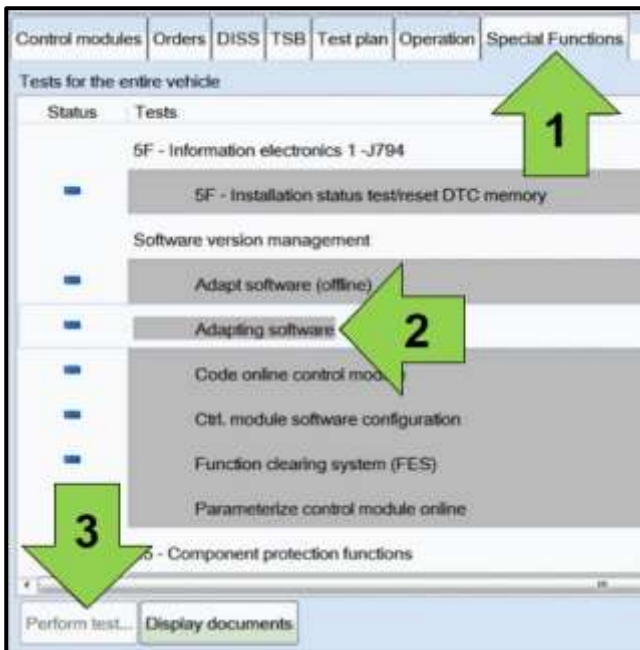
- Select option 2 to "Update software via action (or measure) code".

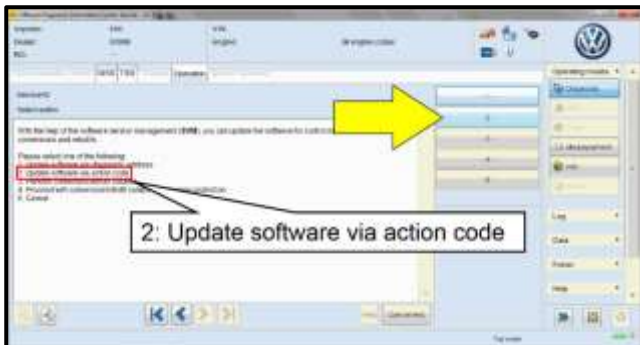
The procedure to update the software may not always be option 1.

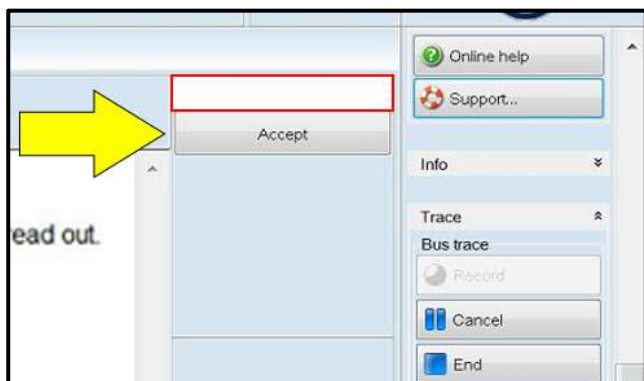
- Enter the corrective action code (SVM code) as listed below.

**SVM code**

**43E7**

- Select "Accept" <arrow> and follow the on screen prompts.

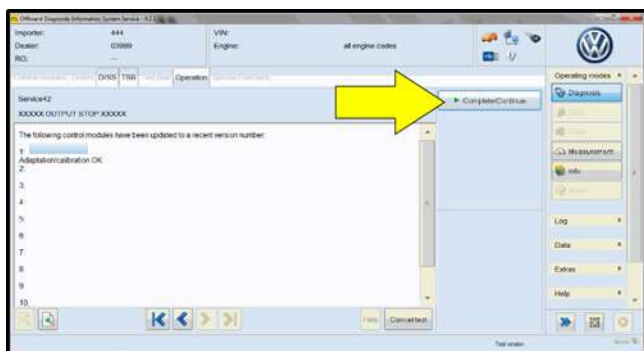
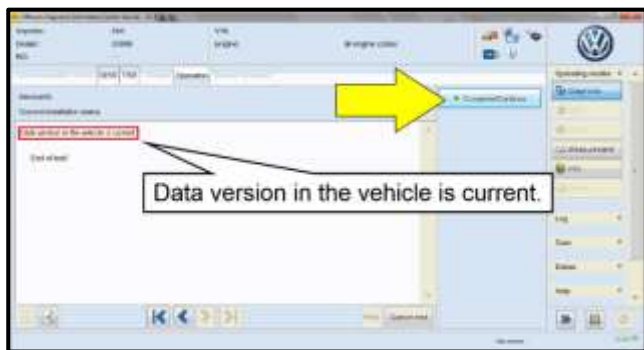
- When the SVM update is complete a confirmation message is displayed <as shown>.
- Select "Complete/Continue" <arrow>.

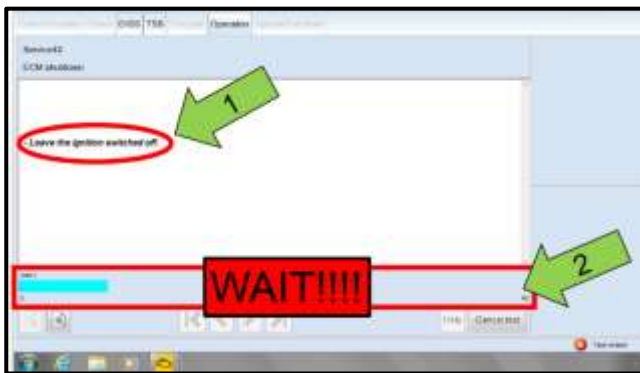
- It is **IMPERATIVE** that **ALL** of the ignition cycle on/off delay requests are fulfilled in their entirety during this flash process <arrow 1>.
- Failing to wait for the ignition on/off timing cycle to complete (progress bar and countdown timer <arrow 2>) before cycling the ignition on/off MAY damage a control module.
- Damage to control modules as a result of failing to wait the specified time displayed by the progress bar and countdown timer <arrow 2> are **NOT** covered under this action.

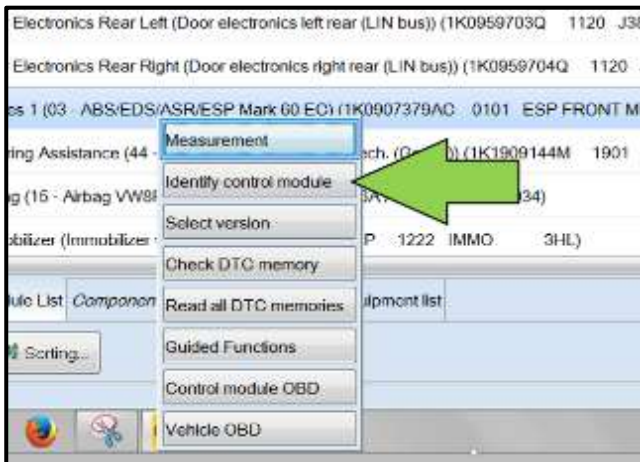
- After the software update is completed and before sending the GFF Log Online:
  - Select the "Control Module" tab.
  - Scroll down and right click on the module that was updated (0001).
  - Select "Identify Control Module" <arrow>.

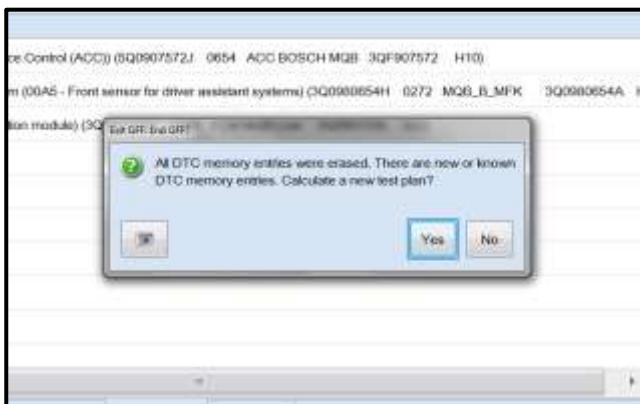
- Exit GFF and send diagnostic protocol online when prompted.

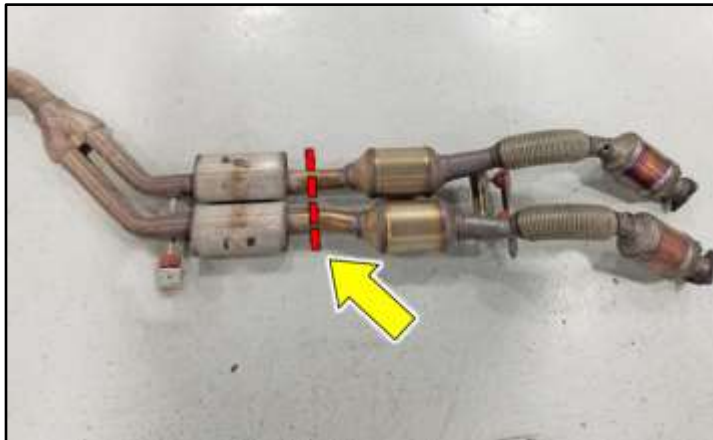
The catalysts **MUST** be separated from the exhaust system for recycling. Cut the exhaust pipe between the muffler and the catalyst in the area shown <arrow>.

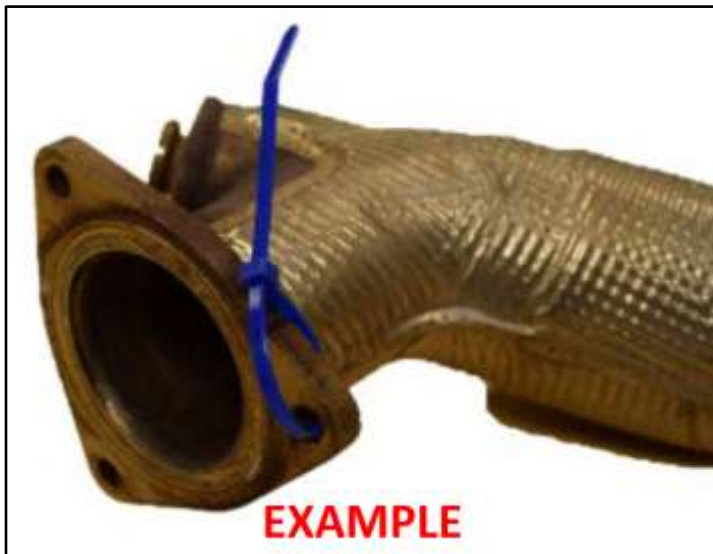
The Catalyst must be tagged with a red or blue zip tie <as shown> and returned in order to be considered for core charge reimbursement.
