SIB 11 01 20

B58C AND B58M ENGINES: ENGINE OIL FILTER INSERT IS DIFFICULT TO REMOVE – REMOVAL

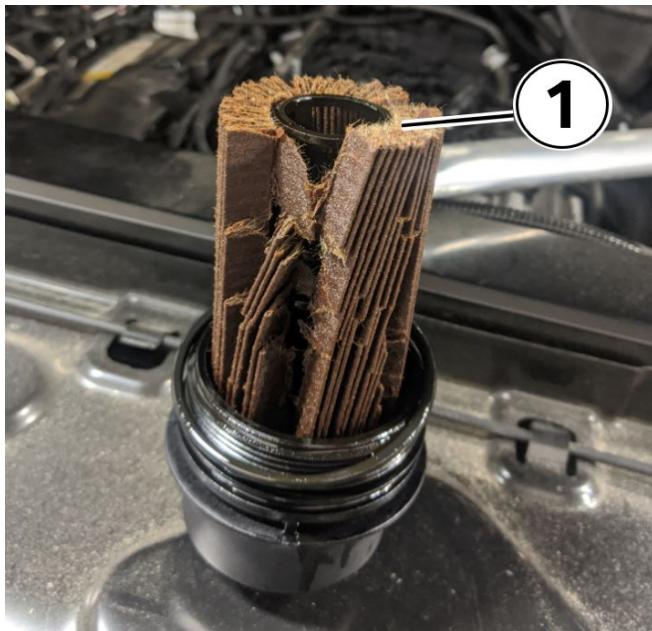
The engine oil filter is broken. The paper is torn, and the lower plastic section is stuck in the engine oil filter housing (1).

If the engine oil filter insert has broken apart inside the oil filter housing:

1. Replace the complete engine oil filter housing per the applicable repair instructions.
 - **Do not replace the heat exchanger**
 - **Do not remove or try to clean the oil filter fragments from the engine oil filter housing**
2. When the oil filter housing is removed from the engine,
 - Allow time for the residual engine oil to drain into a suitable container before returning the part to the WPRC
 - Do not use any solvents on the oil filter housing
 - **All parts will be collected and inspected by the WPRC**
