# STAR Case

**Case Number:** S1318000031

CEL (Check Engine Lamp) on, DTC P0455 Evaporative System Large Leak

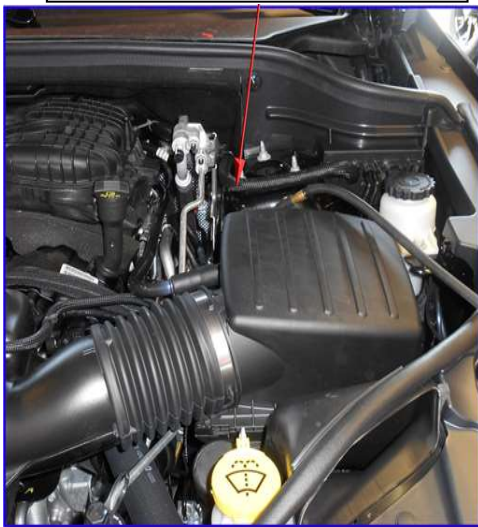
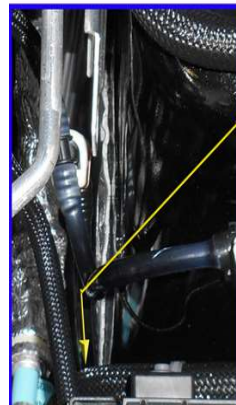
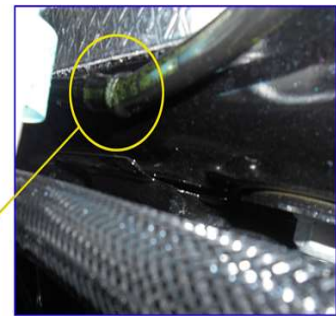
Review Suspect Location

A recent report indicates the CEL is on with DTC P0455 Evaporative System Large Leak stored or active. Inspection revealed an evaporative line loose crimp at the left shock tower location. Review the line in the suspect area, replace, re-position, and secure the hose as needed to repair.

Review hose routing at the left shock tower.
