STAR ONLINE PUBLICATION

Case Number: S2008000033

Symptom/Vehicle Issue: MIL Lamp On, DTC P0325 - Knock Sensor 1 Circuit

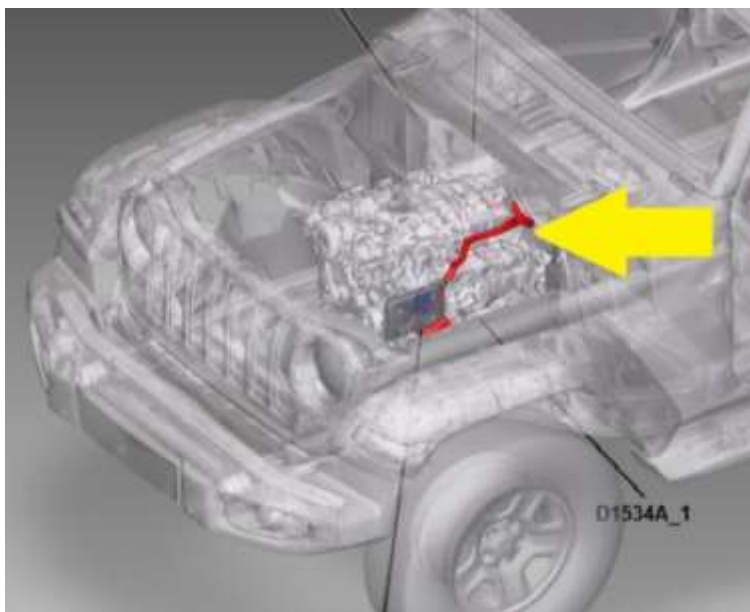
Fig 1

Discussion: Inspect the engine harness routing at the rear of the engine as shown Fig 1, 2. Review for any signs of chaffing damage, repair and isolate the harness concern as needed, no parts required.
