### **Repair Tofino Headliner**

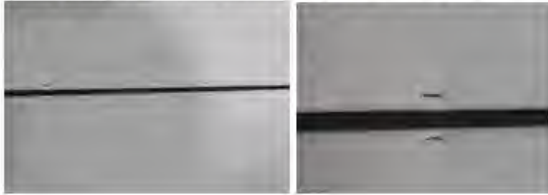
- 2) Place  $\frac{3}{4}$ " #5 Flat head screws -  $\frac{1}{4}$ " from the plastic T edge track on the roof, screwing the head liner up to the roof blocking. Place the screws 7" - 8" apart. (Indicated in picture as staples) Place screws on both sides of the plastic track. Before installing the screws predrill through the head liner and plastic track with a  $\frac{3}{32}$ " drill bit.**

**There is  $\frac{3}{4}$ " blocking between the fiber glass roof and the head liner panel.**

- 1) Remove the ceiling T Edge strips from the track on the ceiling panel.**

- 3) Once the headliner is screwed in place reinsert the ceiling T edge strips back into the track. Ensure there is no duct tape preventing the harpoon on the T edge from engaging in the track.**
