DOC #	PROCESS NAME	PAGE	REVISION	STATION	BY	DATE
AR874	Eqess Front Air Brake Hose Routing/Clamp Repair	1 of 1	-	SER-E	C.Ward	3/10/20

Complaint: CUTR did not approve brake hose routing with P-Clamp

Correction: Remove/Discard P-clamp and replace with L-Bracket Standoff and Hellermann Clamp

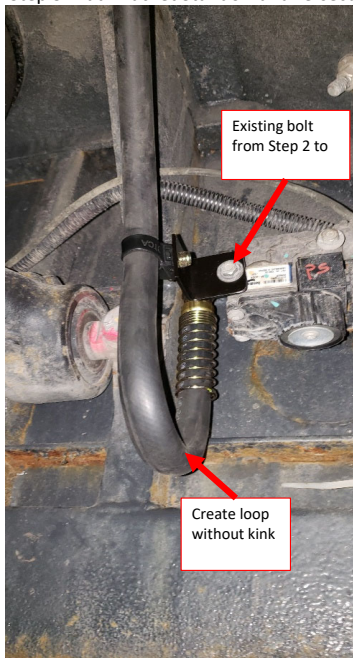
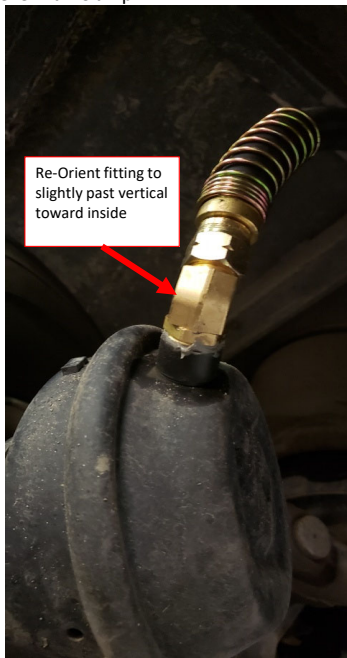
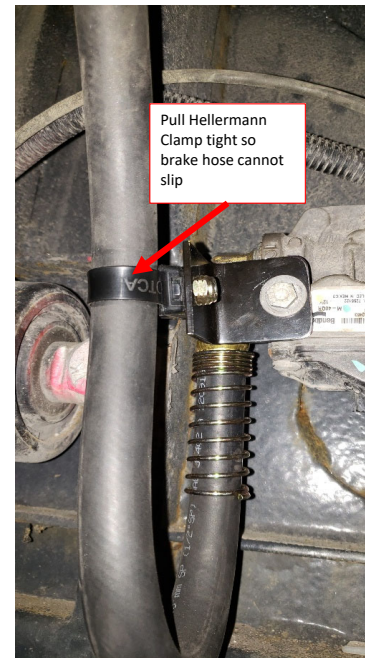
Step 2: Remove bolt (usage in step 3) from P-Clamp from interior wheel fender currently holding brake hose. P-clamp can be discarded.

Step 3: Add Bracket Standoff and re-secure hose with Hellerman Clamp.
