**THIS IS A TECH TIP, NOT A TECHNICAL BULLETIN.
TECH TIPS ARE NOT ASSOCIATED WITH WARRANTY CLAIMING.**

Model(s)	Year	Eng. Code	Trans. Code	VIN Range From	VIN Range To
Golf, GTI, Golf Sportwagon, Alltrack	2015	All	All	All	All

Customer concern indicating that the radio display flickers while radio is ON.

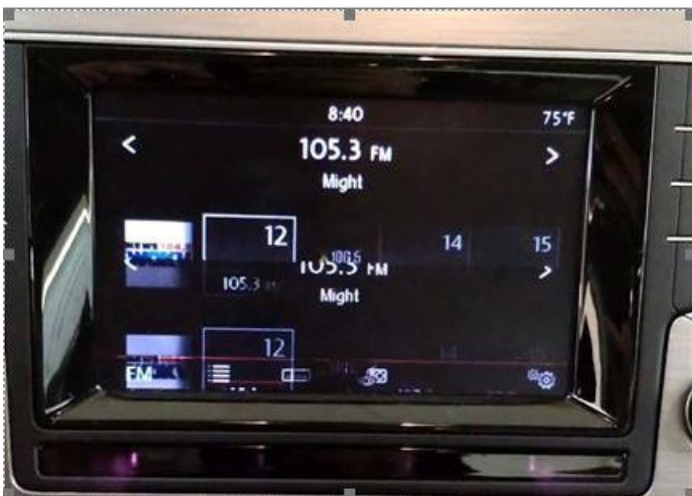
Figure 1: Example of radio flickering

Replace the **-J794-** Information Electronics Control Module 1, 5F module. After performing the replacement test plan, perform the control module software configuration test plan and the function clearing system FES test plan, selection #2.
