Latest Vehicle Concern Fixes

Outer Door Seal Adrift

18 - 20MY E-PACE

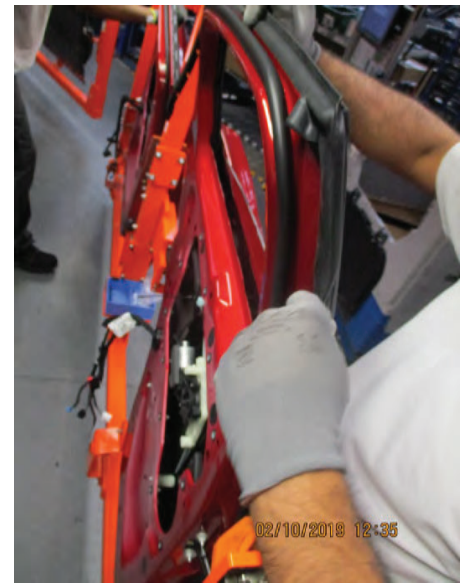
- A customer may report a wind noise or that the door seal is coming loose.

- The door seal may be coming loose from it's retaining clips or incorrectly positioned.

- Engineering is currently investigating this concern and request your support by reporting any door seal concern via EPQR.
- Please include pictures of the door seal and any customer verbatim regarding the symptom experienced.
