EL20-010
 NTB20-042
 June 17, 2020

2020 TITAN AND TITAN XD; AV CONTROL UNIT REPLACEMENT PROCESS

APPLIED VEHICLE: 2020 Titan and Titan XD (A61)

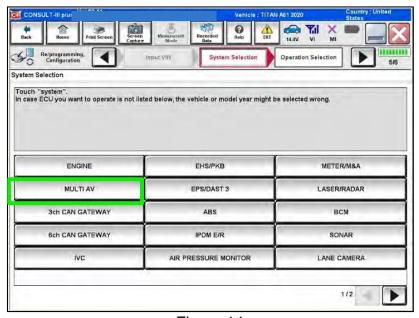
Figure 14

27. Select MULTI AV.

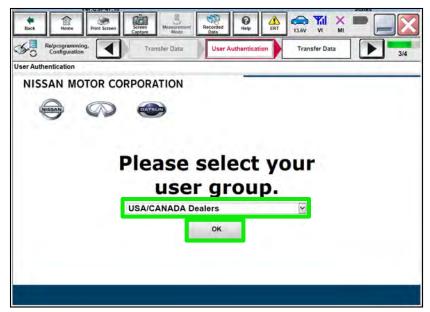
Figure 24

38. Select your user group from the drop down menu, then select **OK**.
