## Warranty Extension: Daytime Running Lights LEDs

Supersedes 19-042, dated December 7, 2019 to revise the information highlighted in **yellow**

Year	Model	Trim	VIN Range
2016-17	Accord	ALL	Check the iN VIN status for eligibility.
2017	Accord Hybrid	ALL	Check the iN VIN status for eligibility.

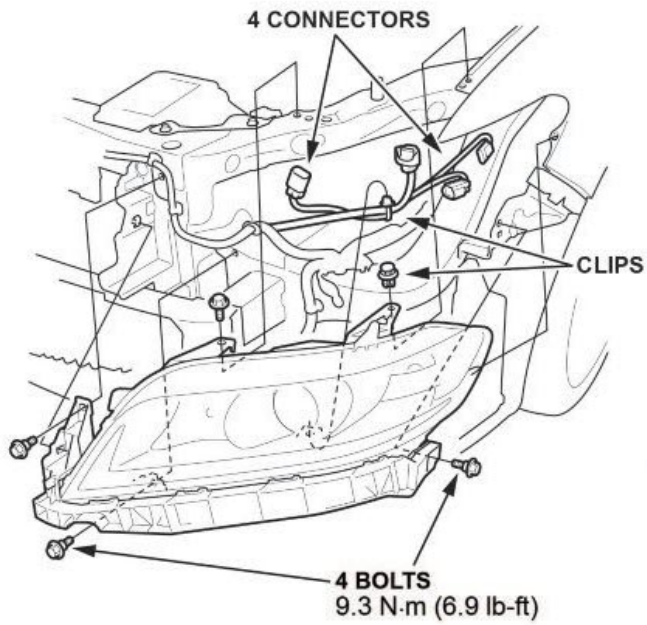
**2-DOOR**

- 2.1. Remove the bolts.

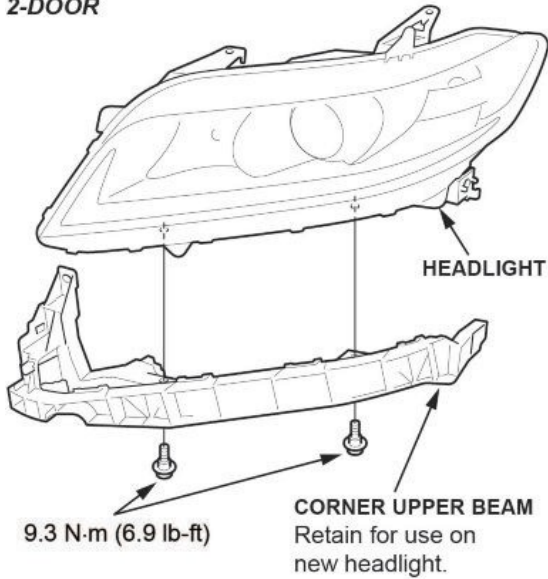
**2-DOOR**

- 2.5. Remove the two bolts to separate the headlight from the corner upper beam, and drill a hole in the headlight to ensure it will not be reused.

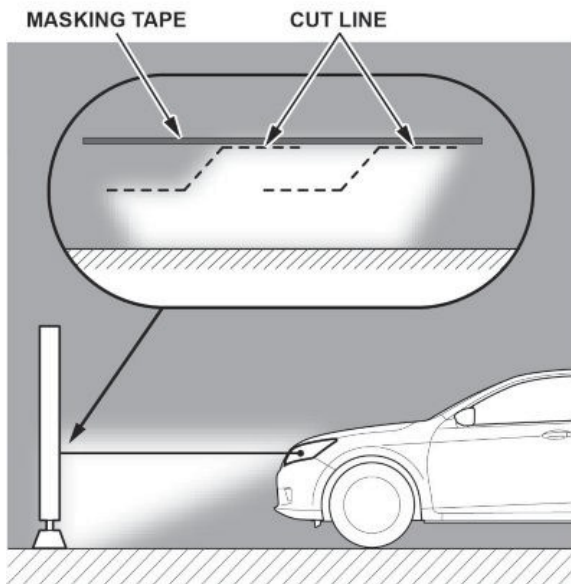
- 6.4. Turn on the low beam headlights.

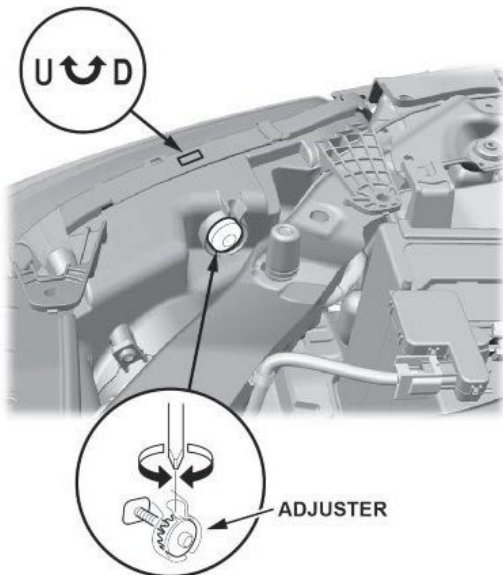
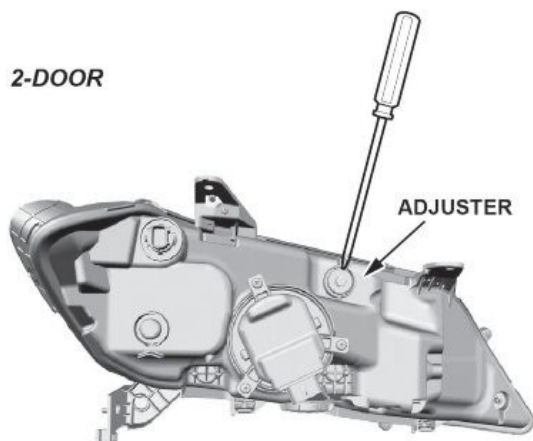
2-DOOR

- If the beam is at the same level as the masking tape, the headlights are properly aligned.
- If the beam is higher or lower than the masking tape, adjust the headlight(s) by opening the hood and turning the adjuster until the beam is level with the masking tape.
