## Implausible "service due" instrument cluster message, head unit pop-up, or MMC message

| Topic number | LI00.20-P-070791 |
| Validity | Model series 118, 167, 177, and 247 |

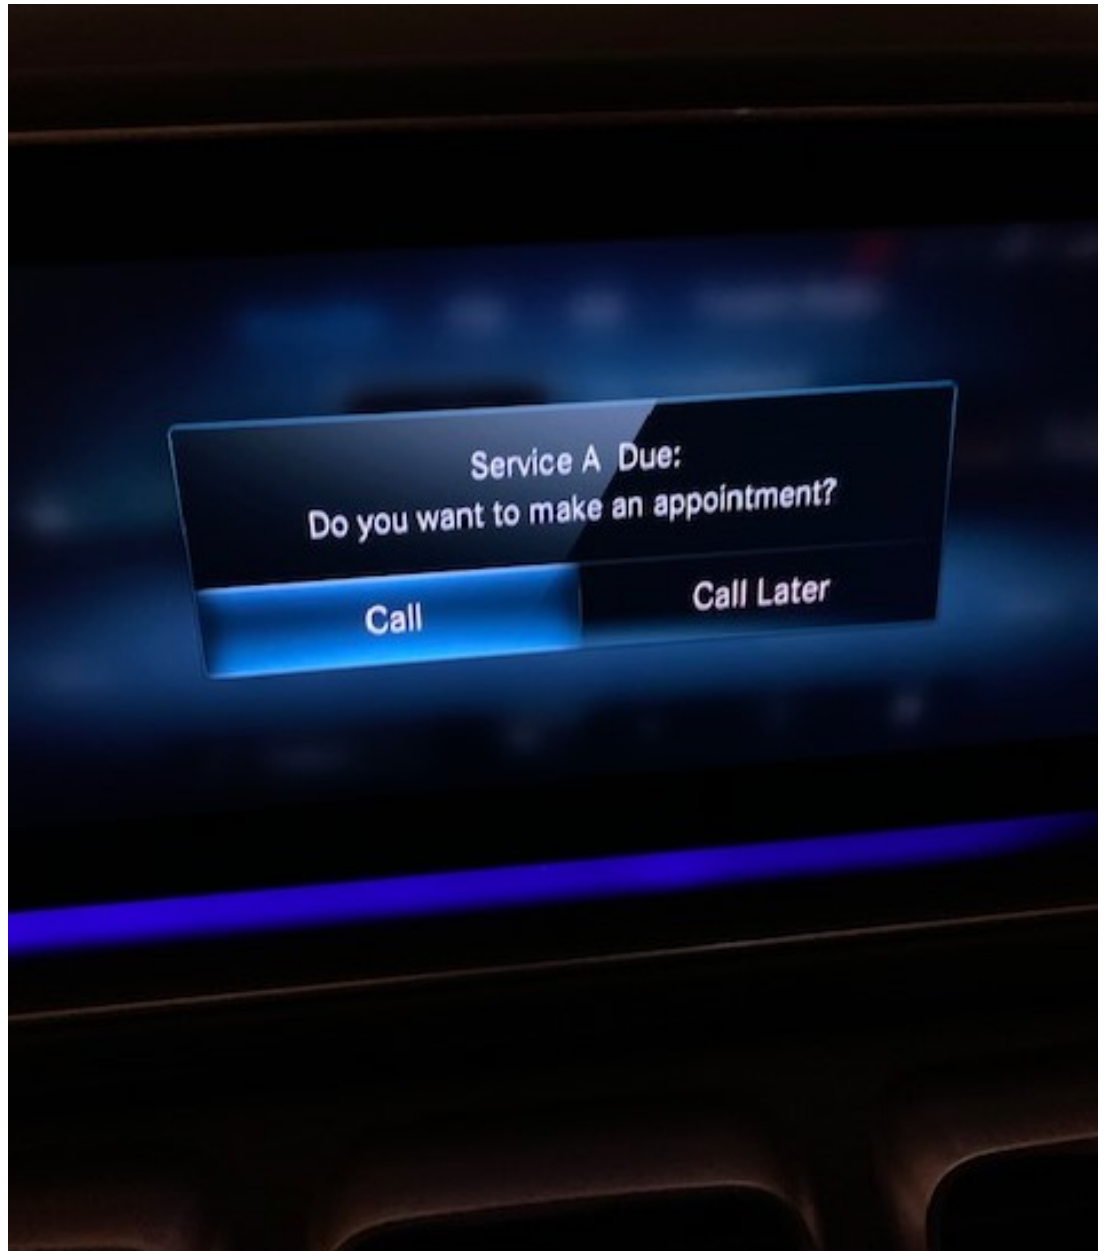
service lead popup example.jpg:

- "Service A/B Due" message is displayed in the instrument cluster before the appropriate mileage or date is reached
- "Service A/B Due: Do you want to make an appointment?" pop-up message in the head unit display (see attachment) before the appropriate mileage or date is reached
- "Your Mercedes-Benz \_ is due for service." MMC service lead email or App message (see attachment) is sent to the customer before the appropriate mileage or date is reached

| Attachments | |
|---|---|
| service lead popup example.jpg | Service Lead head unit popup message |
