Document ID: IK0800284
Revision: 25
Created: 5/16/2011
Last Modified: 7/28/2020
Author: Charles Schroeder

Title: Ambient Air Temperature (AAT) Sensor Faults/Location/Diagnostics

Applies To: Navistar N13 Engines and Cummins ISX Engines Cummins ISB, N9 and N10

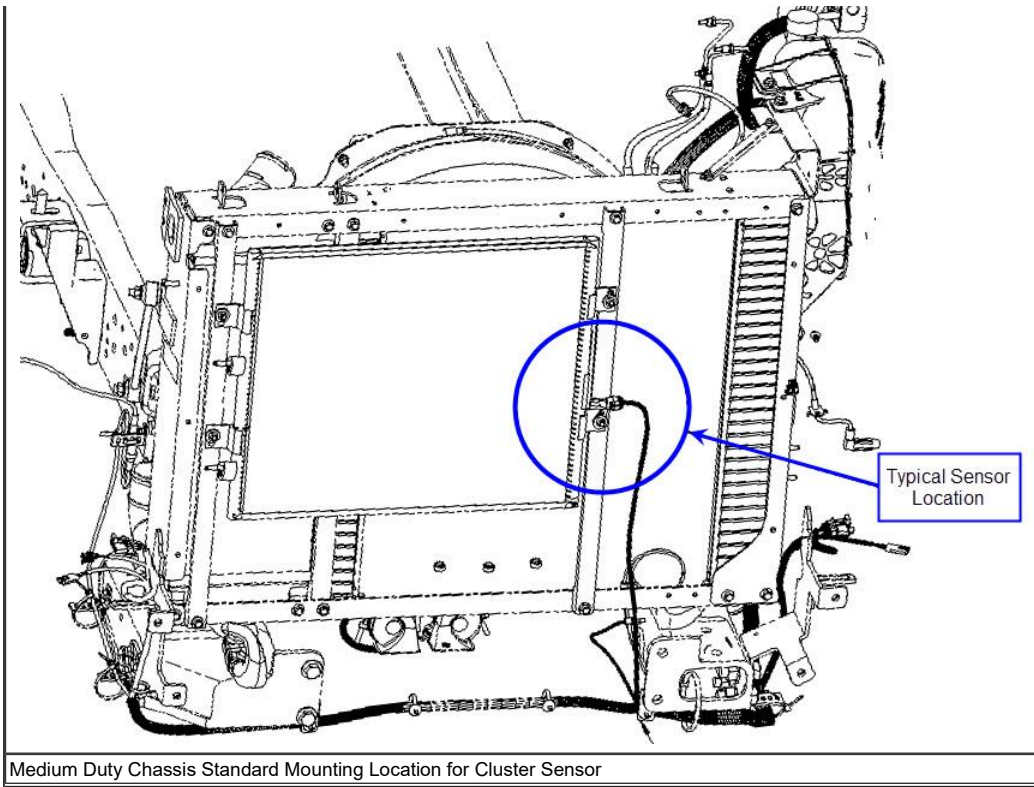
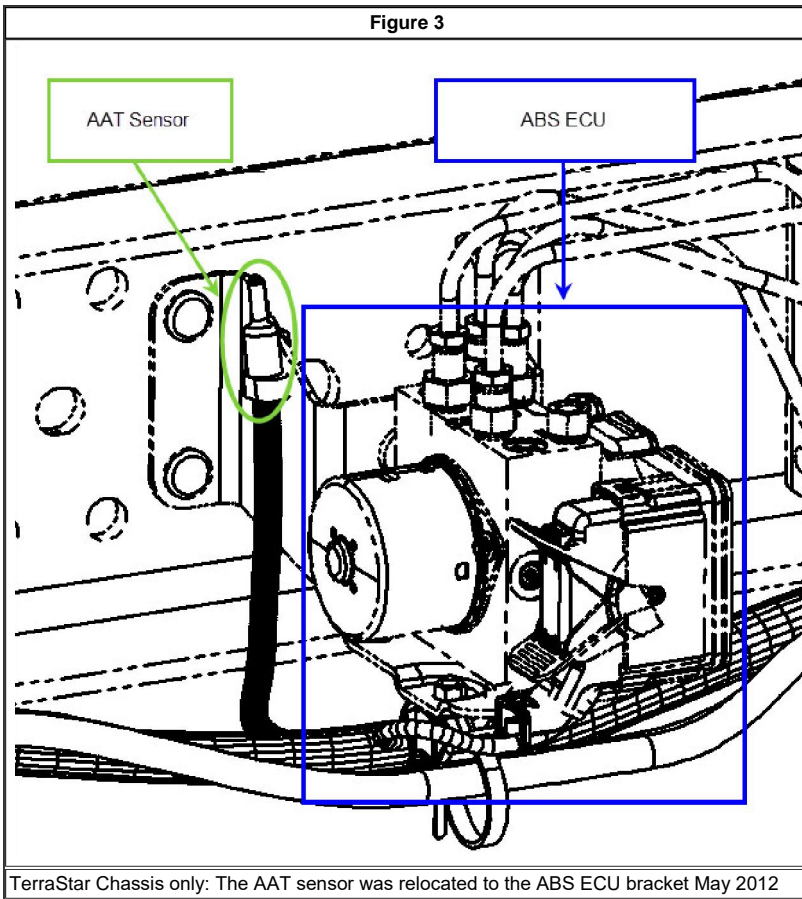
The Cab Temperature Sensor is typically mounted near the front bumper or on the cooling package. If the sensor cannot be found verify the wiring to the gauge cluster is present or that the outside air temp monitor feature as ordered on the truck.

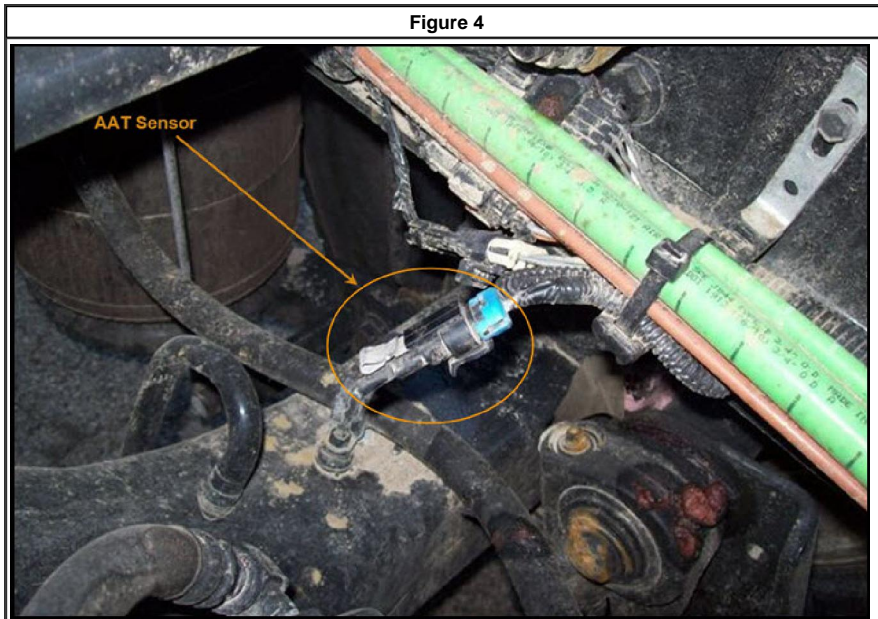
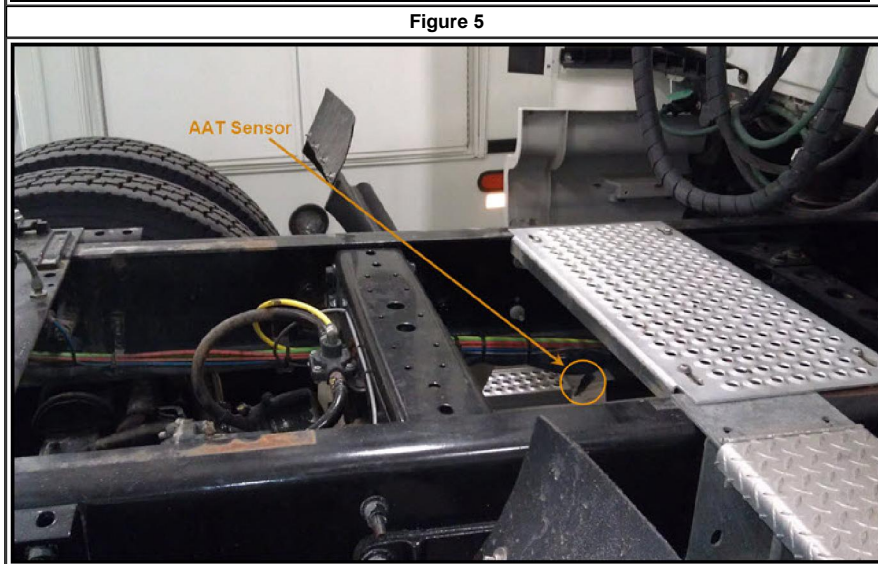
Big Bore Pre-SCR Engines and SCR Engine prior to August 2013:

The engine sensor is located on the left frame rail midway between the back of cab and front drive axle, or near the front drive axle. The two photos below show both possible mounting locations (*Figure 4 and Figure 5*).

There are two ambient temperature sensors. The sensor located behind the cab along the left frame rail is the sensor the engine uses. To confirm this, unplug the sensor and observe the cluster LCD display, if the reading stays the same, the correct sensor is unplugged. There is also a sensor located at the front of the chassis that the gauge cluster uses for the temp display.

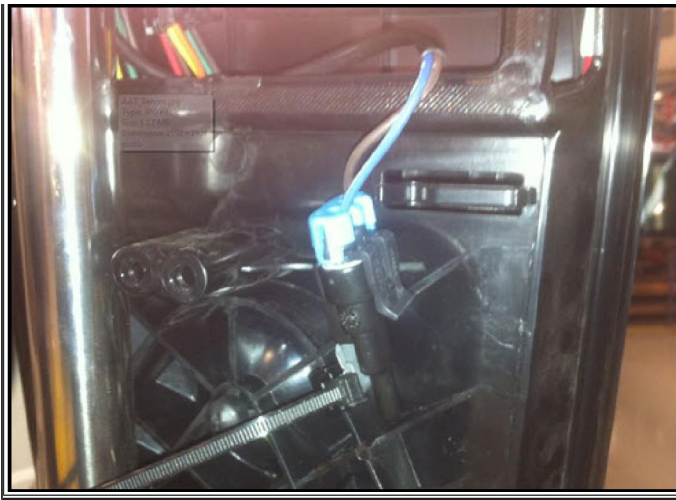
Big Bore Post August 2013 build w/SCR engine, driver's side mirror head (*Figure 6*):

This article begins and discusses the Engine AAT Sensor, prior to and first. After August 23, 2013, Some SCR engines have the Engine AAT sensor mounted in the driver side mirror head and alternatively the sensor could be mounted to the horn bracket. The location depends on build date.

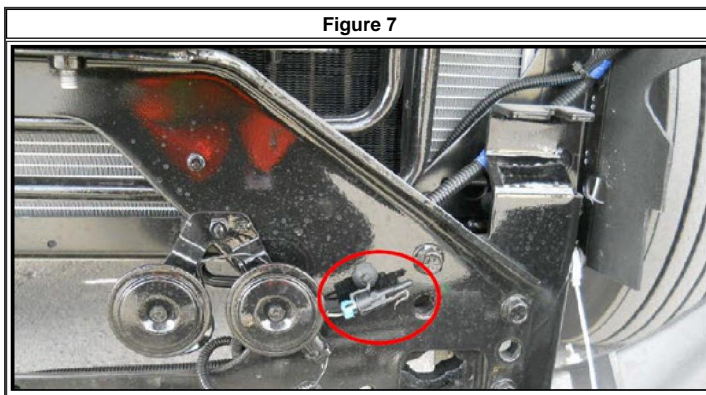
Figure 7

ISX15 and N13 Alternate Location (Figure 7):

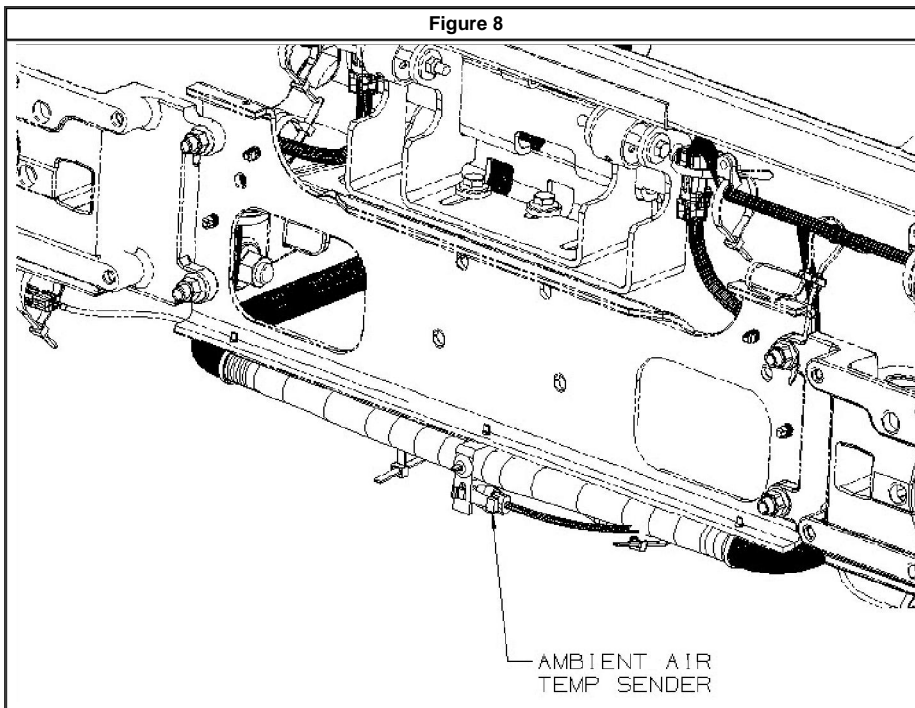
Figure 8

ISX15 and N13 Alternate Location PayStar / 9900i (Figure 8):

AMBIENT AIR
TEMP SENDER

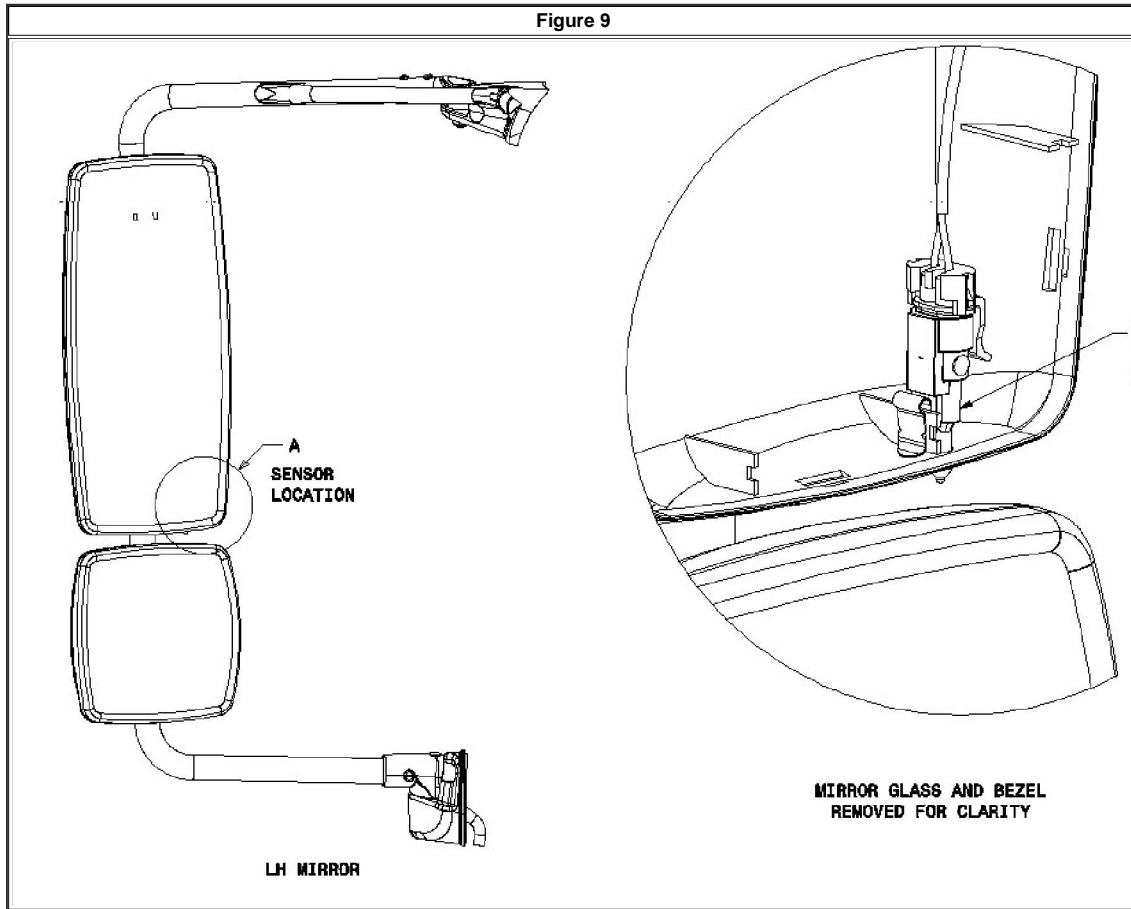
N9/10 and ISB engine platforms moved the Engine AAT to the driver mirror on August 8, 2014 (Figure 9):

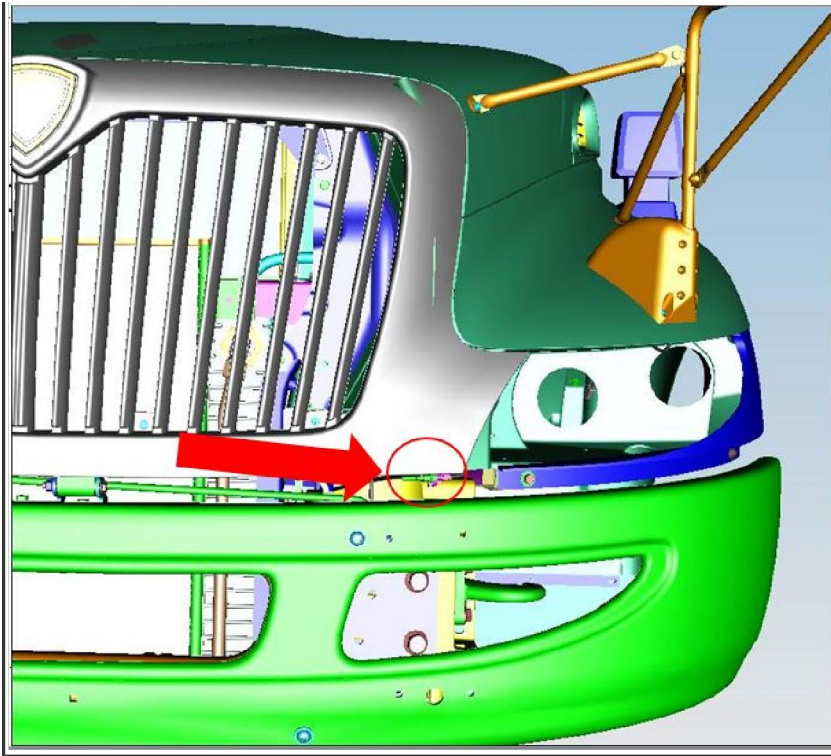
Location prior to August 8, 2014 on CE Bus

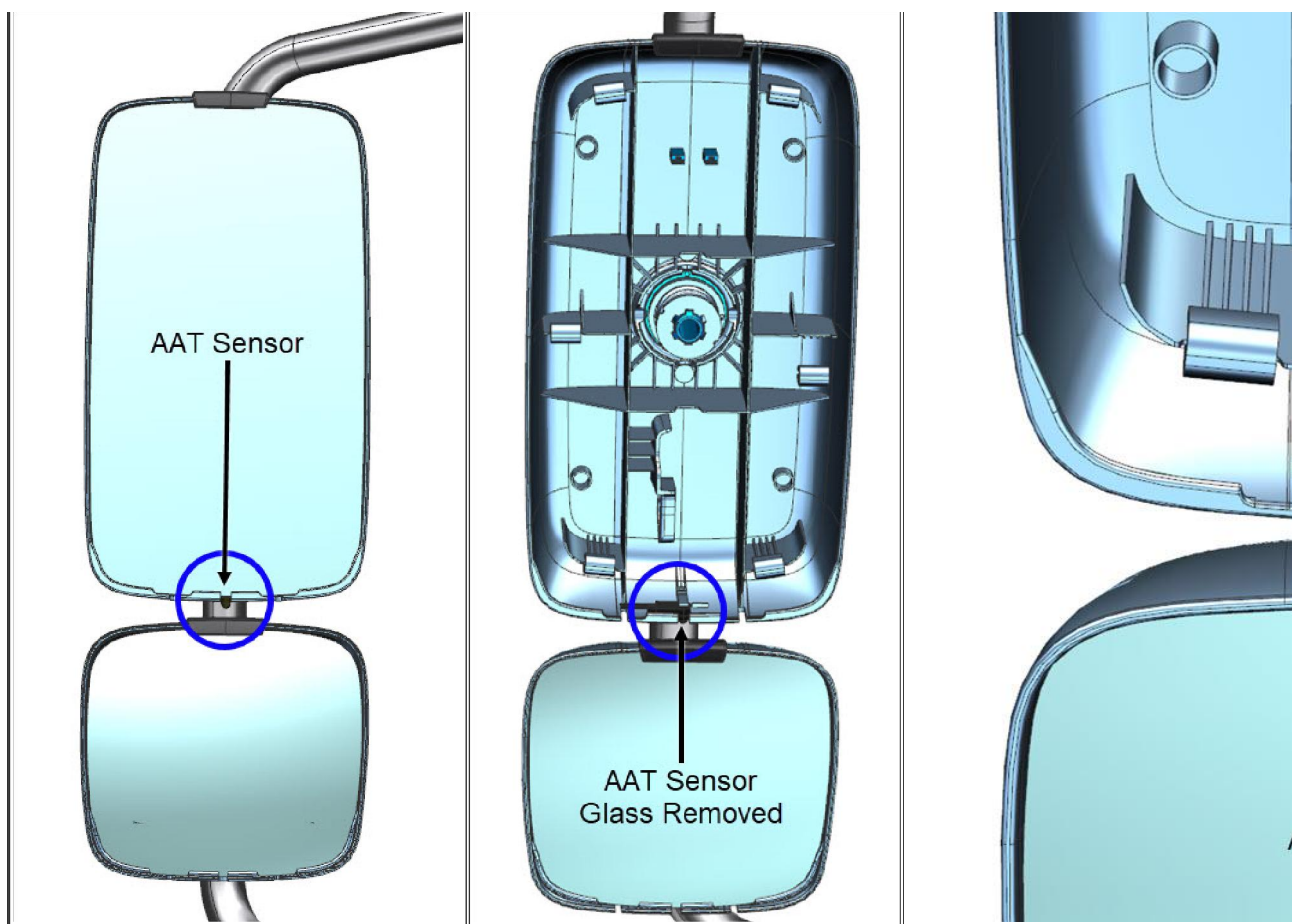
Figure 11	Figure 12

HX Location - Driver's Side Mirror Head
