72 Squeaking noise from the front seat height adjustment

72 20 27 2059448/2 July 16, 2020. Supersedes Technical Service Bulletin Group 72 number 20-24 dated May 11, 2020 for reasons listed below.

Model(s)	Year	VIN Range	Vehicle-Specific Equipment
Q5, SQ5	2018 - 2020	All	Not Applicable

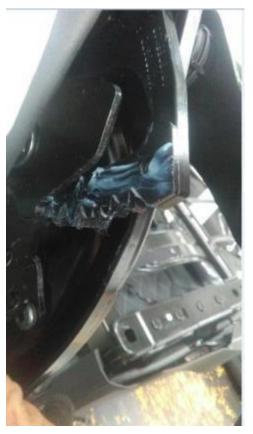
Figure 3. Grease applied to the seat height adjustment toothed segment.

Apply grease spray part number G 052 778 A2 on the toothed segment as shown in Figure 3 (lubricate teeth and lateral surfaces).

- 5. Reinstall seat frame trim panel and install the seat in the car according to Elsa Repair Manual.
- 6. Adjust the seat up and down three times covering the full range of vertical movement to equally distribute the grease on the toothed segment.
