Field campaign

Topic	Trim Strip For Rear Panel Brake Light – Blackware - Paint Adhesion (SC18/05)
Market area	Australia E04 Bentley rest Asia and Australia (6E04),Germany E02 Bentley rest Europe (6E02),United Kingdom E01 Bentley UK (6E01),United States E05 Bentley USA and rest America (6E05)
Brand	Bentley
Transaction No.	2049646/3
Campaign number	EB02
Note	
Type	Workshop Campaign
US code

Bentley Continental GTC / Supersports GTC

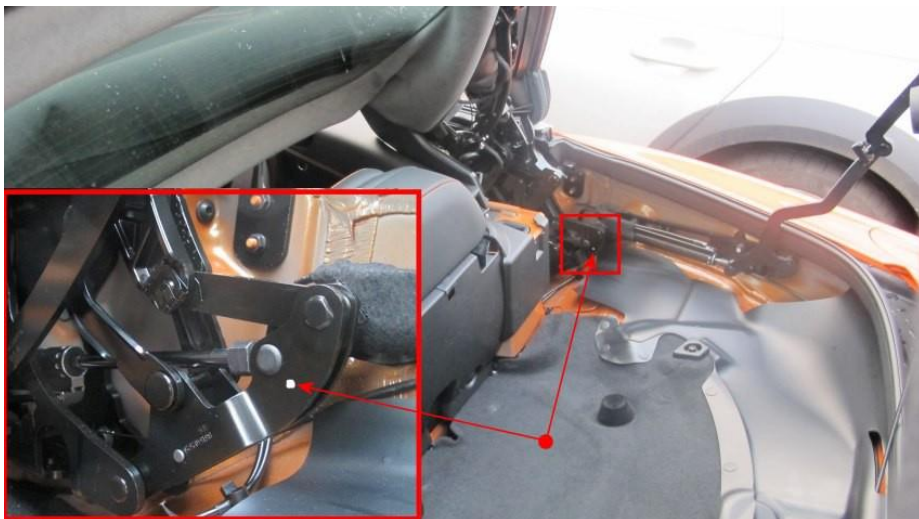
If the vehicle is not already listed as repaired in the "Repair history" (in Elsa pro), check for the presence of a white campaign identification mark on the convertible roof mechanism - see Figure 1 - should neither be evident carry out the required work in accordance with these instructions.

Upon completion apply a white campaign identification mark on the convertible roof mechanism - see Figure 1.
