# Service Bulletin

Bulletin No.: 20-NA-127

**Subject: Rear Brake Lights Stay Illuminated All the Time**

Brand:	Model:	Model Year:		VIN:		Engine:	Transmission:
		from	to	from	to		
Chevrolet	Bolt EV	2017	2020	—		All	All

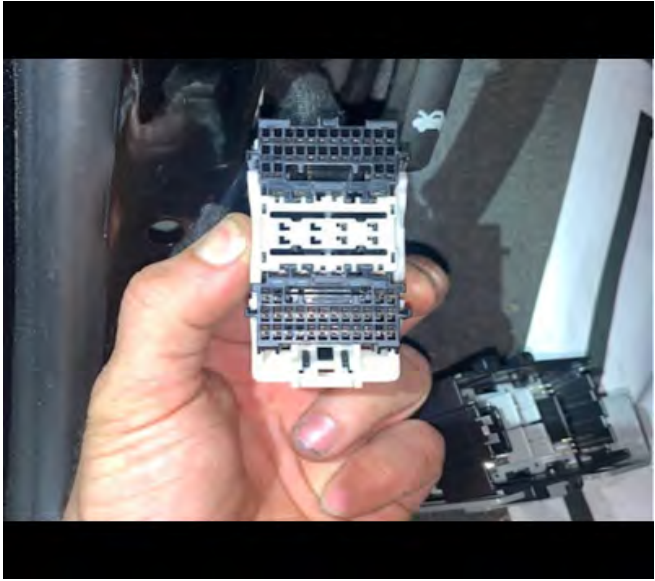
</div> <p style="text-align: right; font-size: small;">5608493</p> <p>The cause of the condition may be a loose/damaged X200 connector at the left A-Pillar near the floor.</p>
<b>Correction</b>	Test for a loose connection at the connector to see if the brake lights will turn on/off. If found to be loose, repair the connection at the X200 connector.

If you encounter a vehicle with the above concern, remove the front side door sill garnish molding and move the harness above the X200 before unplugging to see if the brake lights come on or flicker. Refer to *Front Side Door Sill Garnish Molding Replacement* in SI. Open the connector and inspect for internal damage to the connector and terminals.

- If the X200 connector is not fully seated or damaged, repair as necessary.
- If the X200 connector is fully seated and no damage can be found, continue diagnosis referring to SI.
